70TH ANNUAL CONFERENCE FOR PROTECTIVE RELAY ENGINEERS

MICROPROCESSOR RELAY DIRECTIONAL CHANGE DURING CURRENT REVERSAL

CENTERPOINT ENERGY – HOUSTON, TEXAS

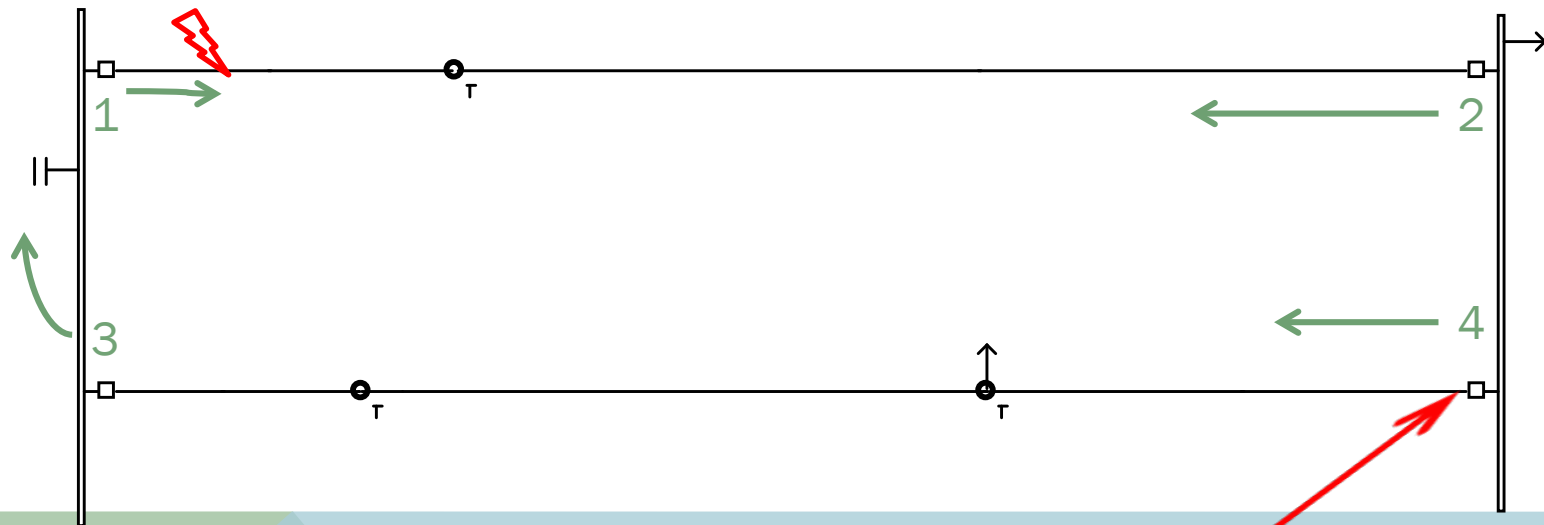
TOPOLOGY OF AREA – FAULT CURRENT DIRECTION

- An SLG fault occurred on one transmission line of a parallel circuit
 - Fault duration was 83.33 ms (5 cyc at 60 Hz).
- After one end cleared, one terminal of a parallel line operated.
 - There was no fault on this parallel line.
 - A reverse fault appeared to be forward
 - Reverse fault current value was higher than the instantaneous overcurrent pickup value.

Relay with the unintended operated

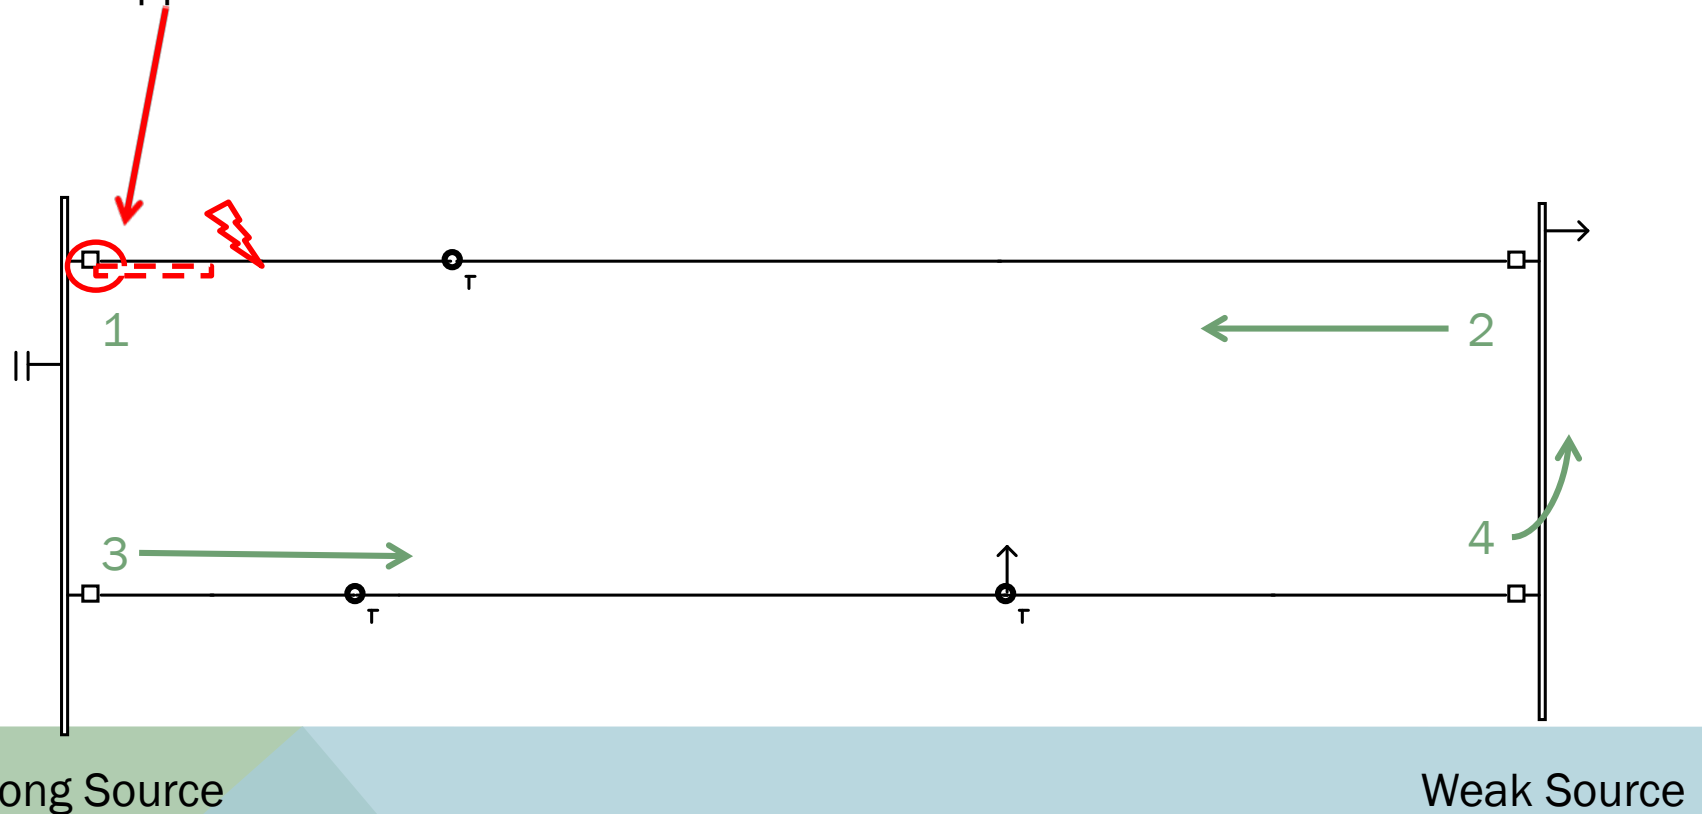
TOPOLOGY OF AREA – CURRENT REVERSAL

BKR's Tripped

- There's a current reversal on the parallel line after an end has cleared
- This is more likely to happen on parallel lines

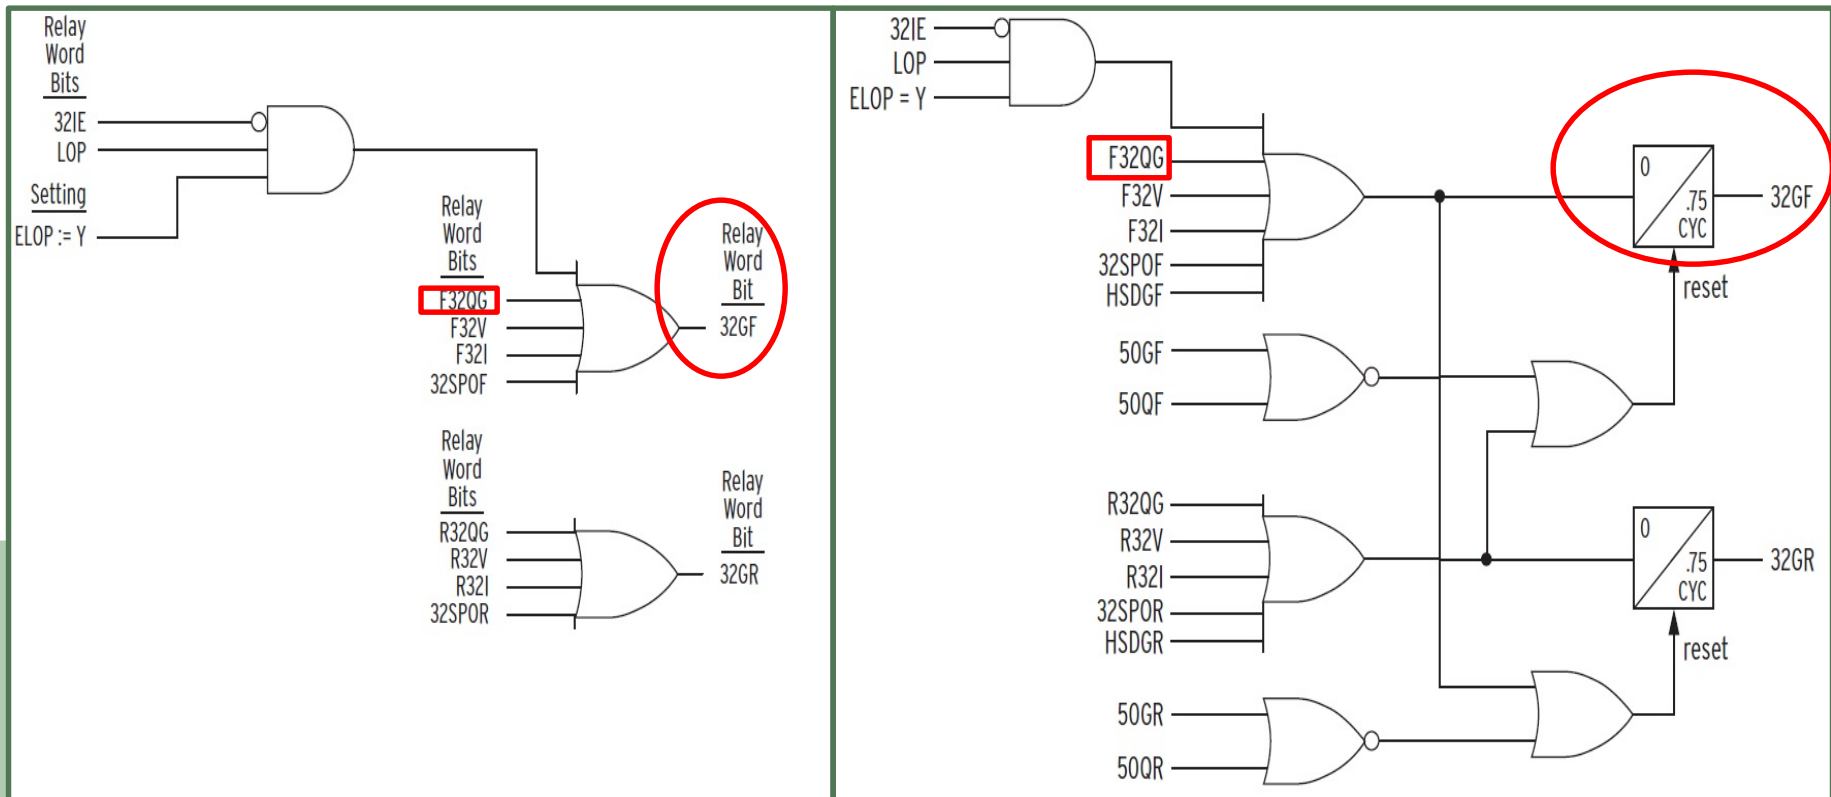
CHANGE IN RELAY LOGIC

- It was also realized that the relay settings didn't account for a change in the directionality logic
 - A directional element dropout timer led to the relay still seeing a forward fault when other directional elements dropped out
 - This forward decision and the high reverse current led to the ground instantaneous overcurrent element operating
-

- There was a dropout timer added to the relay's directionality logic for ground directional elements

- Initially, the torque control was set to 1 since there was no dropout time delay between F32QG and 32GF in the original logic
 - 32GF used to establish forward direction for the ground instantaneous overcurrent tripping element
 - An adjustment can be made by torque controlling with the F32QG element
- The forward ground instantaneous element picking up for a reverse fault would have been difficult to test since studies are usually done to test the forward pickup
