Voltage Potential Device Impact on Negative Sequence Directionality

Sophie Gray, P.E.
CenterPoint Energy – Houston, Texas

70th Annual Conference for Protective Relay Engineers
Texas A&M University – College Station Texas
April 3 – April 6, 2017

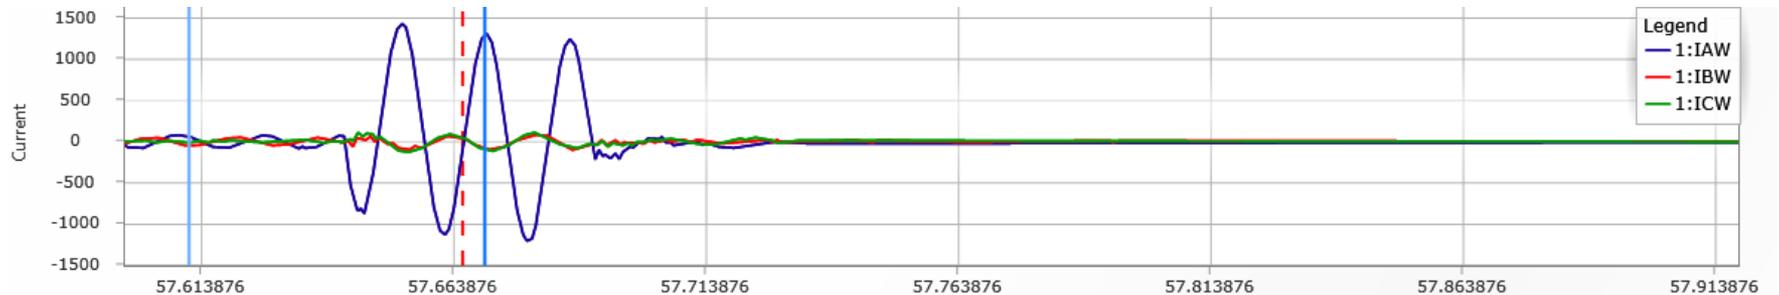
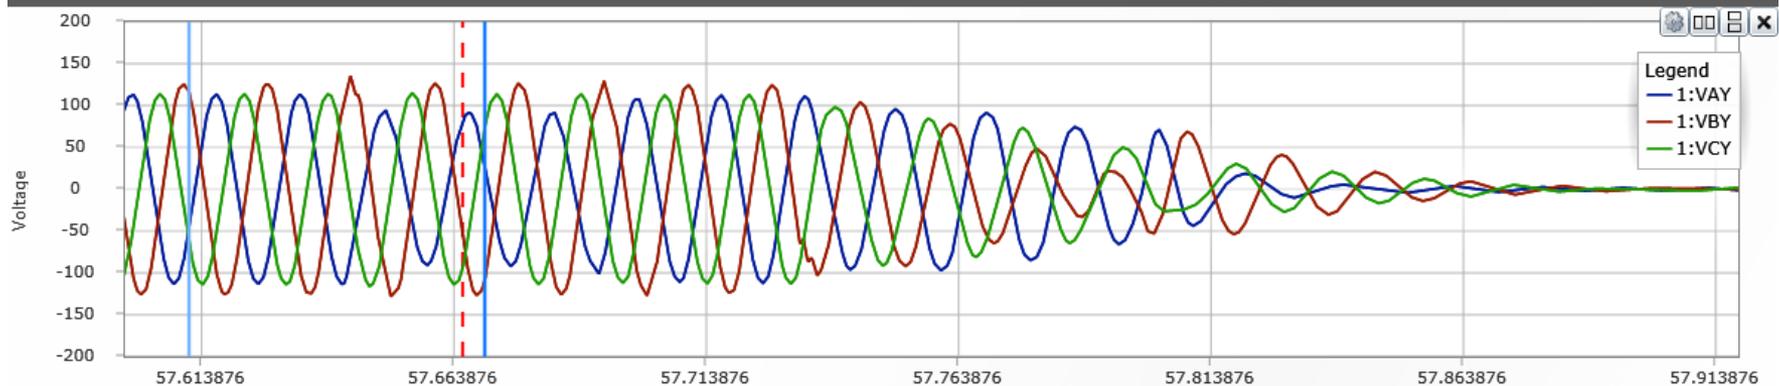
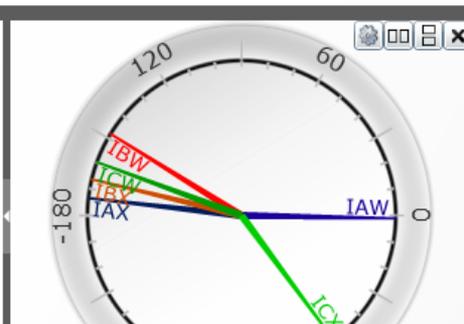
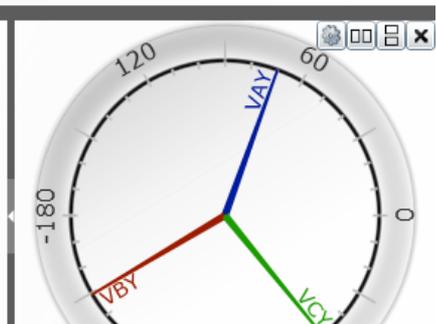
The relay's measured quantities at one end of the line that misoperated are shown below.

Co	Name	Mag	Angle
1	1:IAW.Phase	922	-1.08
1	1:IBW.Phase	59.1	148
1	1:ICW.Phase	72.6	160
1	1:ICX.Phase	258	-53.3

Co	Name	Mag	Angle
1	1:VAY.Phase	64.2	70.1
1	1:VBY.Phase	89.6	-149
1	1:VCY.Phase	81.7	-50.7

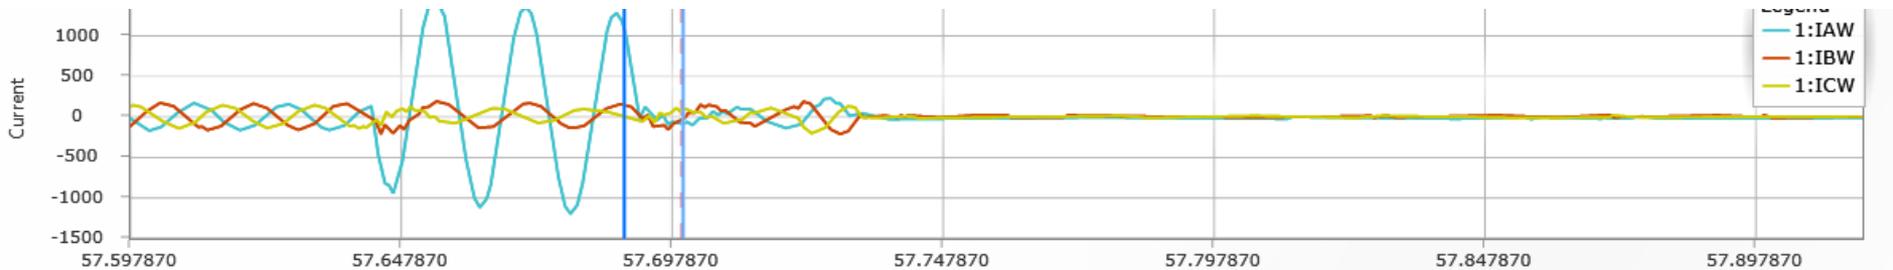
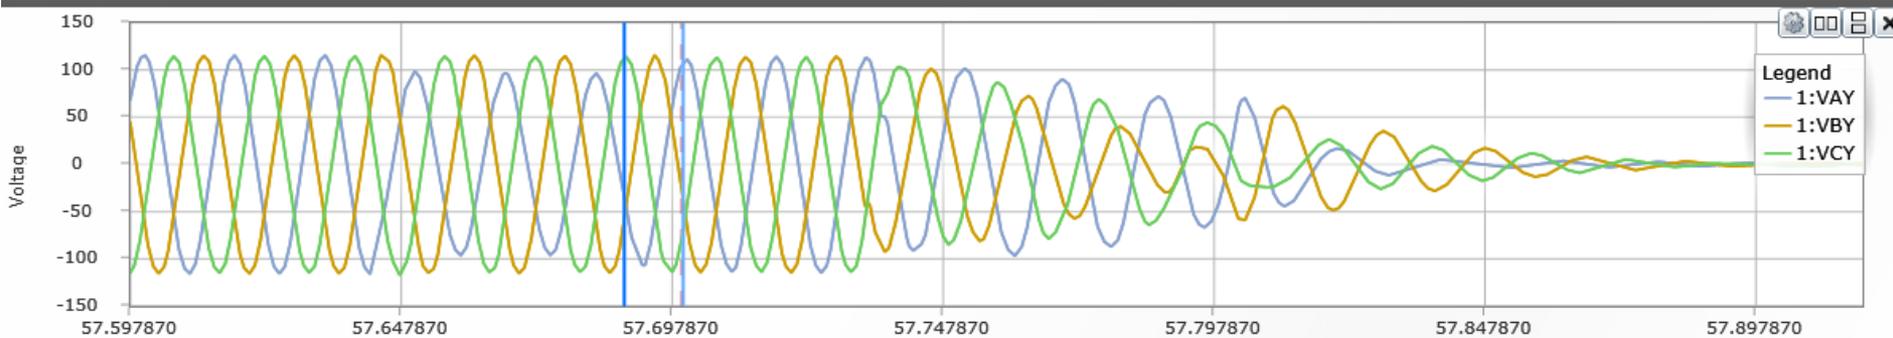
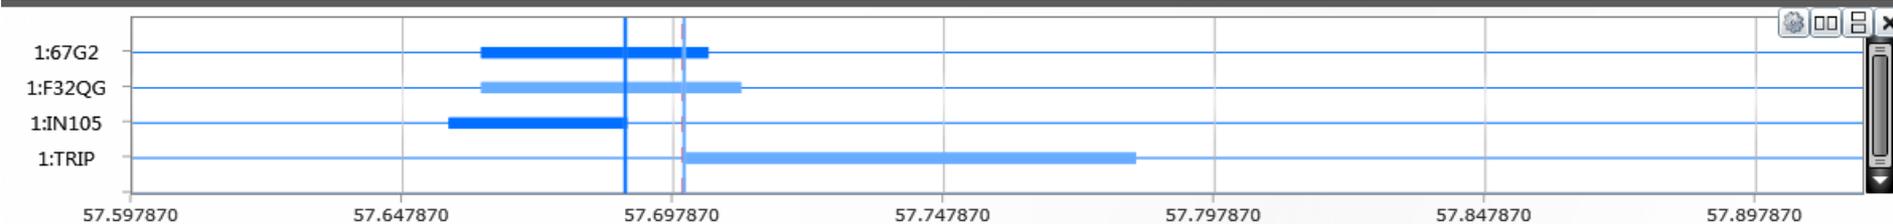
Shown below is the relay's oscillography at the other end of the line that misoperated.

Co	Name	Mag	Angle
	1:VAY.Phasor	68.4	113
	1:VBY.Phasor	81.8	-123
	1:VCY.Phasor	80.5	-5.61

- ▶ Root cause of both relays that misoperated stemmed from a defective B-phase CCVT at one end.
 - Line that misoperated is short (1.5 miles). So voltage readings at both ends should be close in magnitude and phase.
 - When measurements were taken, B-phase CCVT at the end that should have been seeing fault as reverse was giving an inaccurate reading. (During the fault, relay measured 89kV, L-N on B-phase. Nominal voltage at 138kV, L-L should be about 81 kV, L-N and un-faulted phase voltage should only go up slightly during fault)
 - That inaccurate B-phase voltage reading resulted in the relay calculating an inaccurate V_2 value that in turn gave a Z_{2c} value that the relay saw as being in the forward region.

- ▶ Consider feasibility of various mitigation possibilities:
 - Monitor the health of CCVT's to intercept the occurrence of misoperations using, for example, protective relays.
 - Changing out aging or defective equipment.

- ▶ If a problem is detected on equipment on one phase, it is best to replace all three phases w/ the same make and manufacturer equipment to ensure similar performance characteristics.
