A Current Story – When Primary Met Secondary

Genardo Corpuz, *Lower Colorado River Authority*
Swagata Das and Ariana Hargrave, *Schweitzer Engineering Laboratories, Inc.*

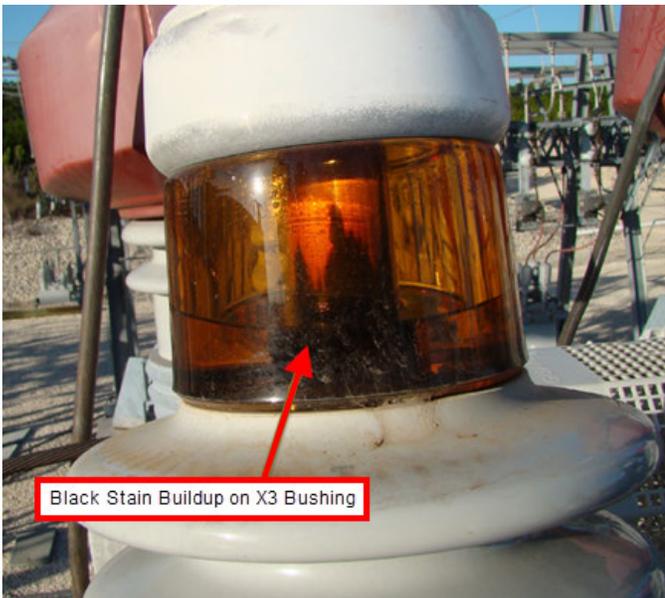
After the test, a visual inspection of the bushings was performed. Although the low-side bushings had tested normal, a black stain was visible through the sight glass on the X1 and X3 bushings, as shown in Fig. 9.

Fig. 9. Black stain buildup observed through the sight glass of the X3 bushing

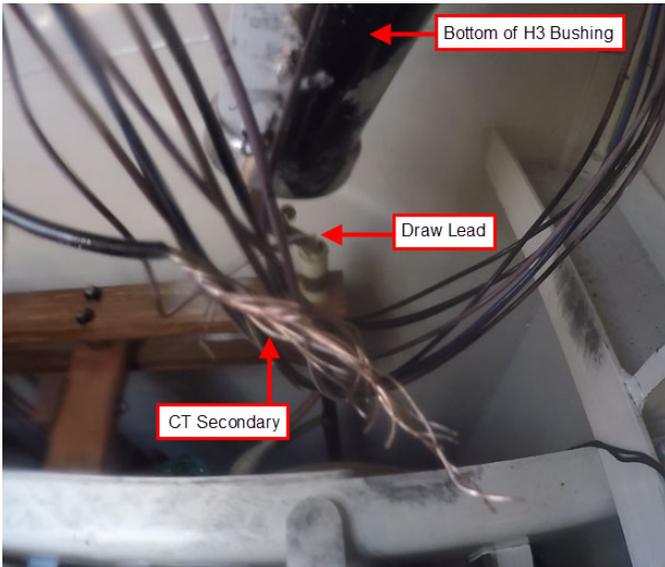
Although the electrical tests described in Subsection C indicated a problem with the H2 bushing, internal inspection found no visible damage on that bushing. Internal inspection did, however, find significant damage on the H3 bushing. In addition to the damage on the H3 bushing, there was also significant damage to the CT secondary wiring associated with that bushing. Three of the CT wires were damaged, broken, and had bare wire exposed, as shown in Fig. 11. The coloring of the wires is no longer visible due to the carbon coating from the fault. It was also noted that the CT wires associated with the H3 bushing had more slack than the CT wires associated with other bushings and were not bundled together. The bottom of the H3 bushing, which showed pitting and carbon deposits from an arc on the lower end shield, is shown in Fig. 12.

Fig. 11. Broken CT wiring and damaged H3 bushing

Once the root cause of the transformer failure was identified, the process of repairing the transformer began. The utility replaced two 115 kV bushings (H2 and H3), the pressure relief device, and the secondary wiring for all of the CTs. The utility decided not to replace the low-side bushings because they believed that the staining found on those bushings was likely there before the fault occurred and would have been found during routine five-year maintenance testing. The cost of procuring all of this new equipment amounted to thousands of dollars. Other significant costs to the utility included rolling trucks; testing, draining, repairing, and refilling the transformer; personnel time; and revenue lost during the outage.

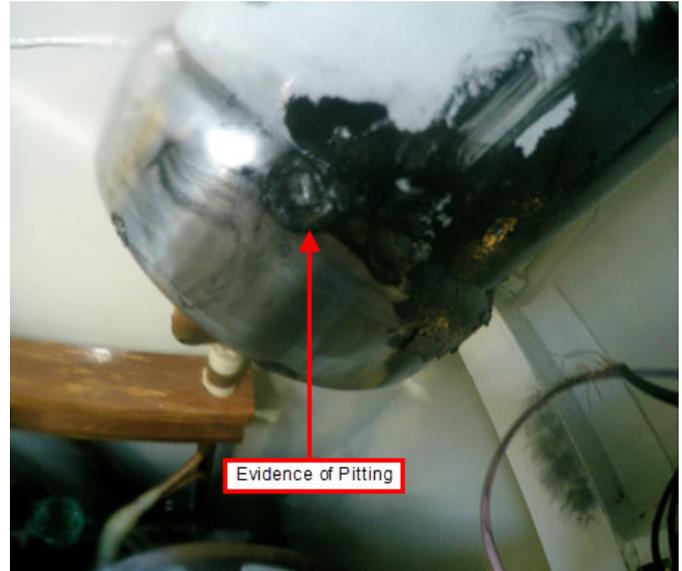
Fig. 12. Close-up view of the pitting observed in the bottom of the H3 bushing

Physical damage was clearly evident on the H3 bushing, so why did the H2 bushing fail the power factor test while the H3 bushing passed? It is important to understand that a lower power factor measurement does not necessarily mean that the bushing experienced a fault and could simply be a result of regular deterioration. In the case of the H3 bushing, the fault was located at the lower end shield and did not affect the insulation or the results of the power factor test.

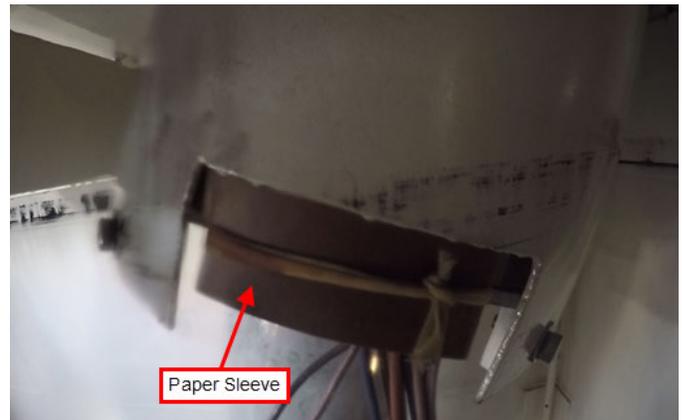
The utility reported that extensive cleaning would need to be completed before the transformer could go back in service. Fig. 13 shows a line of carbon at the top of the tank, where carbon was floating on the surface of the oil. There was also some carbon sediment sitting on the core and at the bottom of the tank. Although the bushing itself is removed, Fig. 13 still shows the metal casing that holds the CTs at the top of the tank, along with the paper sleeves where the CT wiring is routed out and away from the bushing.

Fig. 13. Carbon at the top of the transformer tank

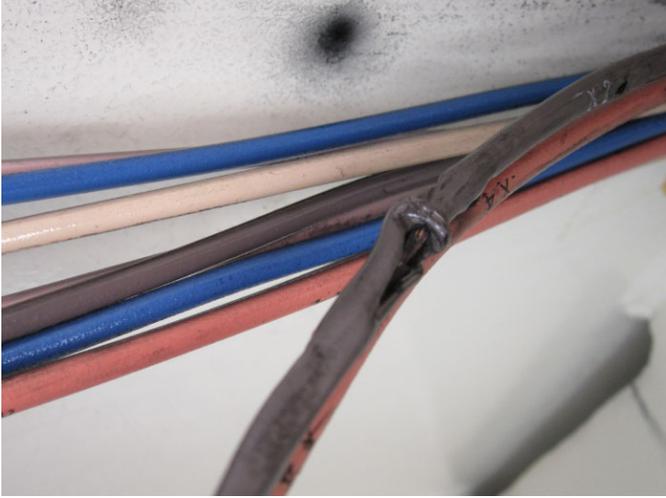
Evidence of arcing and insulation punctures was found in the CT secondary wiring going toward the junction box, as shown in Fig. 14. High-side CT Junction Box J1 was completely burned, as shown in Fig. 15. CT wiring from this box is routed to the current inputs of the transformer differential relay (Relay Y) and the backup overcurrent relay (Relay Z). The other three junction boxes were not damaged.

Fig. 14. Arcing to the tank and punctures on CT secondary insulation

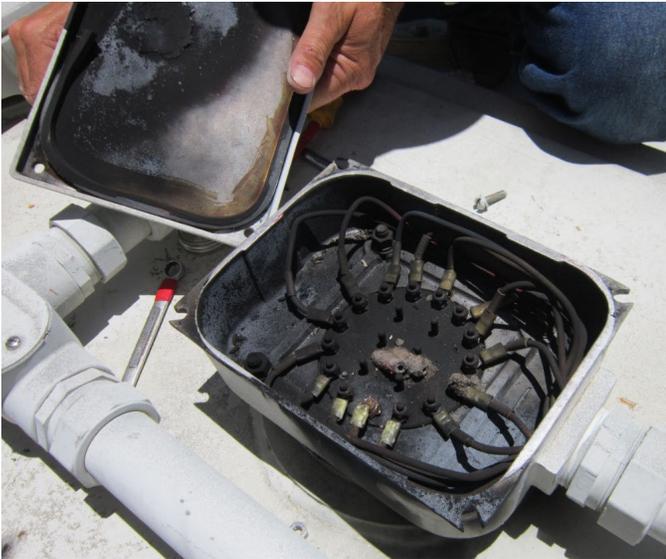
Fig. 15. Damage to high-side Junction Box 1

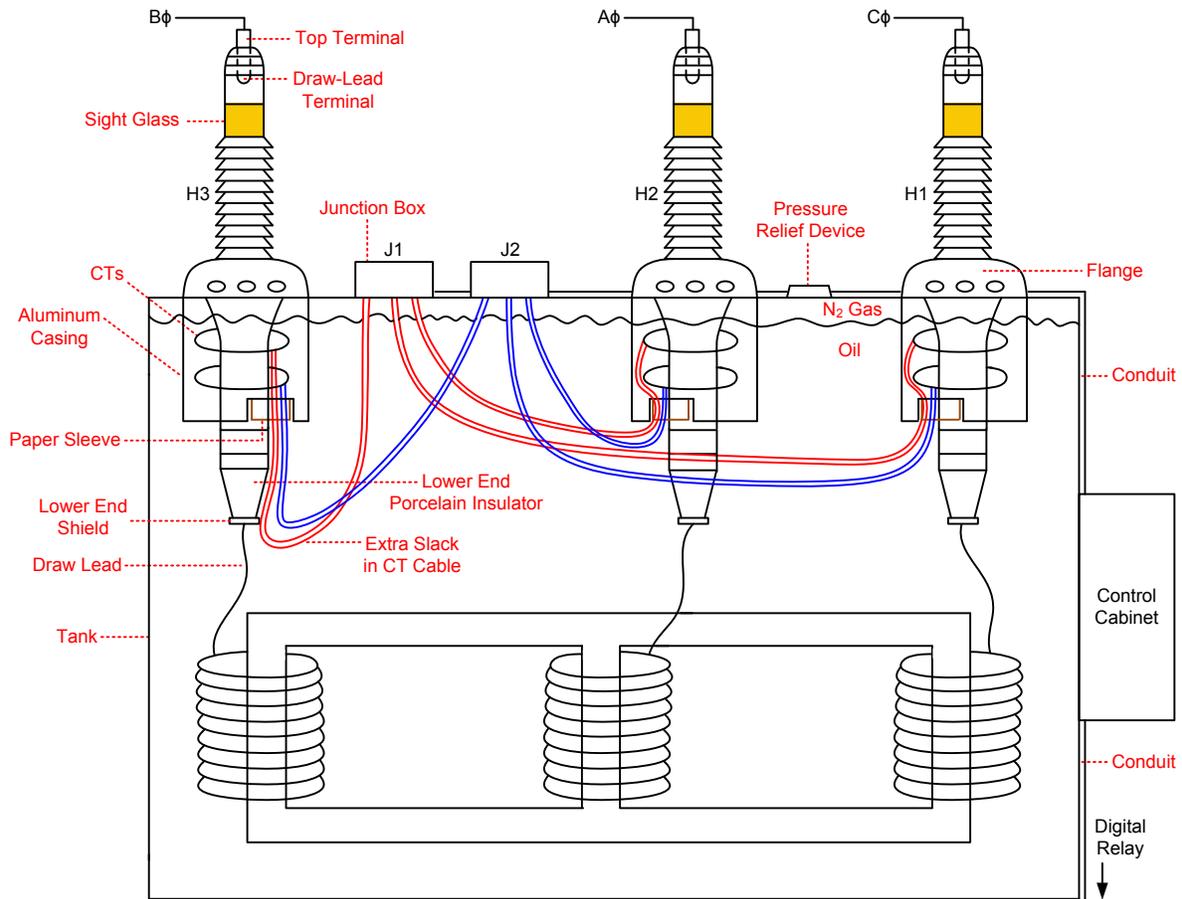
It was theorized that the excess slack in the CT wiring allowed the wires to fall low enough to make contact with the lower end shield at the bottom of the H3 bushing (see Fig. 16). Because the lower end shield is at line potential (80 kV) and the insulation of the CT secondary wiring is rated for only 600 V, a catastrophic insulation failure occurred when the CT secondary insulation made contact with the lower end shield. The insulation failure subjected the secondary CT wiring, along with the CT junction box, to primary-level voltage and caused an arc to ground at the junction box.

The internal inspection described previously led to additional questions. What caused this excess slack in the CT secondary wiring? Why was the wiring not bundled? Initially, the utility thought that the CT secondary wiring could have been moved if a bushing had been replaced, but their records showed that no such maintenance had been done. Therefore, the utility concluded that the lack of bundling and excess slack must have been a manufacturing defect. However, the transformer had been in service since 1994. If this was indeed a manufacturing defect, why didn't this fault occur sooner? What changed between 1994 and 2015?

It is possible that the oil circulating in the transformer tank moved the secondary wires over time until the wires eventually made contact with the bottom of the bushing. Through faults also cause movement inside of a transformer and may have been responsible for moving the wires. In addition, fans are used to cool the transformer and a pump is used to circulate oil in the tank. It is possible that either of these devices turning on or off could have jostled the transformer enough to displace the secondary wiring. However, without data showing when the pump and fans were in operation, the exact cause could not be identified.

Fig. 16. CT secondary associated with the H3 bushing has excess slack and was not bundled

- The fault described in this paper was caused by excess slack and a lack of bundling in the CT secondary wiring, which the utility deemed to be a manufacturing defect. Such defects can easily be identified through visual inspection at the time of installation, before the transformer has been fully assembled or filled with oil. Transformers are very expensive pieces of equipment, and requesting a visual inspection before accepting ownership may be worthwhile if it means avoiding a costly and dangerous fault.

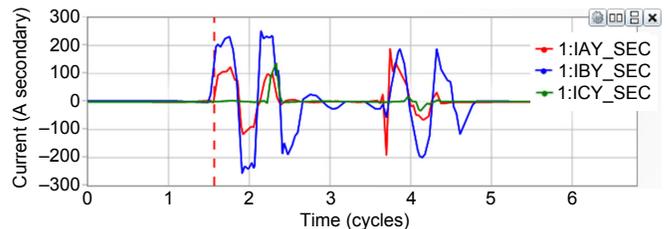
The event report shows that B-phase current (IBY_SEC) spiked first, followed shortly thereafter by A-phase current (IAY_SEC), and then the C-phase current (ICY_SEC) a cycle later. This corresponds to the transformer high-side B-phase CT, located on the H3 bushing, making contact with the primary system first. The fault then quickly propagated to the A-phase and C-phase CTs. Because all CT secondary wiring is routed together from the CTs to the junction box, it makes sense that a fault involving one lead would quickly propagate to the others nearby. Recall that the high-side CTs connected to the transformer relay were routed though Junction Box 1, which is the box that was severely burned after the fault.

Fig. 20. Raw currents on high side of transformer

Note in Fig. 20 that the peaks of the B-phase waveform are flat. The analog-to-digital (A/D) converter of the relay in Fig. 20 is rated for a maximum peak value of 230 A secondary. When the A/D converter is exposed to current above this limit, it reports its maximum value (230 A), resulting in a waveform that looks clipped. This means that the event report cannot tell us the maximum current that the relay actually saw, but we do know that it had to be higher than 230 A. Recall that the values in the raw event report are the same values that were filtered and reported in the filtered event report in Fig. 18, so the magnitudes and angles in Fig. 18 are also affected.

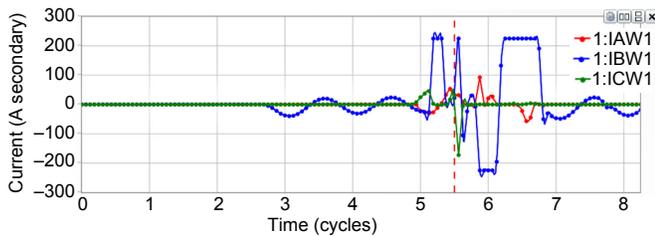
The raw event report from the bus relay, shown in Fig. 24, confirms our theory. For the first couple of cycles, the bus relay sees an external fault and restrains. Then, around Cycle 5, the external CT wiring fault evolved to include the B-phase bus relay CT. A/D clipping occurs on this relay as soon as the amplitude reaches a peak of 225 A secondary. Note that the time axes on raw and filtered event reports cannot be directly compared because of the delay caused by the internal relay filters that produce the filtered event report.

Fig. 24. Raw currents on W1 (corresponding to high side of Transformer T1) reported by the bus relay

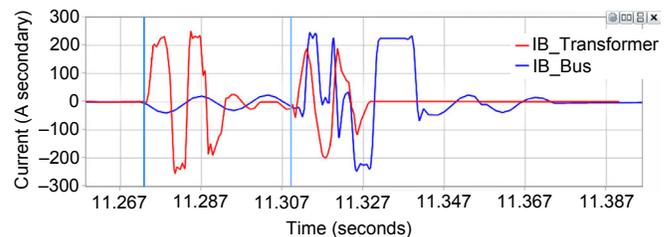
Fig. 26. Raw signals from the B-phase transformer CT (red) and B-phase bus CT (blue)

The first section of the fault, between the two blue vertical lines, shows where the transformer CT wiring made contact with the bottom of the bushing. The bus CT sees the current passing through it to the external fault. The fact that current on the transformer CT changes in magnitude throughout this first section of the fault points to possible arcing. The second

section of the fault, after the second blue vertical line, shows where high currents again began to flow in the transformer CT, and the bus CT also got involved. It is interesting that the current went to zero completely on the transformer CT while the bus CT was still arcing, meaning the circuit switcher had not yet fully broken the fault current. The drop in the transformer CT current is likely a result of the transformer CT wiring burning open and therefore being unable to deliver current to the relay while the bus relay CT wiring was still in the process of melting. The fault current measured by the bus CT goes away exactly 6 cycles after the beginning of the fault, which happens to be the maximum clearing time of the CS1 circuit switcher. This suggests that the circuit switcher was able to clear the fault before the bus CT wiring melted completely.
