# Entergy's Record Flooding Across our Grid

Ricky Daniels Jr  
Entergy Services, Inc.

**Abstract-** This paper will discuss two flooding events that took place across our grid in 2016. Between March 8<sup>th</sup> and 9<sup>th</sup> of 2016 there was eighteen to twenty-one inches of rain in northern Louisiana, and over a foot of rain along the southwest portion of the state. A large portion of the rain water from northeast Texas to northwest Louisiana drains into the Toledo Bend Lake, continuing on into the Sabine River. With the torrential rainfall in the area, the Toledo Bend Lake soon filled up causing the dam to be opened. The Sabine River Authority had to open all eleven flood gates on March 9<sup>th</sup> for the first time in its history causing a massive amount of water to flow into the Sabine River. From August 12<sup>th</sup> to the 13<sup>th</sup> of 2016, a slow moving low pressure system brought substantial rainfall to the Baton Rouge and Kentwood Louisiana area causing record flooding. The rainfall totaled twenty-four inches within two days. This rain system was classified as a "1000 year rain", essentially a .1 percent chance of happening in a given year.

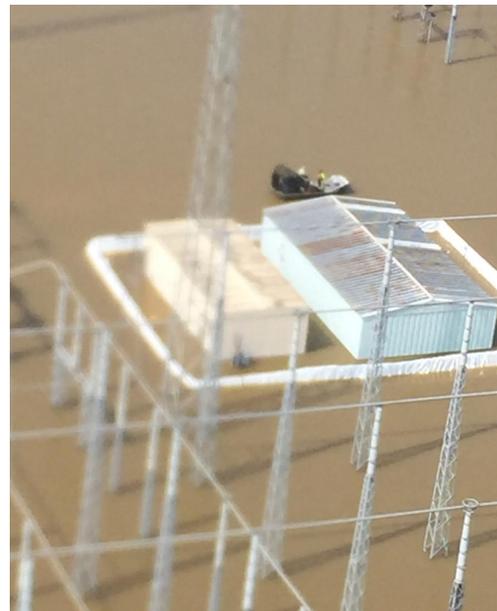
Figure 1: During the Hartburg flood

The three control houses contain equipment which are much more sensitive to water exposure, so it was imperative to try and mitigate these from flooding as best as possible. The local grid employees brought in an outside company to install a plastic berm around all of the control and microwave houses. Figure 1 above shows two of the control houses surrounded by the temporary berm.

As you can see in figure 1 and 3, the temporary berm was not completely water proof. This berm is made of plastic units that were filled with water to hold them in place and then covered with a plastic tarp. Each plastic unit interlocks with the two adjacent ones but they do not form a water tight seal. The seam between the ground and the berm along with the cable trough are also not water tight. The cable trough was filled with sand in an attempt to stop the water from flowing. All of these leaks allowed water to seep inside of the berm but there was enough foresight to expect this possibility. Several water pumps were placed on the inside of the berm and in figure 3 above you can see the discharge hose coming over the side of the berm. The pumps were enough to keep the water level down to one inch of flooding inside these two control houses.

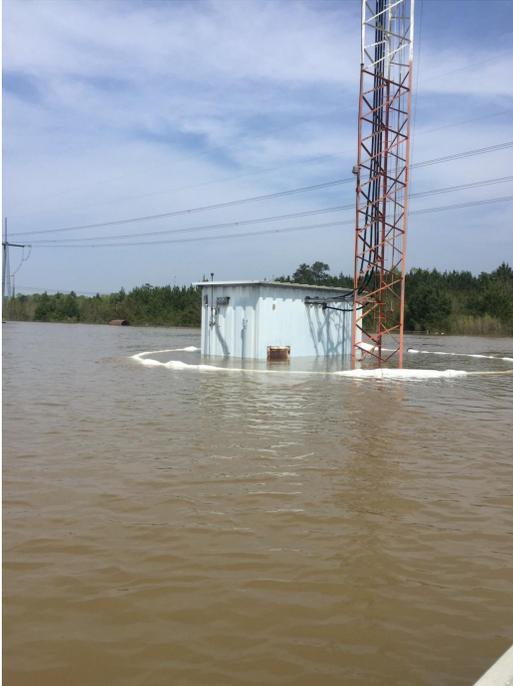
Figure 4: Microwave house

The Microwave house contained telecom equipment, which is also easily damaged by water. This house was at a lower elevation as well and took on a substantial amount of water requiring all of the equipment inside of it to be replaced in the end.

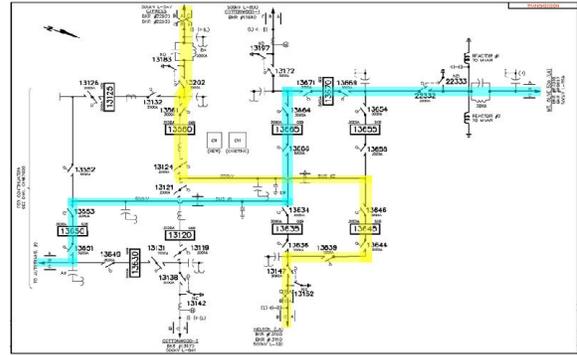
Figure 5: 500KV

Losing this 500KV substation would have a substantial impact on the system in this region so a plan was developed to mitigate this. The flooding would never get high enough to impact the bus or transmission lines, it was mostly a concern for relaying and breaker control cabinets. If water made it into the relay panels, the water would theoretically cause the breaker to trip by shorting everything together or cause the relays to fail and not operate in a fault condition. To mitigate this, the dc to the panels could have been turned off, but it would also remove any necessary protection schemes that were in place. Having at least some type of protection was required. The station was

Certain breakers and switches were opened to only allow power to flow in the configurations seen above. This would then allow the local protection at Hartburg to be turned off and the settings in the relays at the remote ends to be adjusted to protect through Hartburg. The two nodes to the nearby generation were opened since the generation plant was going offline.

The settings were modified to have zone 1 protect 80% and zone 2 protect 120% of the new lines through Hartburg for the primary 1 relays. The zone 2 timers were decreased to 10 cycles because of stability concerns. Hartburg to Nelson used tone communications for both primary 1 and primary 2 relay schemes, but between Hartburg and Cypress the primary 1 relay used carrier and the primary 2 relay used tone communications. The communications path was redirected where the tone for direct transfer trip, DTT, went between Nelson and Cypress for the primary 2 relays. The communications was turned off for the primary 1 scheme because of the materialistic challenge of getting another tone set installed at Cypress. The communications was never turned on between

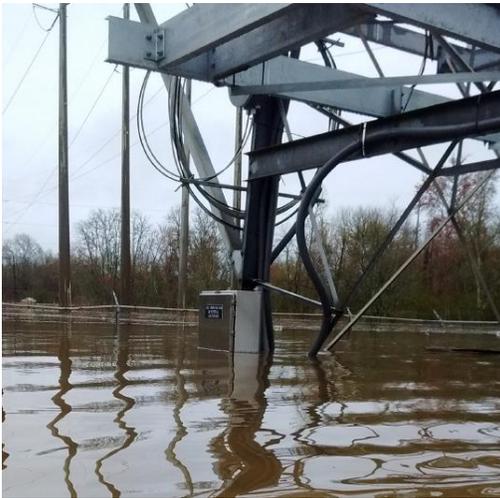
Figure 7: Kentwood Flood

Unlike the Hartburg disaster, we were not able to foresee the flooding that took place at Kentwood. The substation is currently located in an AE flood zone which is approximately 5-6 feet below the 100 year flood level. Earlier in March when Hartburg flooded, the Kentwood substation had flooded as well, which generated discussions about the site elevation and facility expansion for the ongoing construction project, no solution was selected.

With the station flooding a second time in the same year, the project team found it necessary to re-assess elevations for the ongoing project as well as a plan to protect the existing equipment from future flooding. The substation was completely de-energized for a period of time while the power was provided to customers from another substation until the low voltage breakers were replaced.

In order to prevent the station equipment from flooding again in the future the team re-worked the low voltage bus that would allow all the proper clearances for the low voltage breakers to be raised 6 feet resulting in the bottom of the breaker to be positioned at flood zone level. Also, all motor mechanisms were replaced and raised. Platforms were built to allow the cabinets to be serviced for routine maintenance. All of the

junction boxes and conductors were replaced to prevent the possibility of future corrosion.
