Methods and Benefits to the Application of Ultra-High-Speed Transformer Protection

Roy Moxley, Stefan Nohe, - Siemens

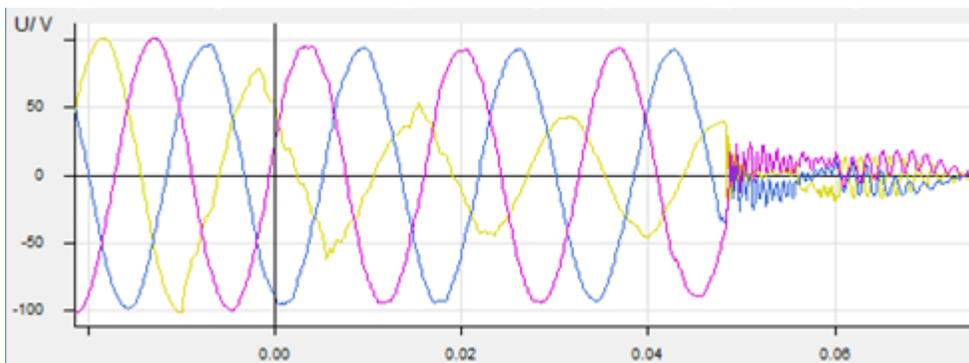
Fig. 1 Transformer High Side Voltage

In the case of this transformer failure we have both the evidence of the failed unit, fault studies and fault records. Examination of the transformer revealed the fault point to be inside the unit near the low voltage connection. This is verified by a comparison of the voltages on the high and low side of the transformer shown in figures 1 and 2.

We can see the high side voltage on the faulted phase dropping to about 50% voltage (roughly matching the high to low side voltage ratio), while the low side voltage drops very low. Based on the event record it appears there was a total of 7900 Amps of fault current from the high side (summing the two breakers), and 46,000 Amps from the low side. The fault voltage on the low side shows 78 kV. This aligns fairly well with a fault study showing 17260 amps for a bolted ground fault at the H1 bushing. Assuming the transformer impedance was the cause of the voltage being only 50%, not zero, this would also lead to 50% of the possible fault current actually flowing.

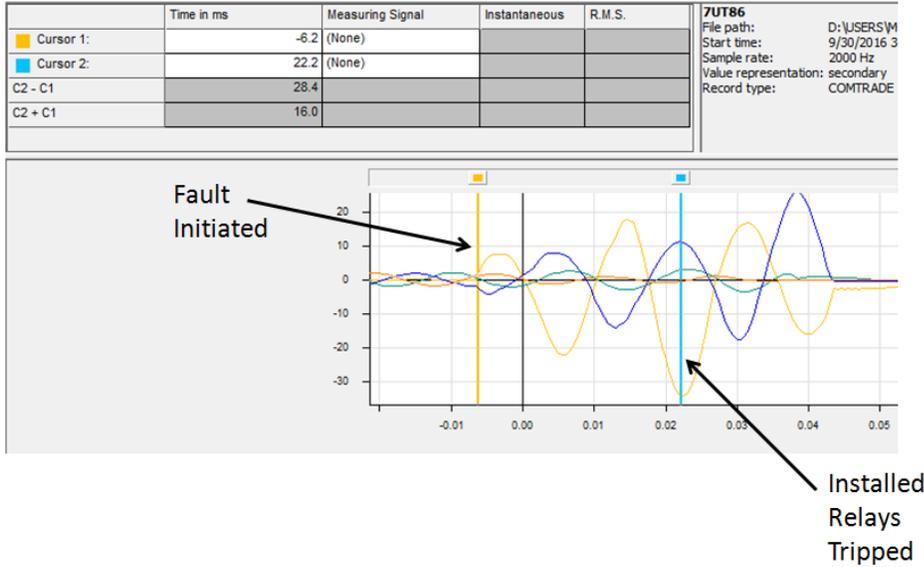
Figure 4. Fault currents and trip times

As shown in figure 4 the relays in the transformer protection scheme operated in about 28 ms for the fault. This was as expected and within the design standards for the utility involved. Notice also that the fault current is rising steadily during the duration of the fault. This is consistent with the fault type, inside the transformer, burning through paper insulation and becoming a more metallic fault. This also explains the collapse in the voltage as the fault progresses. This also makes it more important to interrupt the fault as quickly as possible. The increasing energy and damage involved in the fault both make repair more difficult but increase the possibility of consequential damage such as an explosion or as in this case a tank rupture (with no explosion). The rupture involved about 18 inches of a lower corner of the tank. This caused 30,000 gallons of oil to spill. Even with no fire, the cleanup cost was significant, even when compared with the cost of the transformer (still covered by warranty).

Because there was no evidence of burning around the tank split or fire involving the spilled oil, it was suggested by equipment engineers inspecting the transformer that the split occurred just as the fault was interrupted; again pointing out that even a short time gained could have been very significant in terms of cost savings.

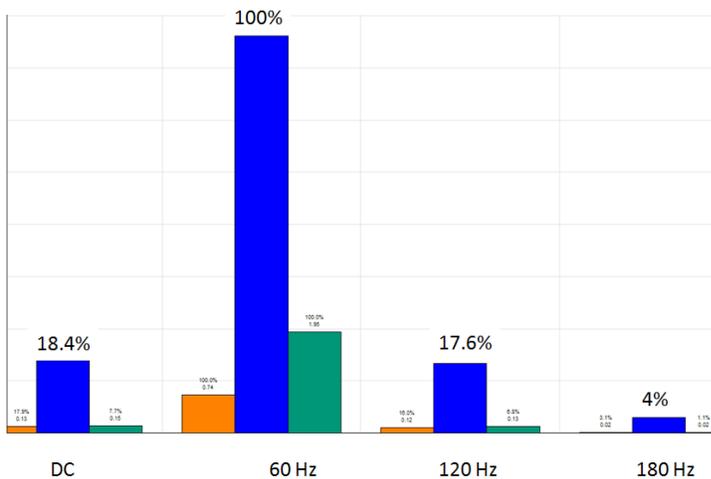
Fig. 5 Harmonic content of the current

The high level of second harmonic, over 17% in this case is probably not present in the primary current but is caused by a partial saturation of the CT. Note that there is significant DC current on the phase

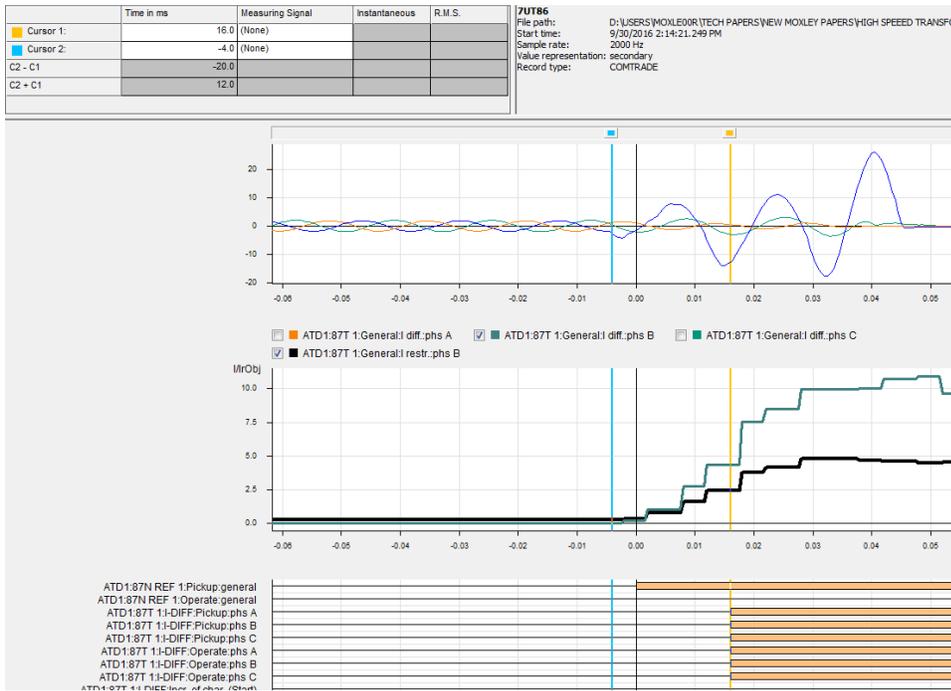
Figure 8. Operating Characteristic with Relay Pickup.

Here we see the differential rising faster than the restraint and the relay tripping 20 ms after the fault inception. If the fault had a faster rate of rise, such as would occur with a metallic fault from the beginning the tripping would have been even faster.

Even with the slow rate of rise, this principle is 8 ms faster than the fastest relay that saw the fault; even without special settings.
