# Transmission Interconnection: Lessons learned from a recent event at an acquired Generating Plant.

Michael Jensen and Lokoko Kitenza  
Electric Transmission System Protection  
Pacific Gas and Electric Co. (PG&E)

Previously presented at WPRC, Spokane in Washington in 2016

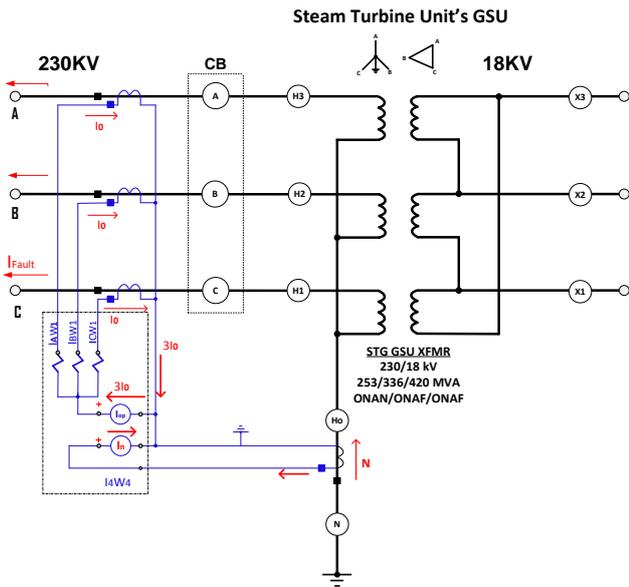
Fig.2 STG Expected wiring and current flow for a phase to ground external fault

As shown in in Fig. 2, the expected current flow of the zero sequence for an external fault should be opposite to the neutral current recorded by the relay. However, the raw event record downloaded from the relay showed that the ground differential

picked up and initiated the breaker tripping for this external fault. After reviewing the event records, and double checking the settings, we suspected the CT wiring may have been rolled.

Field investigation of the current transformers (CT) wiring revealed that the phase CTs summation point for the bank differential protection was mistakenly not terminated to ground, and the neutral CT wiring was grounded at the outdoors CT cabinet and also indoors at the relay terminals. Our standard practice is to ground the CT at a single point (see Fig. 2).

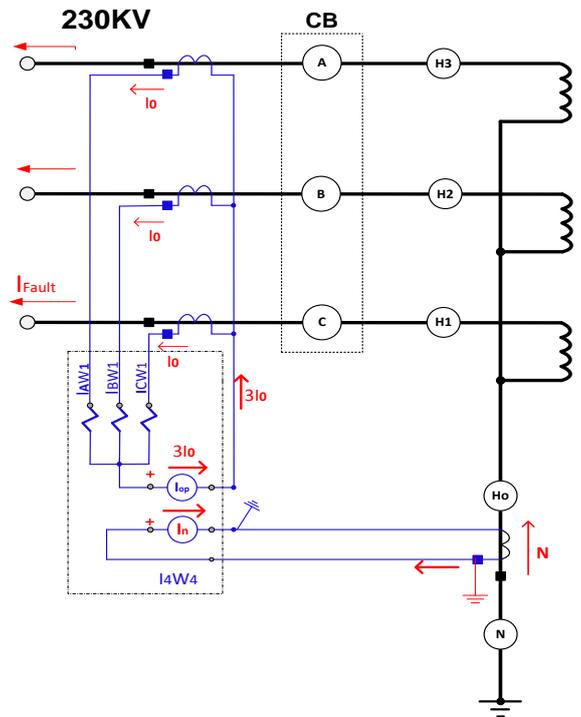
Fig. 3 As found CT connection and interpreted Relays current direction based on event records.

This unusual setup made the event analysis even more complicated because the grounds were made at different sides of the CT leads, such that the CT circuit was in parallel with the relay coil from one grounding point, through the ground grid and back to the other grounding points (Fig. 3 and 4). After this discovery, we realized that a lot more investigation was required. However, we were running out of time because the plant management was asking to go back in service as soon as possible. After a long discussion and negotiation with the plant operation management they allowed the protection and Test department to do the necessary work to bring the plant back for service after mitigating the wiring and the settings' issues.

The double ground, after a circuit analysis, justified why REF polarizing neutral current ( $I_{0W4}$ ) was so much smaller (1.5 to 2 times less) than the operating current ( $I_{0W1}$ ). As seen in fig. 4 the secondary currents split proportionately between the ground grid's impedance and the relay coil since the grounds were at two separate locations.

Field investigation revealed the sensitive ground relay's CT was wired wrong. Fig. 2 shows the expected simplified wiring of the GSU high side, Y-connected winding differential protection. The drawing does not show the CT connection for the 18kV side of the transformer.

Per the relay manufacturer's logic for the REF scheme, the relay to operate, it requires the CT to be Y connected. However, in this case, the CT circuit "star" point was not grounded, leaving the CT circuit floating, with no ground reference. With this wiring, under normal balanced conditions there are no issues since the voltage at the "star" point may be approximately equal to ground potential. However during fault or transient conditions the potential difference between ground and the CT's circuit can be significantly different. This voltage difference can very well lead to insulation breakdown and damage on all CT circuit equipment. For example, as the result of the field test after the event, one of the transformer differential protection phase CTs failed the insulation test. We believe the insulation failed during the fault, but it did not necessarily lead to the misoperation because the three phase differential protection did not pickup.

The observation above led the protection Engineers to recommend checking all GSU's differential wiring for both the CTG1 and STG, verify all differential protection settings, and do load and directional checks before the plant goes back online after repairs.

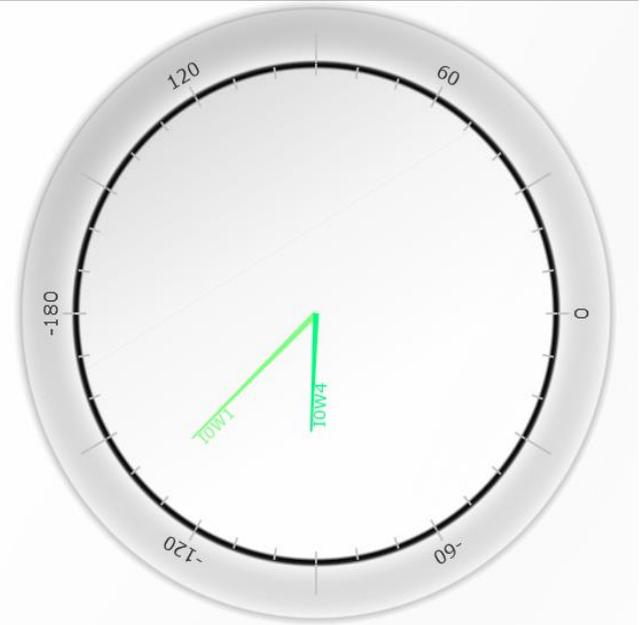
Fig. 6 Recorded Phasor  $3I_0$  Vs Neutral current

Additionally the lack of a voltage reference could also lead to induced currents on the CT circuit resulting in a false relay operation. Relay event analysis indicated there were uneven currents through the unaffected phase CTs with a difference in magnitudes between phase IA (1,810A primary) and phase IB (1,250A primary) (Fig. 8). The zero sequence current ( $3I_0 = I_{AW1} + I_{BW1} + I_{CW1}$ ) was much greater than the recorded neutral current (IBW4) as seen in Fig. 5. We expect  $3I_0$  to be equal and out of phase compared to the recorded neutral current if the CT "star" point was grounded as designed.

Co	Name	Mag	Angle
	1:I0W1.Phasor	6.15	-136
	1:I0W4.Phasor	4.06	-92.4

Phase CTR1 = 300:1  
Neutral CTR4 = 260:1

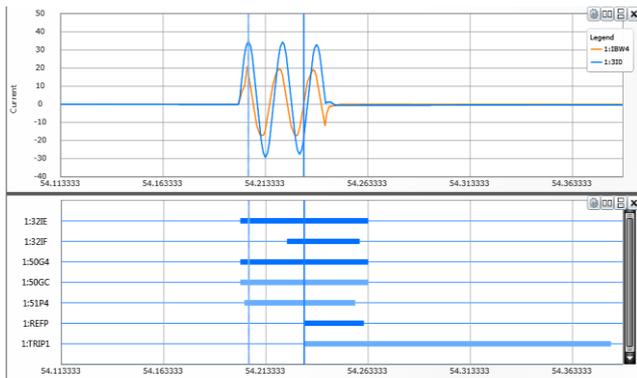
Fig. 5 Recorded operating  $3I_0$  vs. polarizing IBW4 neutral Currents

Per the logic, REF is enabled if the measured neutral current is above the pickup setting element, 50GP. To prevent the directional supervision element 32IE from asserting if the CT saturates (or if the relay word bit CTS asserts), the directional element inhibit was set  $E32I = !CTS$ . The raw event signal did not indicate CT saturation, and E32I did not assert, allowing the forward direction element E32IF to assert.

As referenced in Figure-5 the trip occurred when REFP operated. For the discussion below refer to Figure-7 for REF scheme logic.

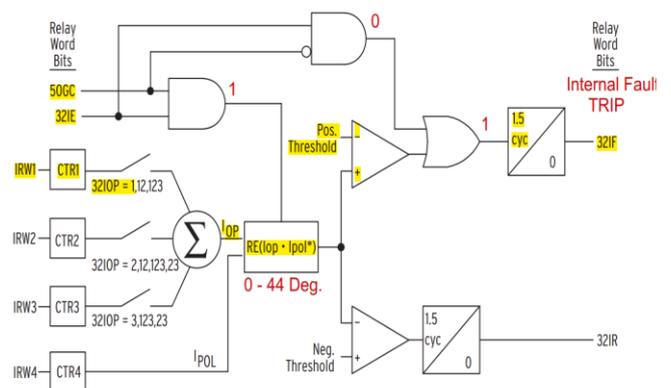
Fig. 7: SEL 387 REF logic diagram. Source SEL Manual

Per both relays' event reports, all the conditions were met to trip as if the fault was internal to the differential zone (see Fig. 7's highlighted elements). Note that the angle between the Operating current IOW1 and the polarizing current IOW4 stayed between -44 and 44 degrees from fault inception to the time the relay sent the command to trip on REF.

To determine the direction of the fault, the relay calculates the product of the operating current ( $I_{op}$  or IOW1 in our case) and the complex conjugate of the polarizing neutral current ( $I_{pol}$  or IOW4 in our case) [4]. This equation is also known as the relay's torque control (T). If the torque is positive, it means the fault is in the protection zone, otherwise it is external or out of the zone:

Since the result is positive, it means the fault is within the zone. The relay waited for about 1.5 cycles before it called to trip on ground differential (REFP). In general the requirement is that the angle must stay between -90 and +90 degrees for 1.5 cycles before a trip is issued.

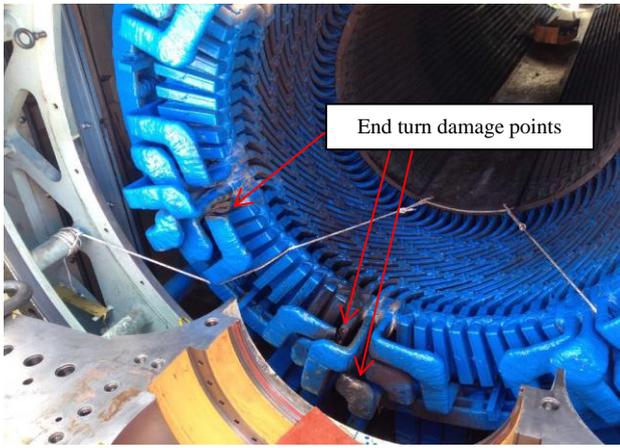
Fig. 9 STG Stator End winding damage

The inspection of the plant by field personnel, as the result of the CTG1 transformer bushing flashover operation, revealed that the STG sustained great damage to one of the stator's windings, which required a complete rewind. The burn marks were at the end windings towards the end turn of the generator stator. The fault locations were evidence of possible excessive vibration that may have caused the winding copper bar to break at specific points over time due to high cycle fatigue before the CTG1 fault. Figure 9 shows the picture of the actual stator winding damage at three different locations as described. It is possible that the Combustion Turbine unit 1 GSU flash over fault accelerated a pre-existing condition. Relay data event analysis concluded that the GSU busing failure was not the primary cause of STG winding failure, however there was still the lingering question of why the generator relays did not operate for such a significant winding fault.

As seen in Figure 10, each phase of the winding is made of three parallel circuits. A circle indicates where arcing occurred in the winding. Only one of the three circuits was interrupted. When it was learned that the STG had sustained significant damage in the split phase winding, it was determined there needed to be a closer review of the design drawings. Steam Turbine Generator relay event records also needed to be reviewed. It is important to note that the event recording settings in the generator protective relays were erroneously set, which further complicated the analysis.

1. Relay split phase differential protection was not implemented.
2. Partial Discharge Analysis (PDA) Monitoring system was designed; however it was inadvertently not installed.

In this design, the PDA monitors the stator winding's insulation integrity and could have possibly helped detect the winding problem before it caused significant damage.

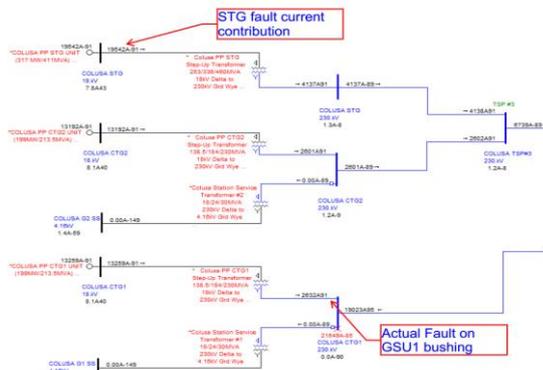
Fig. 11 Fault simulation showing the STG contribution: matches relays record the event

There was a question on whether the winding damage was a result of the GSU bushing fault or was a preexisting condition. Event data analysis showed that the fault was external to the STG and nothing within. The maximum RMS current contributions from the STG was approximately  $I_A=14,000A$ ,  $I_B=5,200A$  and the faulted phase  $I_C=19,200A$ . These values are from the relays located on the Delta connected 18kV side of the step up transformer. These values match almost exactly the simulated model of the system for an external fault (Figure 12.).

The sequence of events from all the other relays such the under voltage, the negative sequence and the distance elements protecting the STG machine, showed them picking up but did not initiate a trip. This observation helped us conclude that the fault was indeed external and the GSU's REF operated within three cycles and cleared the fault before the other elements.

generator differential could not have operated. The reason the differential is not effective in these types of winding faults is because the relays just measure what goes in and what comes out! For an open circuit fault, as it was the case here, there is no differential current to detect. This winding configuration makes it a very difficult, or an impossible fault to detect with differential relaying, unless there is special protection such as a split phase protection appropriately designed for this machine. Split phase design was not part of the design.

Despite the protection deficiency and given the level of fault contribution recorded during the CTG1 GSU fault, we concluded that if the machine was healthy before the event, taking in account its rating, the machine should not have sustained the damage observed. This machine normal load rating is 13,792A (RMS). The RMS fault duty recorded during the event was about 19,200A for 3 cycles. Per IEEE C50.13 Section 4.2.2 the STG should have been able to withstand this fault with no damage. The generator stator shall be capable of operating at 150% of rated stator current for at least 30 seconds starting from stabilized temperatures at rated conditions [5].

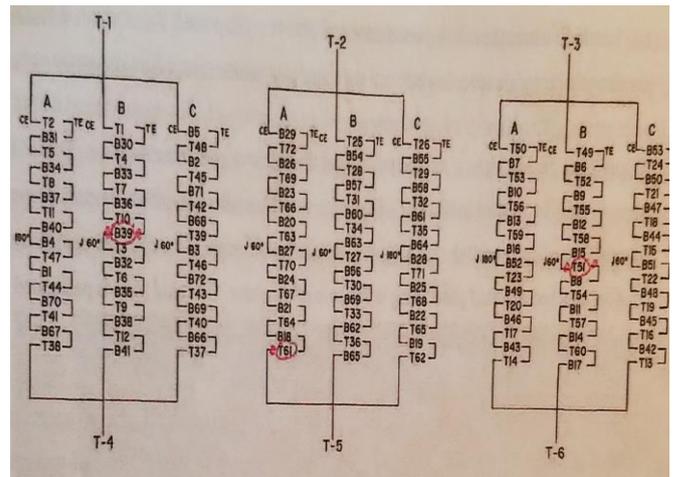
Fig. 10 Stator winding schematic diagram  
Arcs located at B90, T61 and T51

The Steam Turbine Generator in question is manufactured with a three circuits winding design, also known as "split phase" winding design. The stator has 72 slots, three parallel circuits, with eight coils per circuit. Figure 10 shows the simplified configuration of this type of winding. Terminal T-1 to T-2 make phase A, terminals T-2 to T-5 make phase B, and terminals T-3 to T-6 phase C.
