## Return to Service Failure, Cooperative Troubleshooting

Carlos Cordova, Jhobany Tortolero-Rojo, Matthew Klein, Tony Limon  
*POWER Engineers, Inc.*

**Abstract -- After completing a recloser control replacement at a customer's brownfield substation, the subsequent energized closure of the recloser resulted in an instantaneous recloser trip. No fault or equipment damage was apparent in the field. Electrical testing of the recloser was performed to determine its operational condition and found no problems related to the trip. Recloser control event data and sequence-of-events data was gathered and analyzed to determine the cause of the trip. The data presented by the recloser control did not fit classical fault event signatures which prompted further investigation. Field investigation and desk calculation determined that a significant circulating current event initiated when the recloser closed and caused the trip. This paper details the investigation of this event, highlights the critical characteristics to identify a circulating current event and displays the value of effective communication and coordination between field engineers and design engineers. Event root cause analysis

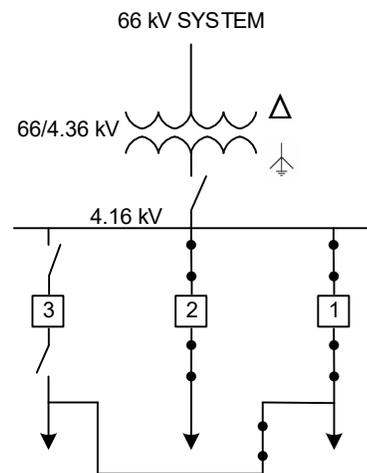
Figure 1 - System One-Line During Planned Work

With Feeder 3 offloaded and isolated, its protection control could be upgraded, tested and commissioned. In addition, legacy RTU, metering, and annunciator equipment for the station was to be retired and replaced with a more modern system. Figure 1 is a one-line diagram that shows the state of the system during the planned work.

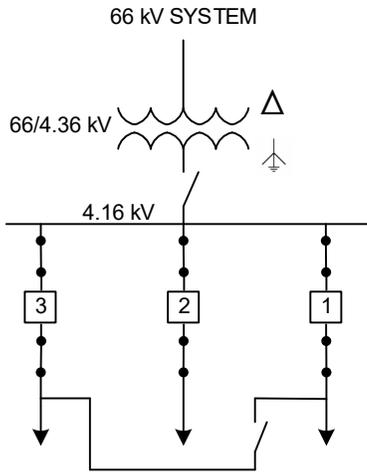
Figure 2 - System One-Line Diagram After Planned Work

Figure 2 is a one-line diagram which shows the intended state of the system after restoration of Recloser 3.

Unfortunately, upon closing Recloser 3 in step 3 above, the recloser nearly instantly tripped open. The trip was un-expected, and the cause was not clear. Upon initial inspection of Recloser 3 and the surrounding station equipment no damaged equipment was apparent, and no signs of a fault were discovered.

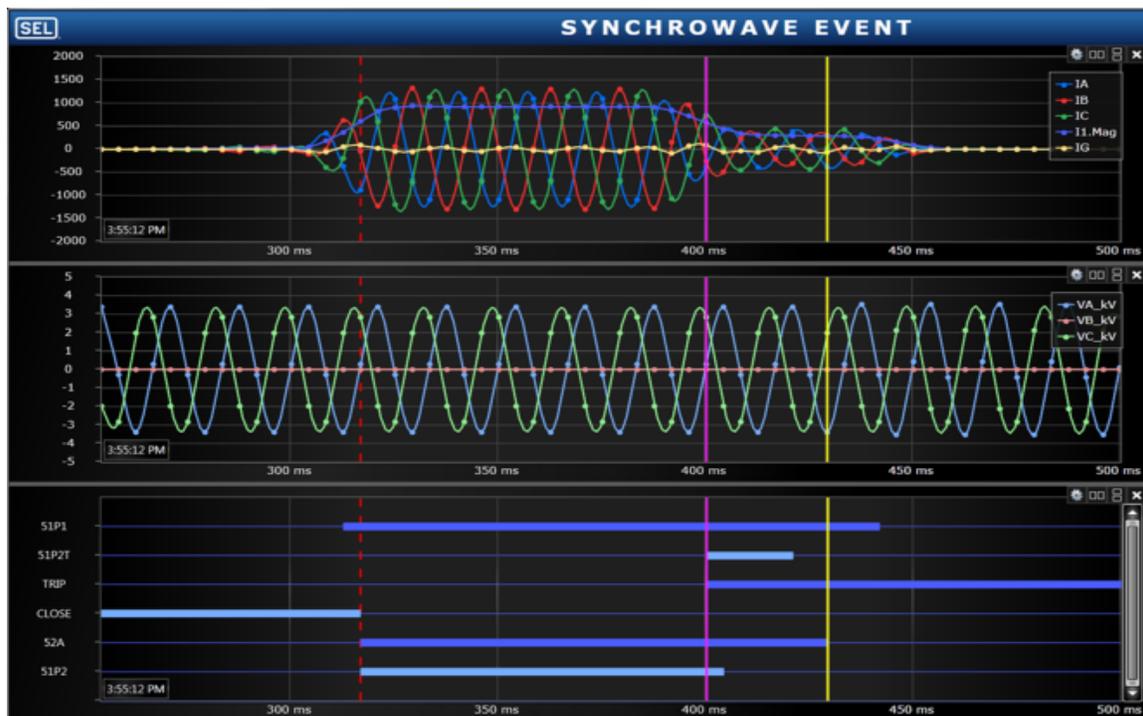
Figure 3 – Recloser Trip Event Report

Several interesting clues are immediately apparent:

- A phase-time over-current element timed out and tripped the recloser approximately 90 ms after the recloser was closed
- Balanced 3-phase fault
- No voltage suppression during the fault

In the office it was determined a fault in the recloser was not the cause as no damage was apparent on the recloser, bushings were intact, the recloser opened and closed successfully and there was no apparent external damage as one would expect to find when a recloser fails outright. Further, the lack of voltage suppression during the fault coupled with a fault that initiated three-phase, strongly indicated that this event was not a fault related event. During the office investigation it came to light that the recloser failed a contact resistance test and was to be replaced. The office-based investigation continued as the clues did not indicate high resistance contacts would cause the signature noted in the event report.

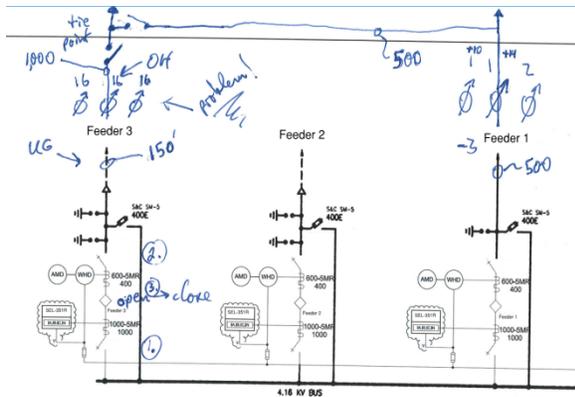
Figure 4 – Walk Down Notes

The walkdown was conducted as a teleconference such that the field engineers could describe to the office-based engineers what they were seeing while the office-based engineers documented it. Figure 4 shows the notes taken during this walk down. Field engineers started at the Feeder 3 recloser and noted underground cable exited the station after roughly 150' and then noted near the overhead riser was a set of regulators. Following the regulator bank was another 1000' of cable and then the feeder tie switches which appeared to be new. Approximately 500' of overhead line connected Feeder 1 to the tie switches. Heading back toward the substation another regulator bank was encountered and then approximately 500' of overhead line lead to the Feeder 1 recloser.

While no un-expected loads were encountered, the regulator banks just outside the substation fence were equipment that had not been discussed previously and which did not appear on the available station one-line. After brief examination of the topology drawn during the walkdown, and based on previous transformer paralleling experience, it was suggested that circulating current resulting from regulator banks with mis-matched taps could have been high enough in magnitude to trip the recloser.

While still in the field, the field engineers noted the regulators were regulators which are standard 32 – 5/8% step regulators capable of +/-10% regulation. They also recorded the as-found regulator tap positions as follows:

- Feeder 3 A-Phase +16
- Feeder 3 B-Phase +16
- Feeder 3 C-Phase +16
- Feeder 1 A-Phase +1
- Feeder 1 B-Phase +1
- Feeder 1 C-Phase +2

A quick hand calculation assuming a conductor impedance of 0.25 ohms indicated a circulating current of approximately 960 A would result if the feeders were paralleled with the regulators at the existing taps, which is 1.71 times the recloser control's 51P2 pickup setting of 560A. This quick calculation indicated more detailed study was warranted.

A recommendation to the operational staff was made to ensure Feeder 1 and Feeder 3 regulator bank taps were matched prior to attempting restoration of Recloser 3. Following that recommendation Recloser 3 was successfully placed in service on the first close attempted
