Case Studies in Analyzing Transformer Installation Faults – Part 1

By Sudipta Maiti, Superintending Engineer (Electrical),

Central Relay and Instrument Testing Laboratory, Damodar Valley Corporation, India.

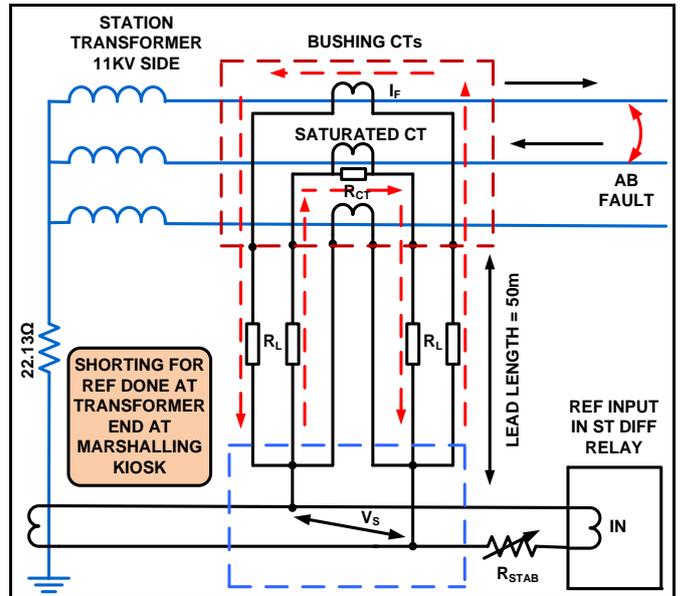
Fig 1.2: Path of Fault Current during CT Saturation for LL Fault [Red dotted line]

On searching for the reason as to why a PS class had saturated during this fault it was found that the defined Knee Point Voltage [V_k or KPV] for this CT was only 100Volts which was too low. The minimum V_k of CT core to be used in this application should have been twice the maximum voltage developed across the stabilizing resistance in case of full saturation of one phase CT during a 3LG fault = 2*146.21V = 292.42V ≈ 300V. **It was clear that this was a design problem and the OEM designers had later acknowledged that the CT KPV calculations had been based on maximum theoretical 1LG fault current of 300A.**

A lower V_k of CT also meant that high magnetizing current would be drawn by the CTs at the stabilizing voltage (V_s) which would mean much higher primary

Any High Impedance REF stabilizing resistance calculation should take into consideration CT saturation during the severest fault conditions i.e. maximum phase fault current among 3LG, 2LG, 1LG and LL faults. Generally Phase Current for 3LG fault or Neutral Current for 1LG faults are the 2 severest currents. So we must take the maximum of the two.

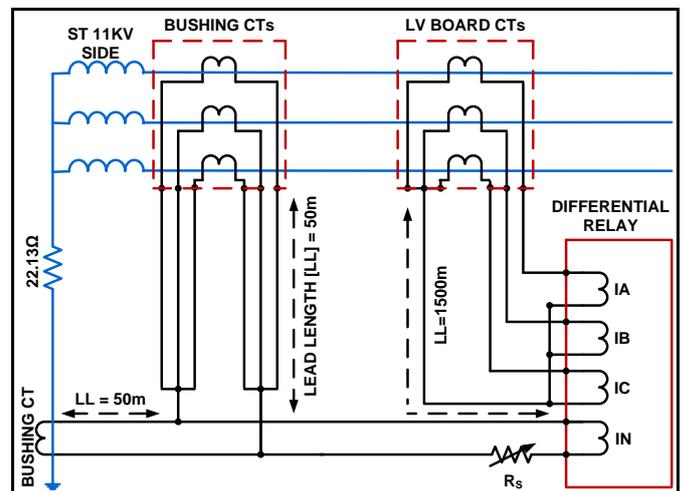
Fig. 2.1: Original Protection Scheme: REF from Bushing CT & Differential from LV Board CT

The original Scheme for LV REF protection was exactly similar to the scheme used in Case Study # 1 i.e. the Phase CTs and Neutral CT would be shorted at Transformer Marshalling Kiosk (MK) and the shorted current would flow through the Stabilizing Resistor and operate the REF relay element (depicted in Fig. 2.1).

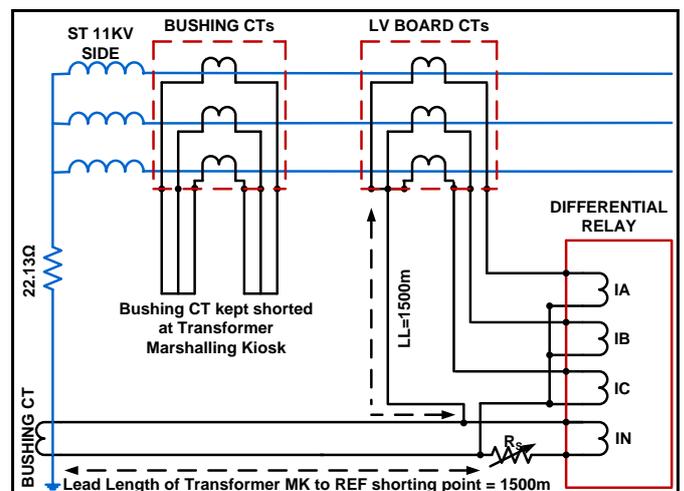
Fig. 2.2: Modified Protection Scheme: REF & Differential Protection both from LV Board CT

But during testing of the bushing CTs the Knee Point Voltages [KPV] of the Bushing CTs were found to be around 100V and as discussed in the previous case study were not implemented in High Z REF scheme in fear of saturation problems. **Instead the scheme was implemented by shorting the LV neutral CT with the 3 phase CTs used for Differential Protection (which had defined KPV at 1000V) after the relay at the panel end** (as depicted in Fig 2.2).

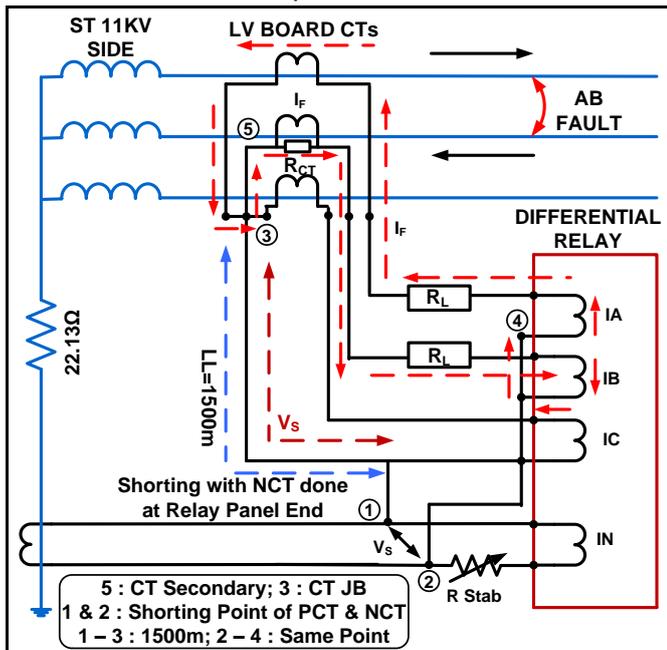
Fig 2.4: Fault Current path during LL fault with PCT saturated

We assume an AB fault with B Phase CT saturating with the fault current path shown in Fig 2.4. As the fault current created by A Phase CT flows through the saturated CT (B Phase CT) it need not traverse the CT neutral cable. Hence terminal no. 1 and 3 are at the same potential. Terminal 2 & 4 are at same potential as they are actually the same point. The voltage at terminal 4 (same as Terminal 2) w.r.t terminal 3 is a result of the voltage drop created by the fault current flowing through the saturated CT till relay coil.

Neglecting relay current coil resistance, (which is very small for numerical relays) the voltage at terminal 4 w.r.t terminal 3 is $I_f \cdot R_L$ and not $I_f \cdot 2R_L$. So the voltage developed between Terminal 4 & 3 = Voltage developed between 2 & 1 (1 & 3 are at same potential) = $I_f \cdot (R_{CT} + R_L)$.

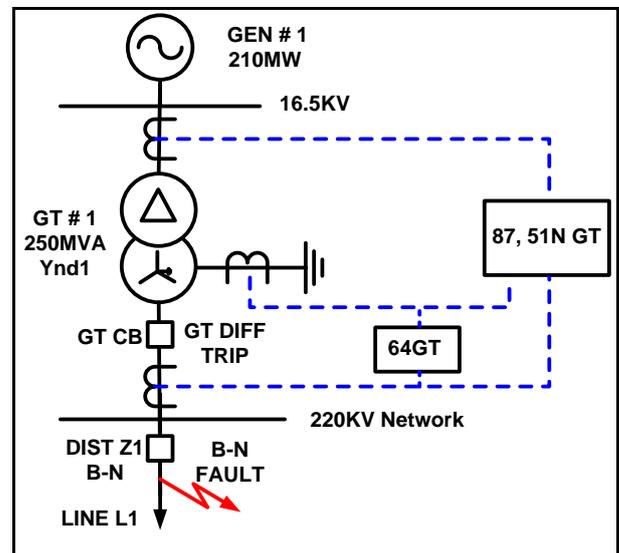
Fig No. 3.1: Protection SLD with fault targets

The most common vulnerable areas in settings viz. mentioning correct Vector Group numeral, CT & PT ratios, CT starpoint towards protected object, Transformer MVA, KV levels were checked and found O.K. It was seen that the zero sequence ($3I_0$) correction had been correctly kept 'ON' the star grounded side and was configured to use the measured mode instead of calculated mode i.e. $1/3^{rd}$ of physically measured ground CT current would be subtracted from the Phase currents on the Star side.

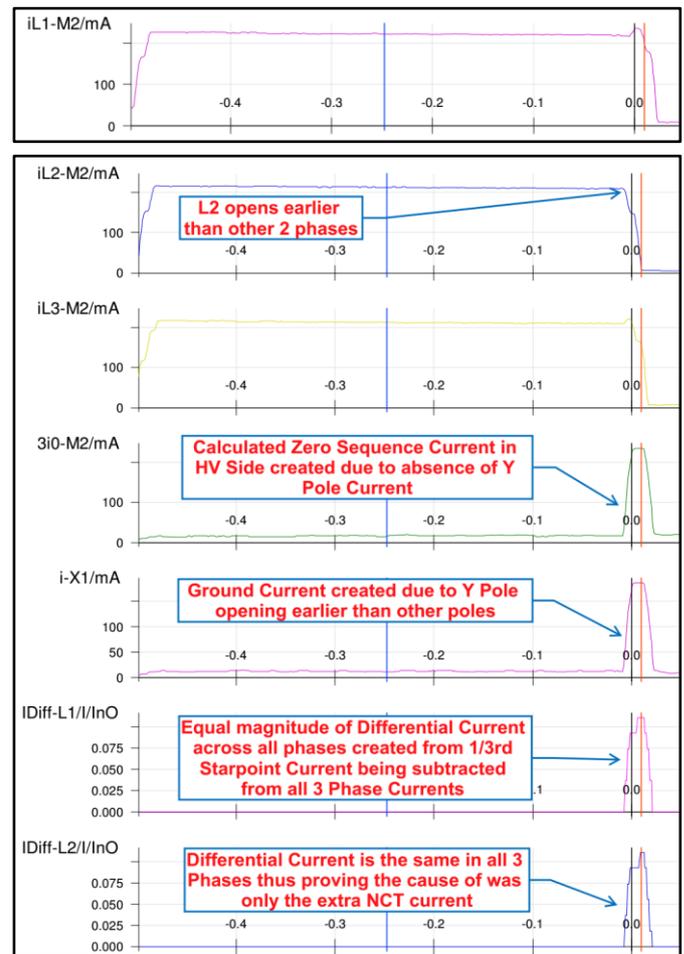
Fig. 4.1 DR of Event showing earlier opening of Y Pole

DR waveforms revealed that when the GT CB had tripped through 'flame failure' the current in the B phase [IL2] started falling down before the other phase currents because of CB Pole scattering. In this case the difference between B pole opening and other pole opening was about one cycle.

As one pole opens earlier some current flows through GT neutral as during one pole open conditions. This is sensed as i-X1 in DR. Now this condition is similar to an out-of-zone Earth Fault condition with E/F current flowing towards ground from transformer neutral.

The ground CT wires were reversed and the Generator was put into service.

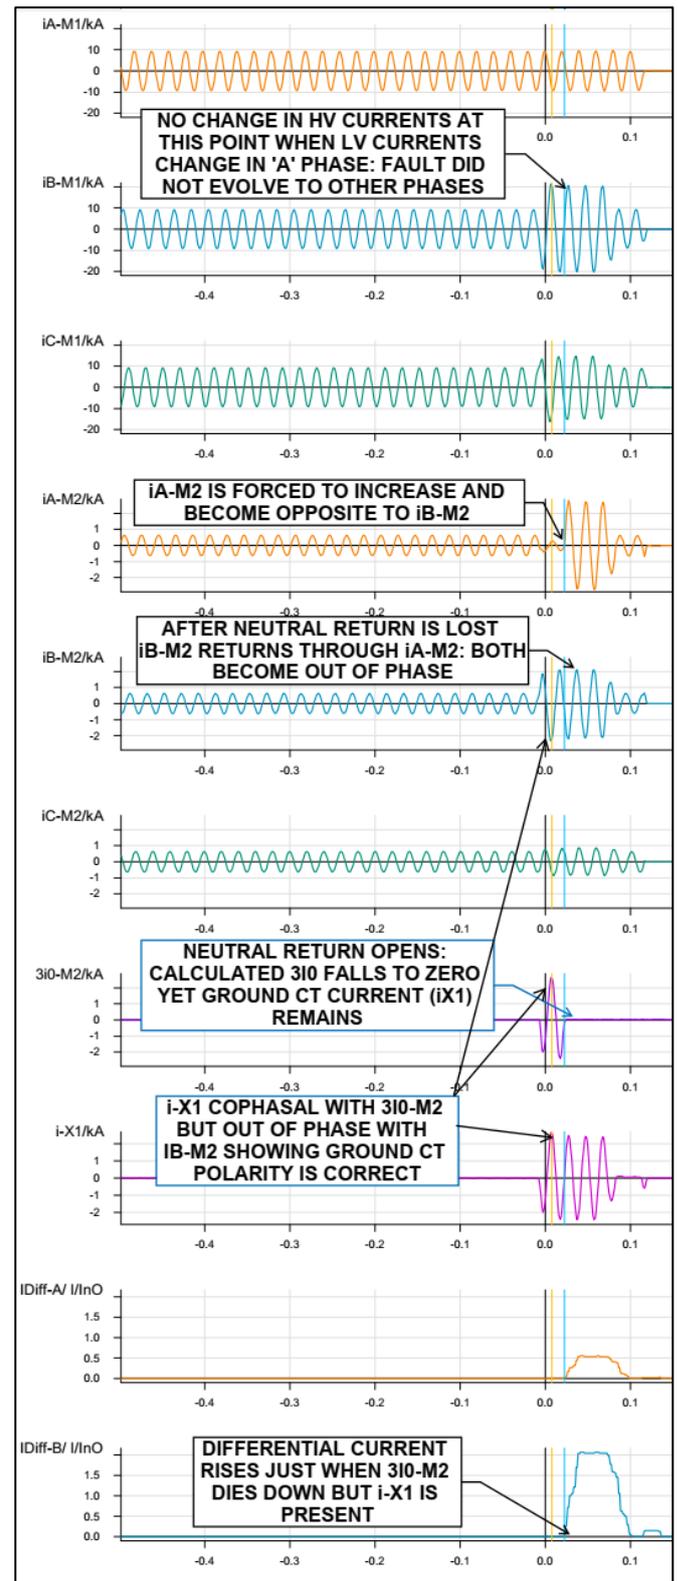
Figure No. 5.1 DR waveforms of first tripping. M1 = HV [System]; M2 = LV Side [Generator].

1. It is a BN [ABC Sequence] external ground fault in the HV system as evidenced by i_{X1} phasor to be opposite to i_{B-M2} and also B & C phase rising in LV [Source] Side in an Ynd1 transformer.

4. On studying the phasor relationship between the phase currents of M2 side (after 20ms of fault) it was noticed that i_{B-M2} current was being vector balanced by corresponding rise in i_{A-M2} and i_{C-M2} current with i_{A-M2} being more dominant. This could not be a case of a BN fault transforming to a AB fault because it can be seen that when the current in unfaulted phases of M2 rises there is no corresponding rise in currents of M1 side.

5. At this point the phenomenon could not be explained and it took three more maltrippings to finally ascertain the root cause.

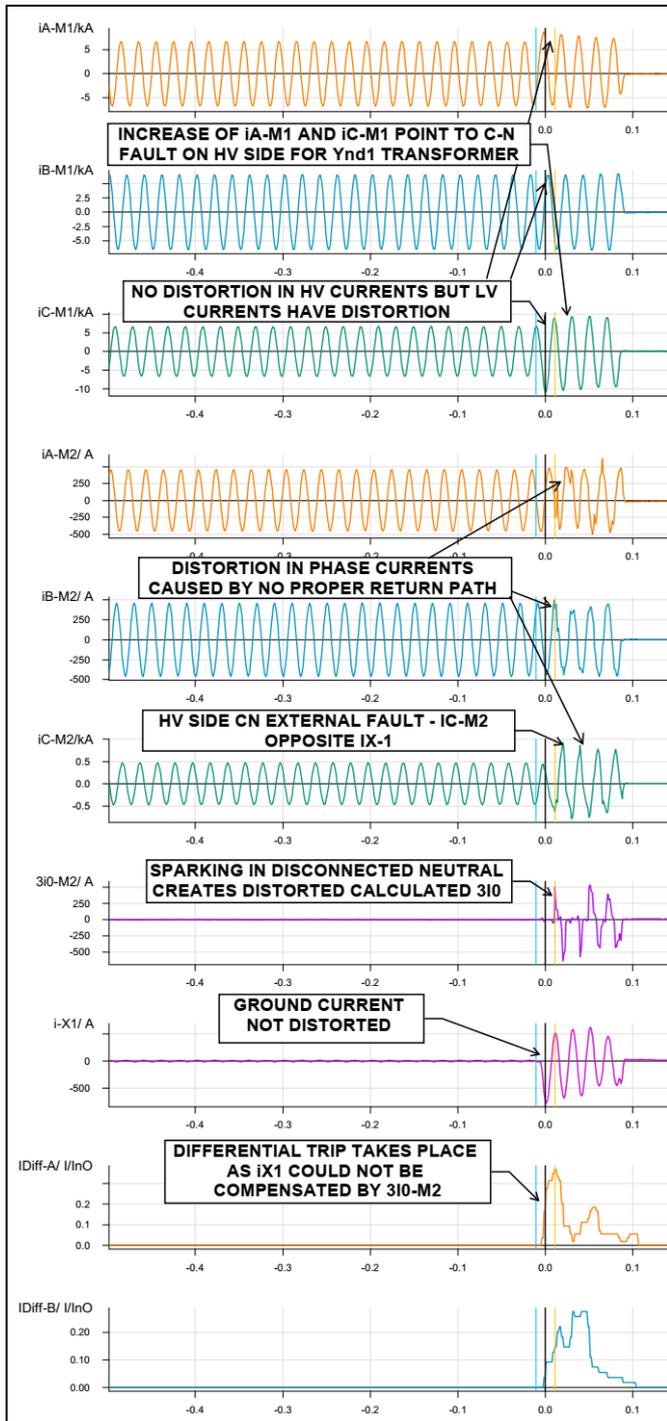
Figure No. 5.2 DR waveforms of second tripping.

1. It is a CN external ground fault in the HV system as evidenced by $iX1$ phasor to be opposite to $iC-M2$ and also A & C phase rising in LV Side.
2. In this case during the first cycle of fault there is ground current but no corresponding rise in $3I0-M2$ to provide zero sequence compensation which causes the Differential protection to pick up. During this period again the HV side CT secondary currents balance among themselves and there is no resultant $3I0$. Thereafter the $3I0-M2$ current is conducting only during peaks of ground current $iX1$.

3. Probable explanation of this could be that there is sparking somewhere in CT secondary circuit neutral return path which was conducting only when the driving voltage from CT was reaching the peak value (during current peaks).

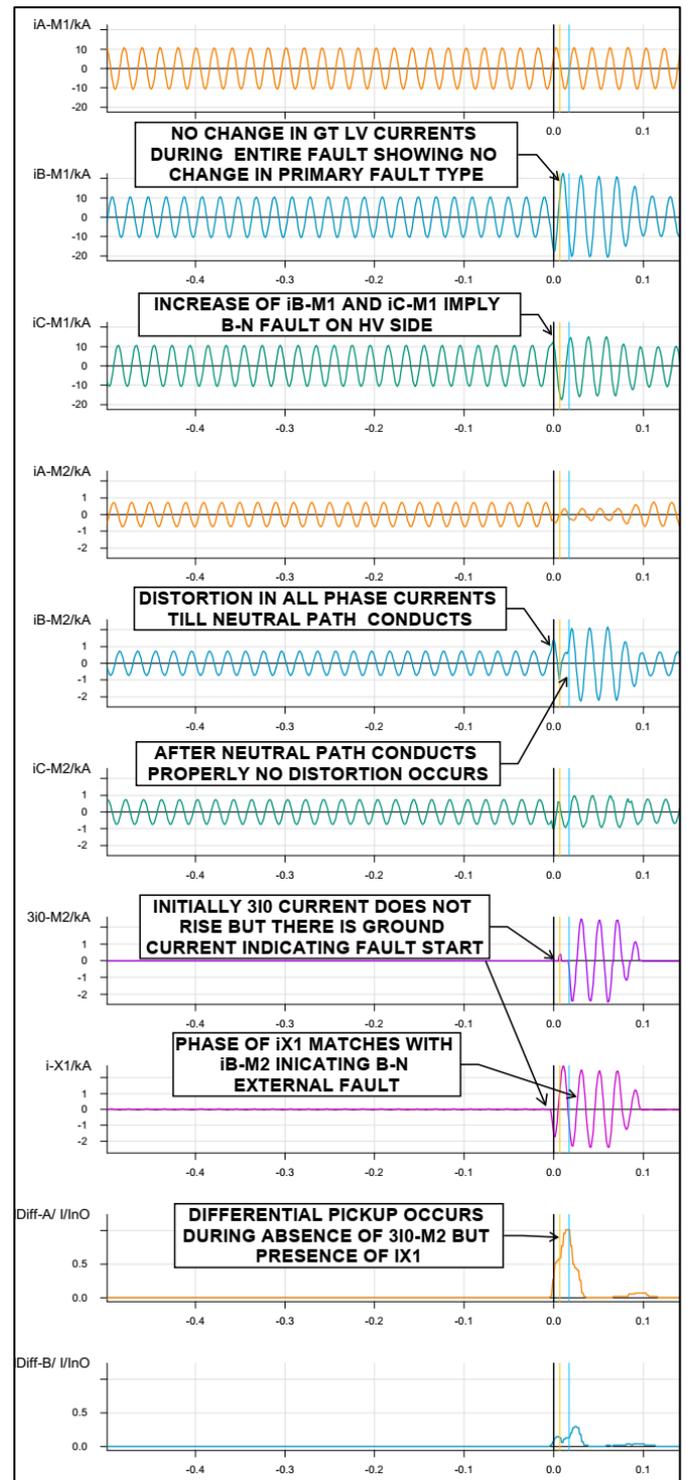
Figure No. 5.3 DR waveforms of third tripping.

4. As the CT Secondary neutral path was not conducting properly highly distorted non sinusoidal currents in HV side in all phases was seen whereas the LV currents had very good sinusoidal waveforms during the entire fault duration.

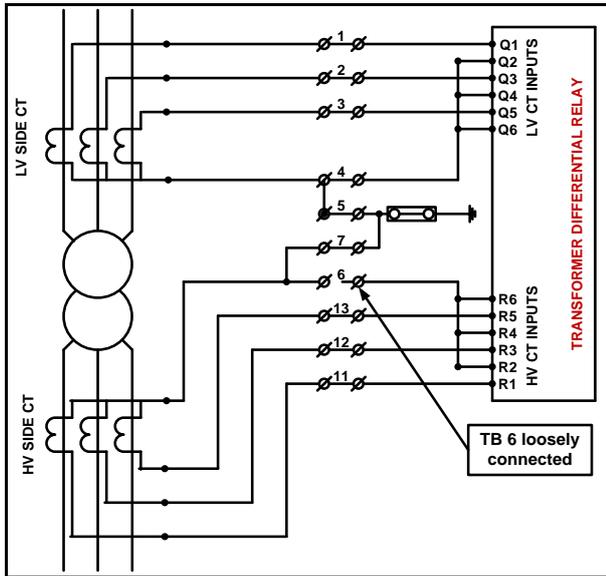
Figure 5.5: CT Circuit as found during investigation

3. Wiring checks revealed that the **HV side CT shorting to neutral link was not properly through i.e. it had much loose connection and the split TB # 6 link was barely touching (Fig 5.5)**. The opening of this neutral was forcing the phase currents of HV side to realign themselves (in secondary). As the LV side secondary current was unable to match this realigned HV current, the summation differential current was having some value which was causing operation of 87 protection.

4. This problem could not be detected in normal differential stability using 3 phase balanced supply as there was no zero sequence current under those conditions. Hence there was no measurement discrepancies during the said test. When zero

sequence stability was done the current was measured at the REF relay whose CT circuit is completely different. No one bothered to check the current in Differential relay during transformer REF / Zero Sequence Stability tests.

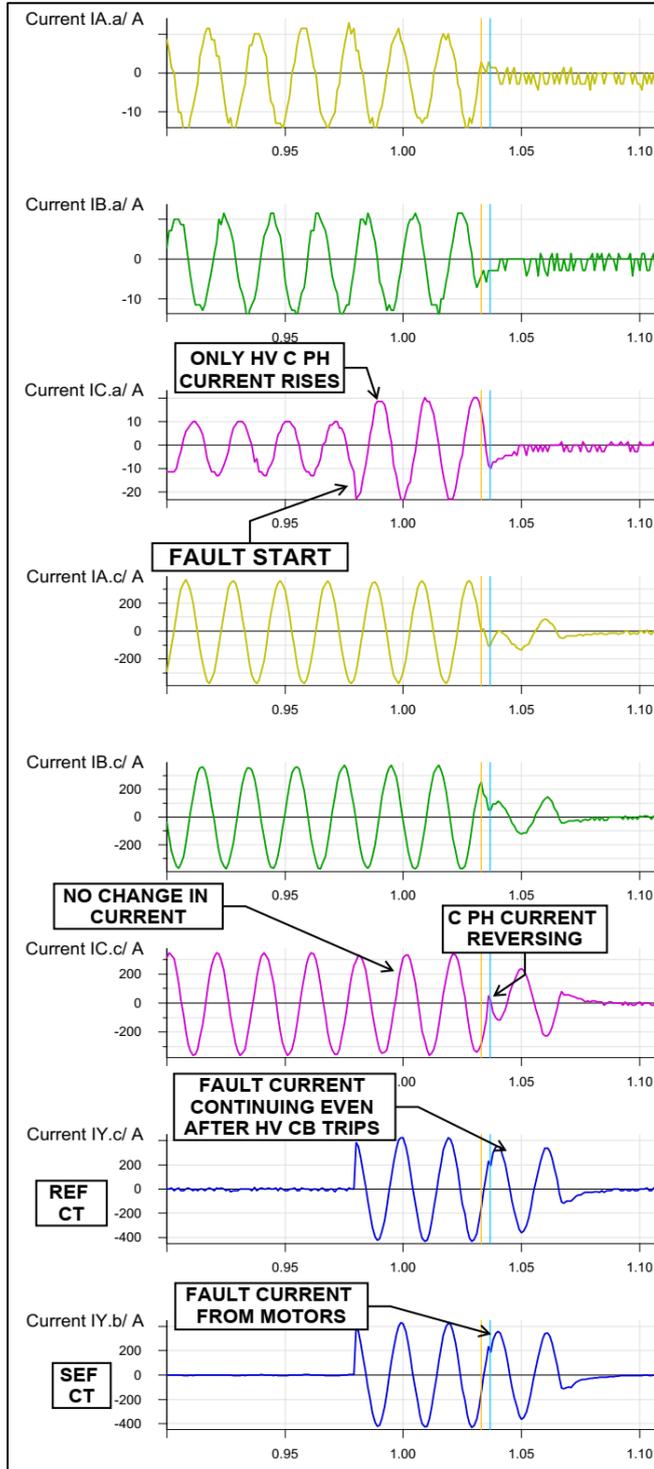
Fig 6.2: DR of ST tripping through LV REF Protection. Side a = 400KV [HV] Side & Side c = 11KV [LV] Side

1. Relay Settings were checked. Operand of LV REF was found to be correctly set to side 'c' currents i.e. the phase and neutral of side 'c' would be used in REF function for if it would have been set to side 'b' the neutral CT would be getting current from Standby E/F CT but the corresponding neutral current would not be balanced by phase current which belonged to the other LV board.
2. In relay settings in field type of REF protection was found to be correctly set to Low Impedance Sum IP i.e. $REF\ Diff\ Qty = |IY| = \text{Measured current in Transformer Starpoint}$ and $REF\ Bias\ Qty = |IY + IN|$ where $IN = I_a + I_b + I_c = \text{Vector Sum of phase currents calculated by relay in software}$. This correct setting meant that the REF function was operating correctly in this relay as here $REF\ Diff\ Current = IY = 300A$ and

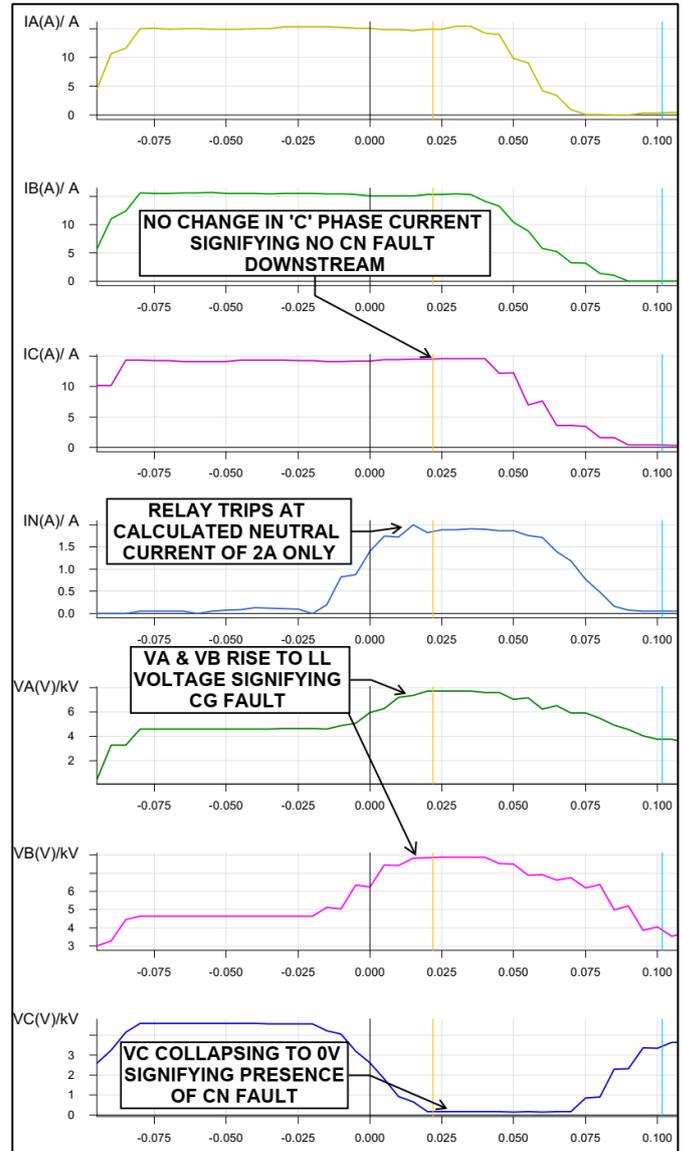
Fig 6.3: ODAT HV Side DR which tripped through E/F Protn.

6. The ODAT relay tripping DR was checked for amount of fault current and surprisingly it was found that the current where trip had been issued was only 2.0A primary. On checking the E/F P/U settings it was found to be only 10% = 2A Primary as it was fed by a CBCT with CTR 20/1. Moreover the timing was instantaneous. Thus it was highly possible that the fault contribution from induction motors in the secondary LV Side of ODAT was responsible for operating the ODAT E/F protection.

8. The question of why differential protection was not operating in spite of the fault being within its zone was that for a 1LG fault the maximum unbalance current was 300A at 11KV and 8.5A at 400KV side. Such low unbalance was below the differential P/U of 20% of transformer full load current. In the other case as the LV fault current was of the order of 20kA, differential protection had operated.
9. So it was theoretically concluded that the actual C-N fault was before 11KV board I/C CT and the ODHT relay was tripping in excess from the unbalance in

REMEDIAL MEASURES: The ODAT relay E/F setting was revised to 10A primary and a time delay of 100ms was introduced in line with the E/F settings of similar transformers. The busduct water ingress was cleaned up and dried before the ST was put into service. After such corrective action no more cases of mysterious REF operation was reported thus proving that water ingress was the only root cause for these events.

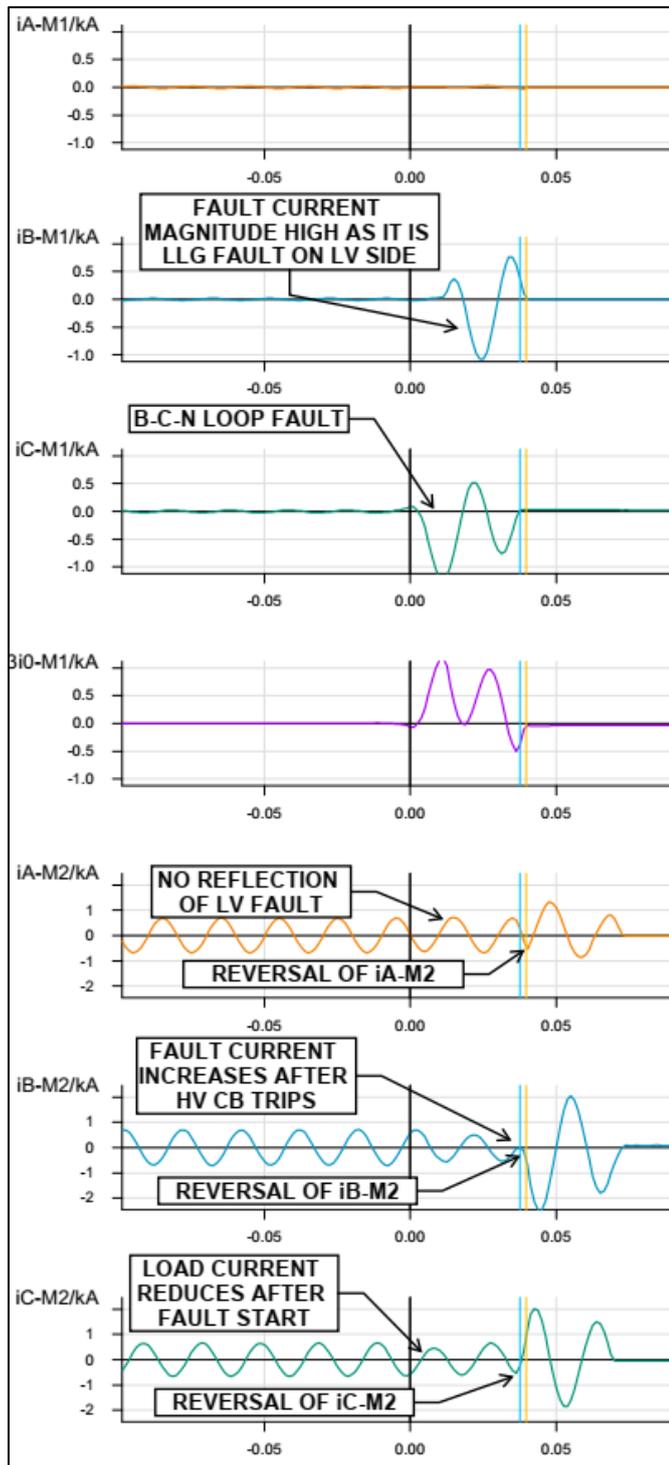
Fig 6.4: Similar DR of 11KV busduct fault of ST. M1- 400KV [HV] Side & M2 – 11KV [LV] Side.

7. **DR of similar fault:** To confirm our assumptions we looked minutely at another DR of a LLG fault in 11KV busduct of the ST in another powerhouse. There a similar ST supplying LV boards had tripped through Differential & LV REF protection for a fault in 11KV LV busduct of ST. So if this time the fault was inside the busduct portion this DR should have the similar characteristics though in the older case the fault was LLG where the 11KV grounding resistance [NGR] had been damaged by fire thus bypassing the NGR causing the neutral current to

rise to approx. 12kA. In this DR the difference in HV fed fault current and LV Motor fed fault current was very clear in the fact that a prominent amount of fault current had continued to flow after the HV CB had opened but the LV CB had remained closed (for about 40ms). Moreover there was clear indication of polarity reversal of the LV current showing that till the HV CB opens it.

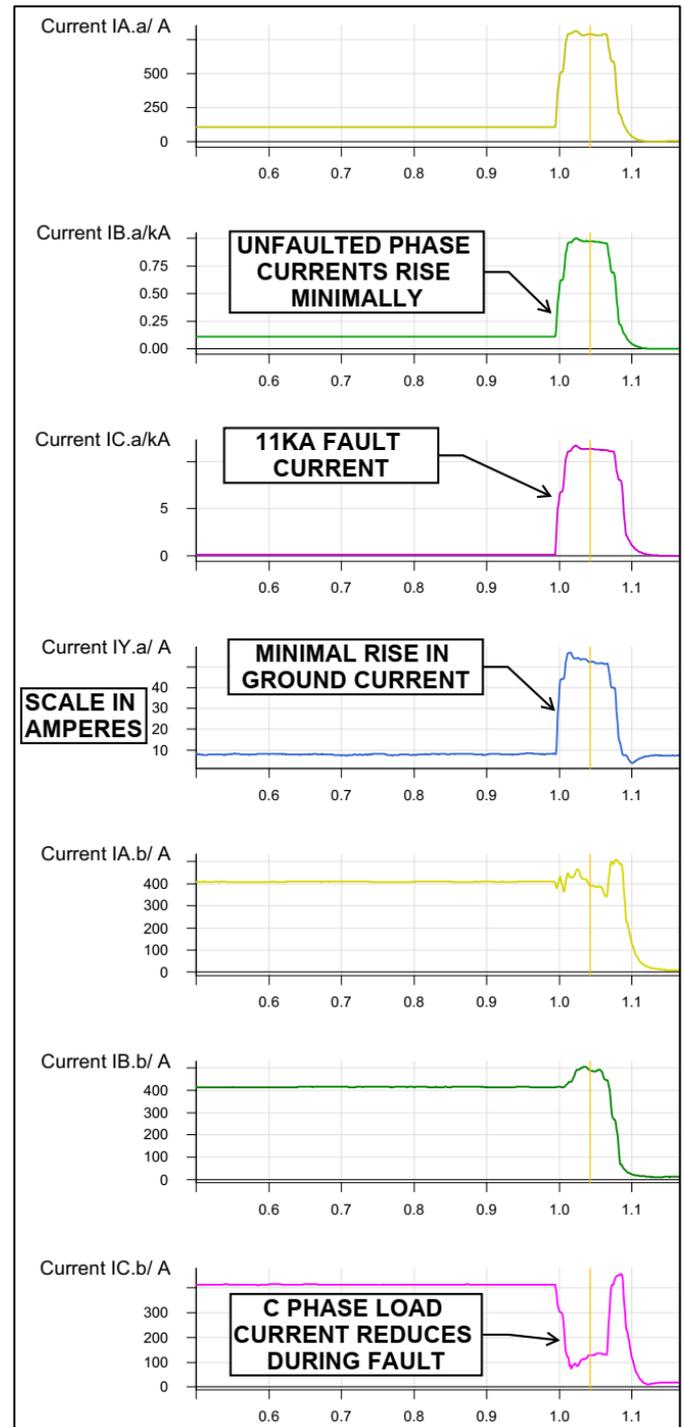
Fig. No. 7.2: DR of Differential relay [Side a. – 132KV side i.e. source side; Side b. – 33KV i.e load side]

of Station X bus. As LV was not contributing into the fault and LV C phase current had dropped drastically during the fault it could be safely conjectured that the fault was within transformer HV CT and transformer bushing.

So operation of differential protection was correct. **But the peculiar point was the absence of ground current (IY.a) in the DR.** As the HV REF protection was implemented within AREVA P632 differential relay and the REF mode setting was 'Low Impedance Sum IP' presence of ground current was mandatory for relay
