Finding Common Ground: A Case Study of Phantom Currents and Ground Loops

Matthew Boecker and Genardo Corpuz, *Lower Colorado River Authority*
 Jared Candelaria and Ariana Hargrave, *Schweitzer Engineering Laboratories, Inc.*

Abstract—In February of 2018, a current differential relay protecting a 138 kV/69 kV autotransformer tripped for an out-of-zone ground fault. System conditions were such that the low side of the autotransformer was open, but the relay event reports showed fault currents present on the low side. Initial investigation hinted at a current transformer (CT) secondary circuit problem (the CT, cable wiring, or relay input), and three more faults that occurred the following week helped narrow it down. This paper describes the investigation into these faults, how root cause was found, and how ground potential rise can cause phantom currents to flow in relay CT circuits.

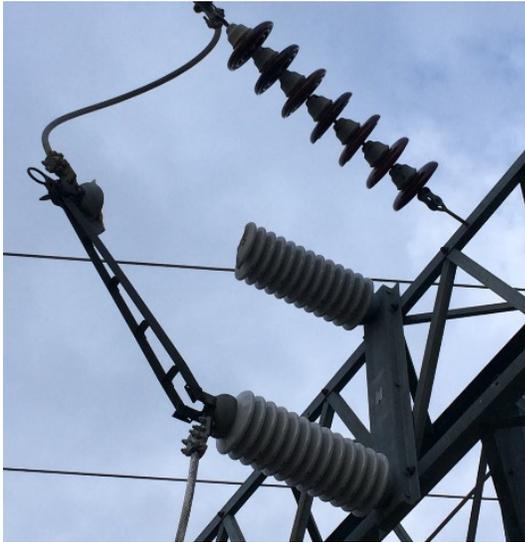
The first fault occurred on February 14 at 3:34 a.m. It was an AG fault on Switch S11 on the line side of the open circuit breaker, CB5. Fig. 5 shows the switch, where a flashover to the structure caused the switch to break away from the insulator. The location on the system is shown as Fault Location 1 in Fig. 4. Even though this fault was clearly not in the transformer relay's zone of protection, the relay tripped on the C-phase percentage-restrained differential element. The 138 kV circuit breakers (CB2 and CB3) and the 69 kV circuit breaker (CB4) opened in response.

Fig. 5. First fault on A-phase of Switch S11.

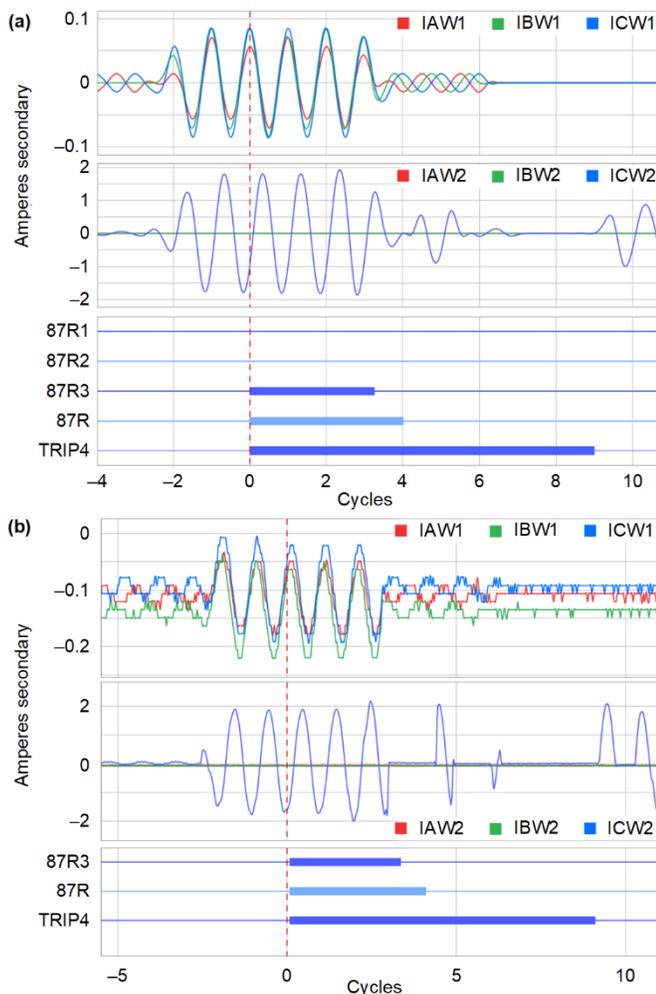
Fig. 6a shows the filtered event report and Fig. 6b shows the raw event report retrieved from the transformer differential relay after the fault. Winding 1 (W1) currents are from the 138 kV side and Winding 2 (W2) currents are from the 69 kV side.

Analyzing the events, what immediately stands out is that the W1 currents are all approximately equal, low in magnitude, and in phase with each other. This is characteristic of zero-sequence ground current. This current is expected, since there is a long path that connects the Substation A 138 kV side to another 138/69 kV grounded autotransformer at another substation and to the 69 kV system. This provides an alternate

Fig. 6. Filtered (a) and raw (b) event reports from transformer relay after first fault.

The second thing of note is that W2 measured current on the C-phase. This was not expected. With the 69 kV side of the transformer isolated, as shown in Fig. 4, no current should flow on W2. The events also show that the current on C-phase W2 is arcing. This arcing continued even after the transformer tripped. The length of this arcing time was due to the remote electromechanical ground time-overcurrent relay taking 34 cycles to clear the fault.

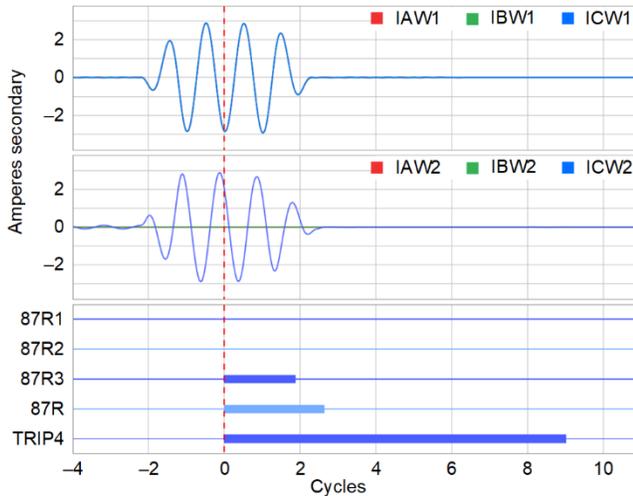
Immediately evident is that the W1 currents are all exactly equal and in phase with each other, again indicating pure zero-sequence ground current. The magnitude is higher this time, since the transformer is serving as a ground source to a fault on a nearby line. W2 is again detecting current on the C-phase with the 69 kV side open. The magnitude is higher this time, as well, and there is no arcing on the W2 currents.

Fig. 7. Filtered event report from transformer relay after second fault.

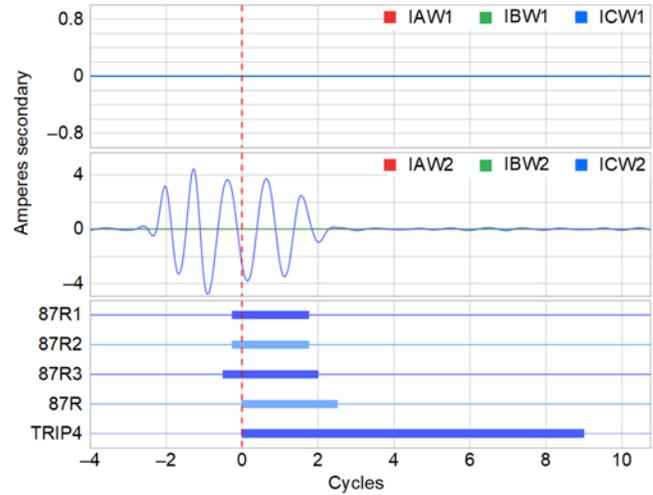
Fig. 8 shows the filtered event report retrieved from the transformer relay after the fault. Since the transformer was completely isolated from the system, there should not be any currents on either of the windings. However, there is still current detected on C-phase W2.

The assertion of all three-phase differential elements was correct based on the transformer compensation settings, which were set at 12 for both W1 and W2. For further information about transformer differential compensation, see [2]. For this fault, the relay again operated correctly based on the currents that it measured. But the question remained: Why did the relay measure those currents?

Fig. 8. Filtered event report from transformer relay after fourth fault.

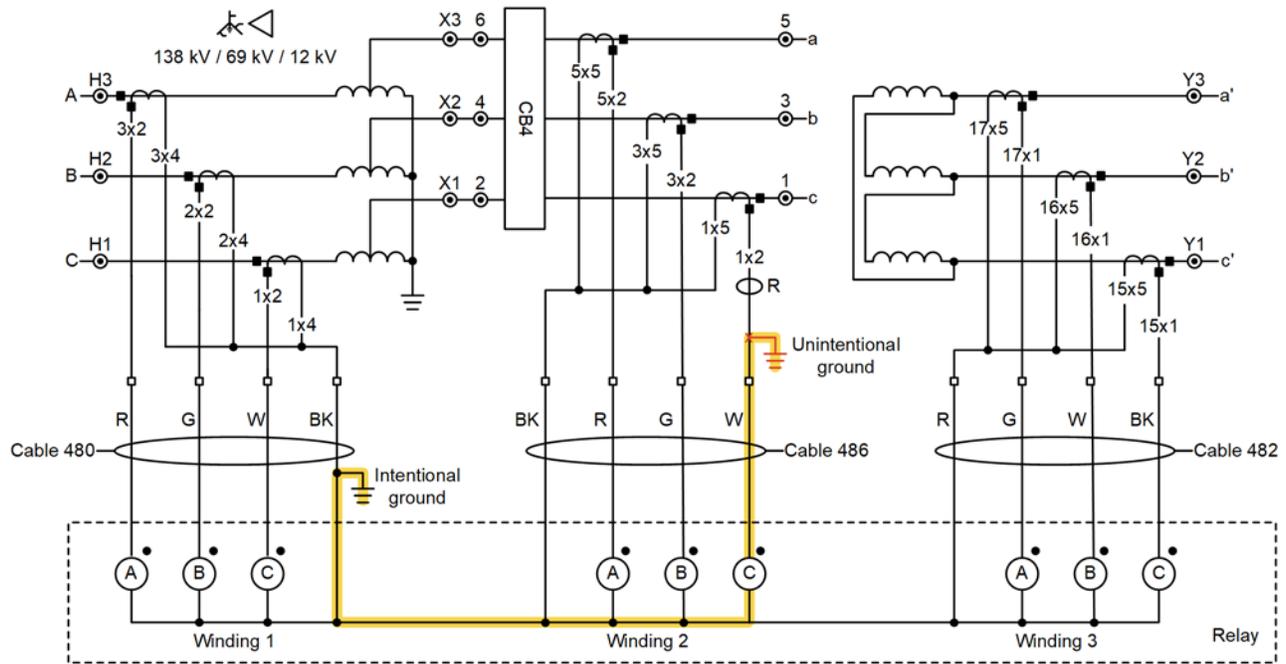
We now knew where the intentional ground was located, and we also knew that current flowed through the C-phase current input (IC) on W2 of the relay. Since the primary circuit on the 69 kV side was open at the time of the faults, that open circuit would reflect on the secondary side of the CT, causing the secondary CT winding (1x2 to 1x5) to appear as an open circuit as well. Keeping this in mind, the only way for current to flow from the intentional ground through the IC input of the relay was through the highlighted path shown in Fig. 10. The unintentional ground would have to be located on the polarity side of the C-phase W2 input of the relay, as shown in Fig. 10.

Fig. 10. Simplified three-line diagram of differential circuit.

An unintentional connection to ground may also occur when the integrity of the insulation on the CT secondary leads has been compromised. Due to the arcing, we hypothesized that insulation breakdown was causing the unintentional ground and was the reason for the misoperations. We asked the technicians to look for an unintentional ground between the polarity side of the C-phase CT and the polarity side of the C-phase W2 input of the relay.

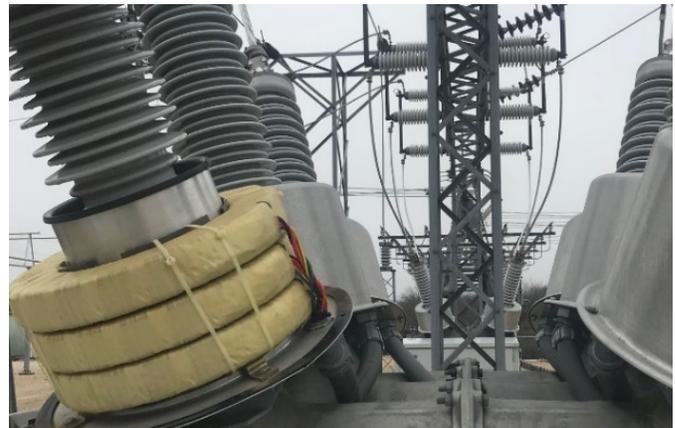
Next, the utility removed the CT cover from Pole 1 (C-phase) on the 69 kV side of the transformer to inspect the CT wires. This is shown in Fig. 11.

Fig. 11. Cover of Pole 1 removed.

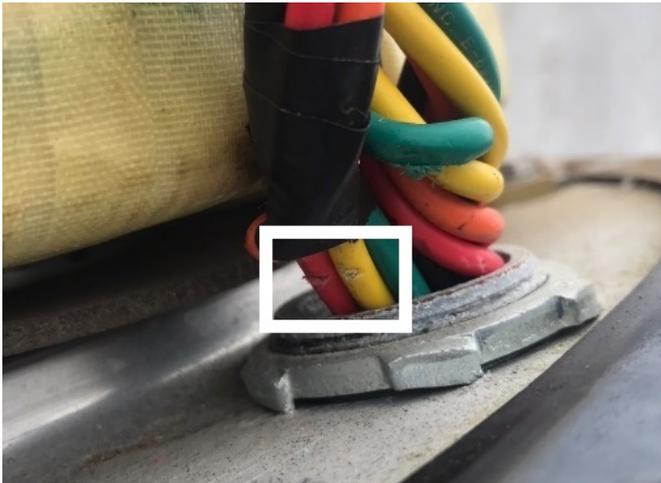
Fig. 12 shows a close-up view of the CT wires. The differently colored wires correspond to the different CT taps of the multi-ratio CT. The wires from the CT are run in flex conduit to the breaker control cabinet, where each wire is terminated. Cable 486 is then connected from the chosen tap points at the breaker control cabinet and routed back to the relay at the control house. Fig. 12 shows that two of the wires (red and yellow) had nicks in them. The wires were rubbing against the side of the flex conduit coupler.

The red wire in Fig. 12 is connected to 1x2, and the yellow wire is connected to 1x4. Fig. 10 shows that 1x2 is brought back to the relay via the white wire in Cable 486. This wire hits the polarity side of the C-phase W2 input on the relay, which is exactly where the phantom current in the event reports was measured.

Fig. 12. Nicked CT wires (red and yellow).

One may initially think that the nicks on the yellow wire (1x4) could not cause an issue since that wire corresponds to an unused tap on the multi-ratio CT. The yellow wire is terminated at the breaker control cabinet and not brought back to the relay. Fig. 13, however, shows how the unintentional ground on the yellow wire could have also caused a problem if the 69 kV side of the transformer had not been open. If 1x4 and 1x5 are both grounded, it effectively creates a short circuit on the secondary side of the CT between 1x4 and 1x5 (highlighted path). This short will cause all the current on the secondary side of the CT to circulate in this highlighted path, instead of forcing the desired ratio current to flow between 1x2 and 1x5. A similar issue could have occurred due to the unintentional ground on the red wire, with current circulating in the short circuit between 1x2 and 1x5, and not being sent to the relay. A misoperation could have easily occurred for either of these cases since the relay would not be measuring correct ratio current.

When the technicians discovered the nicks in the CT wires, they moved the wires to prevent them from contacting the conduit coupler. Before the wires could move again, they quickly performed another insulation resistance test, which passed. Because they were able to turn the problem on and off, root cause was confirmed.

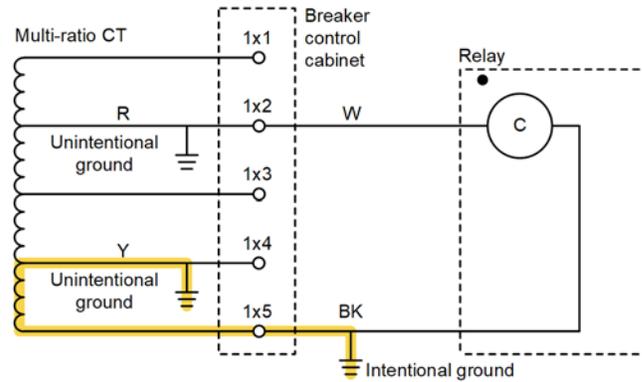
Fig. 13. Ground current path due to unintentional ground on yellow wire.
