# A Troubleshooting Methodology for Issues Discovered During End-to-End Testing

Jose R. Garza

*Transmission Field Services – P&C Tech Support Engineering*  
*American Electric Power*  
Corpus Christi, TX  
jrgarza3@aep.com

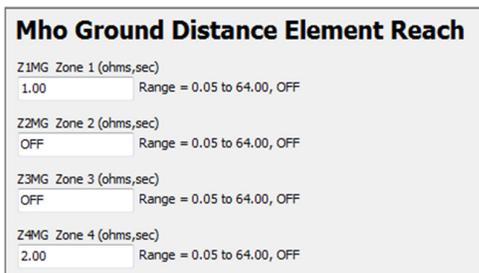
Examining the ground distance settings showed this setting to be OFF. The Kenedy SW-owned utility opts to swap Z2 and Z4 elements as an inherited practice from limitations of earlier generations of SEL relays.

Fig. 15. @Kenedy SW – Z2MG set to OFF

Once the settings errors were corrected, the POTT scheme at Kenedy SW no longer overreached, and operated appropriately for ground faults on the protected line. This is an example of a multi-fold problem solved by this troubleshooting methodology.

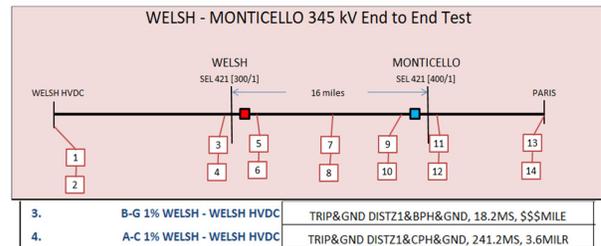
Field personnel were performing no-comm testing at Welsh for the Welsh - Monticello 345kV line. Results showed Zone 1 elements tripping instantaneously for reverse faults. AEP does not implement instantaneous Zone 1 tripping in the reverse direction.

Fig. 16. Welsh – Monticello oneline, simulated fault locations, and no comm results

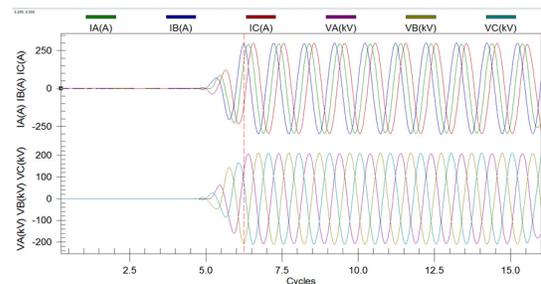
Fig. 17. @Welsh – Pre-fault state, currents not properly balanced

Figure 17 represents a snapshot of the event from the pre-fault portion of the fault on a primary value basis. Comparing the angles of the B and C phase currents to the applied current angles shows a 180 degree difference.

This implies a roll of test leads connected to the polarity and non-polarity relay current inputs. Field personnel reviewed test set connections and confirmed the roll on both B and C phase current leads. The connections were corrected, and proper results ensued.

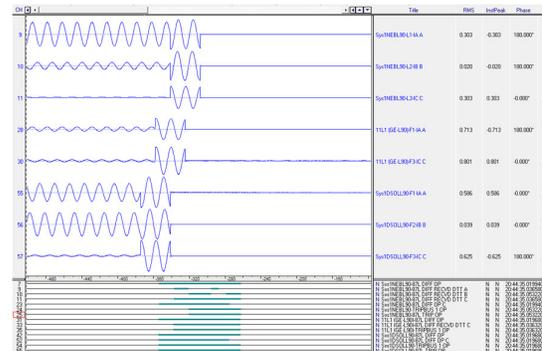
Fig. 21. Synchronized event files depicting each terminal transitioning to fault state at different times

The time-synced file reveals each station transitioning from the pre-fault state to the fault state at different times. This reveals the fact that the test sets were not properly synchronized with each other. Examination of the test set firmware at each end revealed mismatched versions. Once all three test sets were upgraded to the same firmware revision, the GPS synchronization was re-established, and field tests performed as expected.
