# American Electric Power's Experience with Protection System Misoperations and Improvements

75<sup>th</sup> Annual Conference for Protective Relay Engineers

## AEP Misop Event of 1/26/2022

# AEP Fifth Avenue Mobile Misop

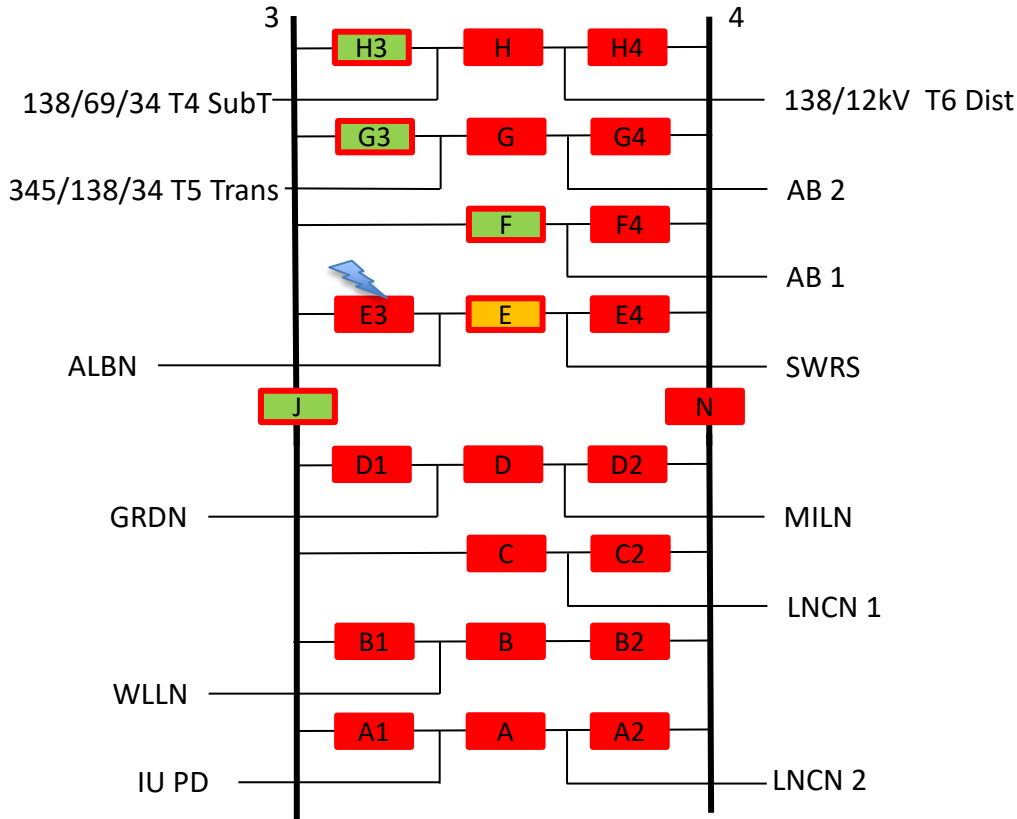
# Fault Stage 1 – Initial Operation

- Internal CB-E3 fault
  - Fault is located between ALBN Line zone and 138kV Bus #3.
  - Both zones operate correctly, with CB's H3, G3, F, and J tripping and locking out from the 87 Bus protection.
  - CB-E trips from line protection zone 1 and is set to reclose highspeed ~18 cycles after initial trip.
  - CB-E sees ~12 kA fault current

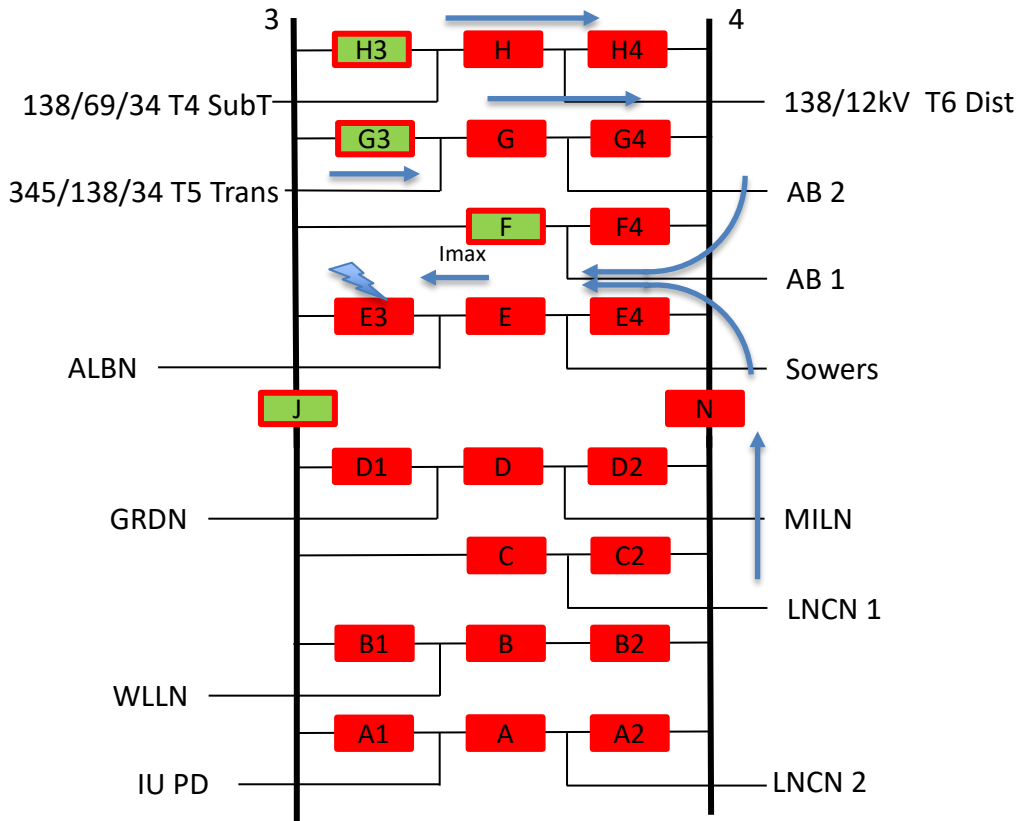
# Fault Stage 2- CB-E Reclose

- CG fault is permanent
  - CB-E recloses back into the permanent fault.
  - $I_{max} = 42$  kA with a large contribution from T5
- Notice the new path of fault current due to 138kV Bus #3 being locked out.

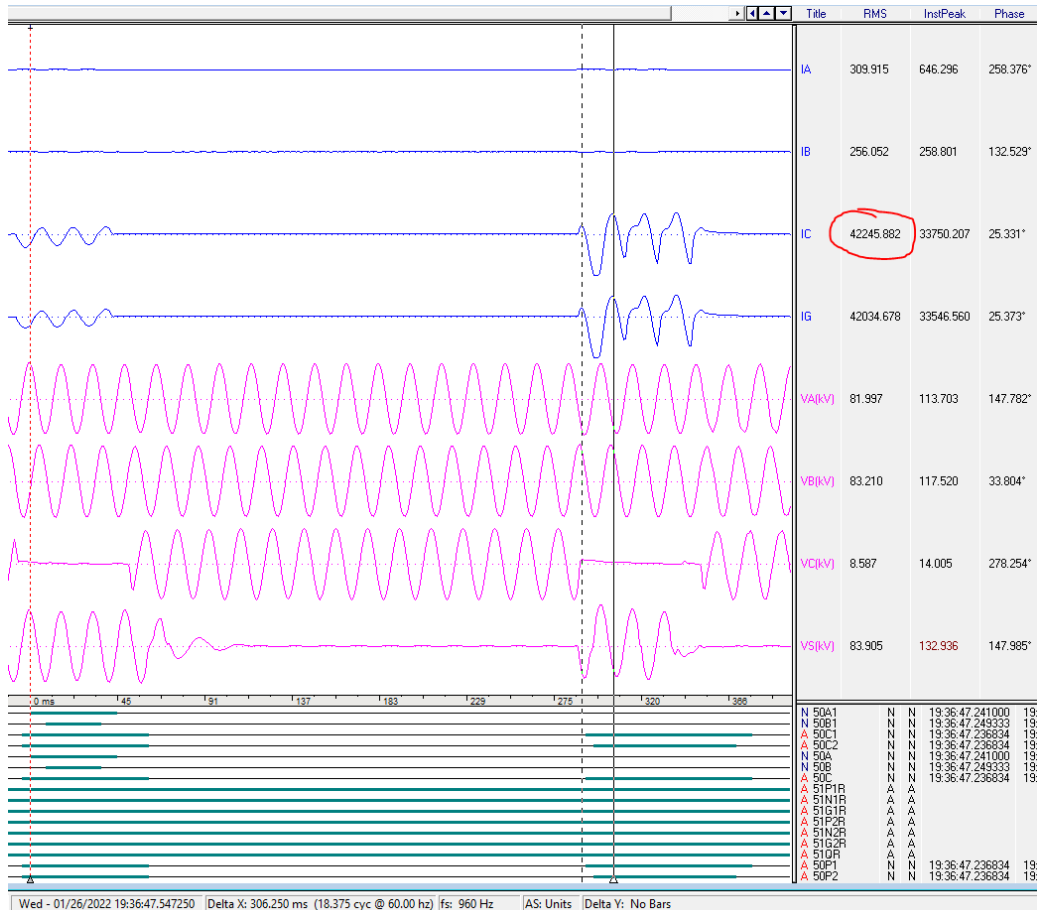
# Fault Stage 2 – CB-E Reclose (SEL-351S 79/551E)

- ~18cyc between cursors verifying CB-E HS reclose time.
- IC RMS magnitude much larger then Stage 1.

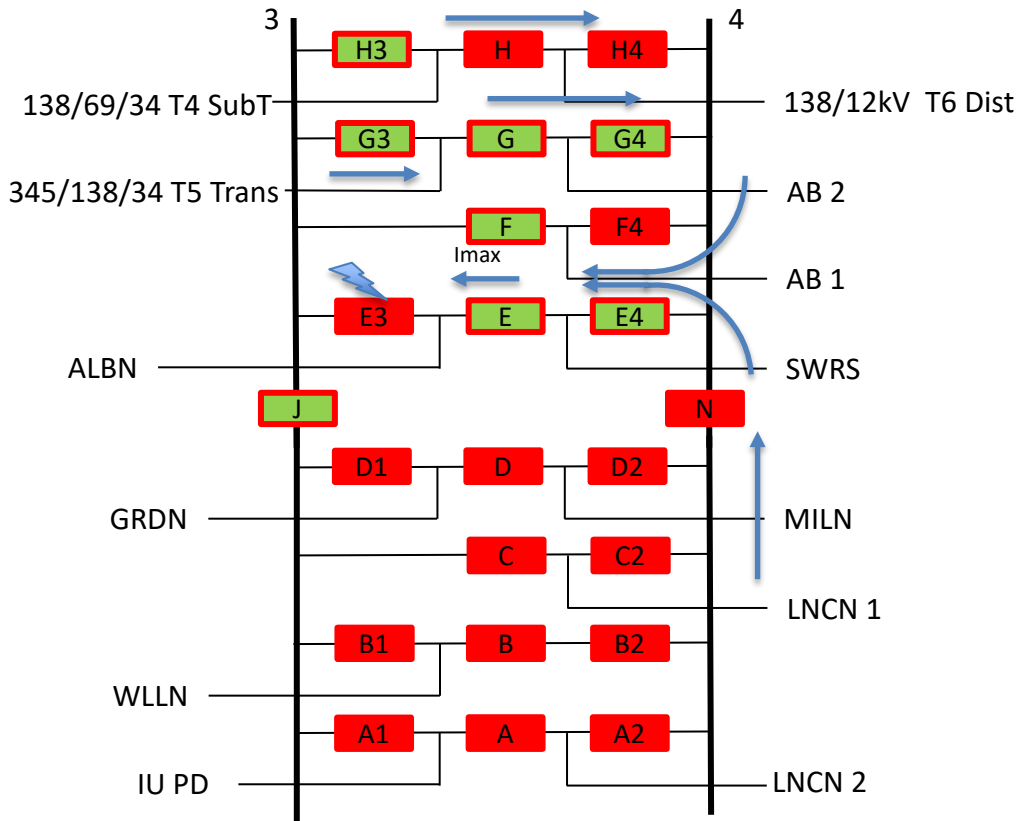
# Fault Stage 2- CB-E Reclose & Misoperation

- CG fault is permanent (same phase as slide 6).
  - CB-E recloses back into the permanent fault.
  - $I_{max} = 42$  kA with a large contribution from T5
- CB's E, E4, G, and G4 misoperate operate for a close-in 1LG fault.
- T5 trips and locks out due to lowside lead differential L90 misoperation.

- **138kV line Misoperations**
  - CB-E high speed reclosing will be evaluated with AEP Operations group and the CT connected ratio will be evaluated and connected at the highest ratio possible to help minimize any future CT saturation.
- **345/138/34.5kV T5 lowside lead differential Misoperation**
  - L90 relay settings will be evaluated (break point, differential slopes, and differential pickup) to better handle any future CT saturation that may occur. The connected CTs are already at full tap (600/1) so the CT ratios cannot be raised any higher.

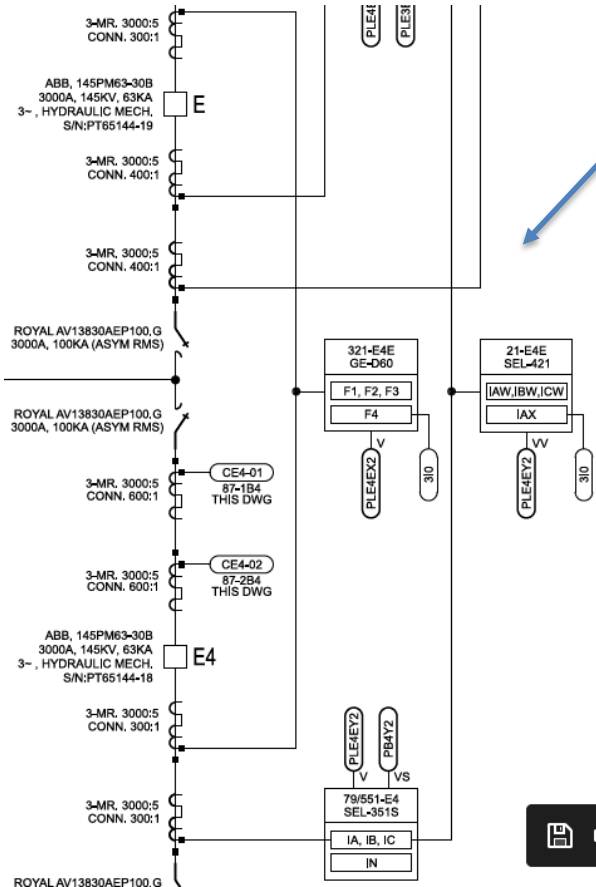
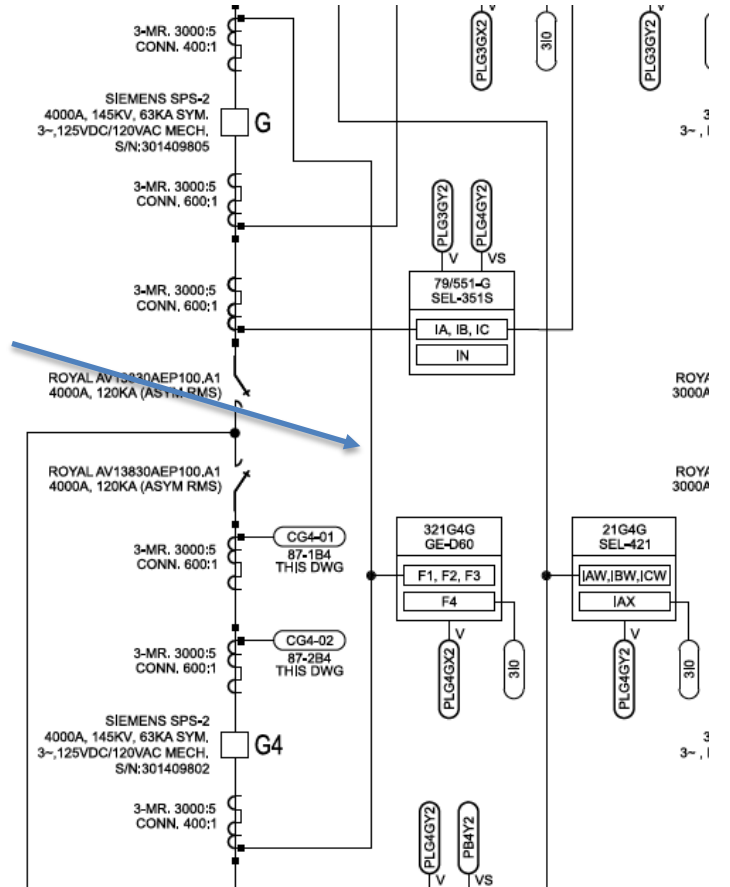
# Misoperated 138kV Line Protection

SWRS Line  
321-E4E DCB  
21-E4E SD

AB 2 Line  
321-E4E DCB  
21-E4E SD

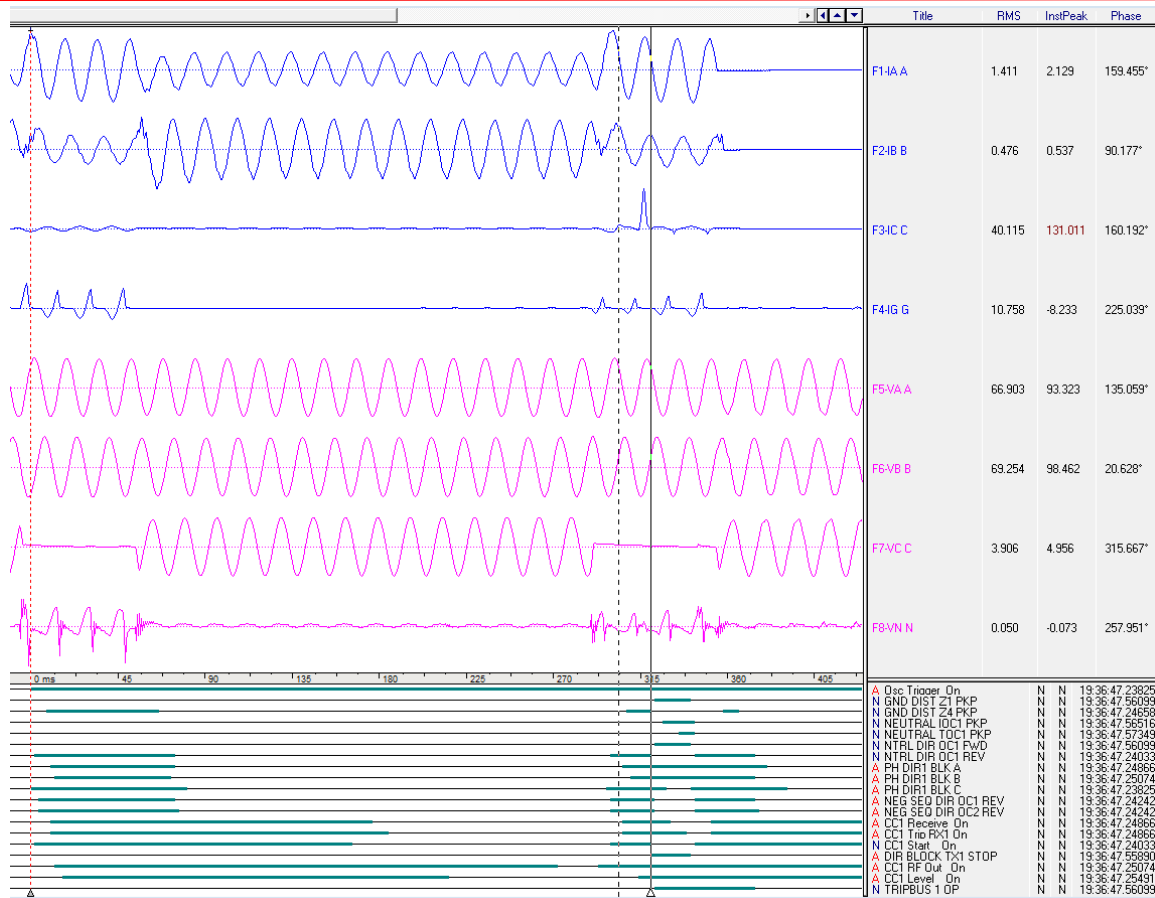
# Misoperated 138kV Line Protection (GE-D60 321-E4E)

- $40 * 300 = 12\text{kA}$

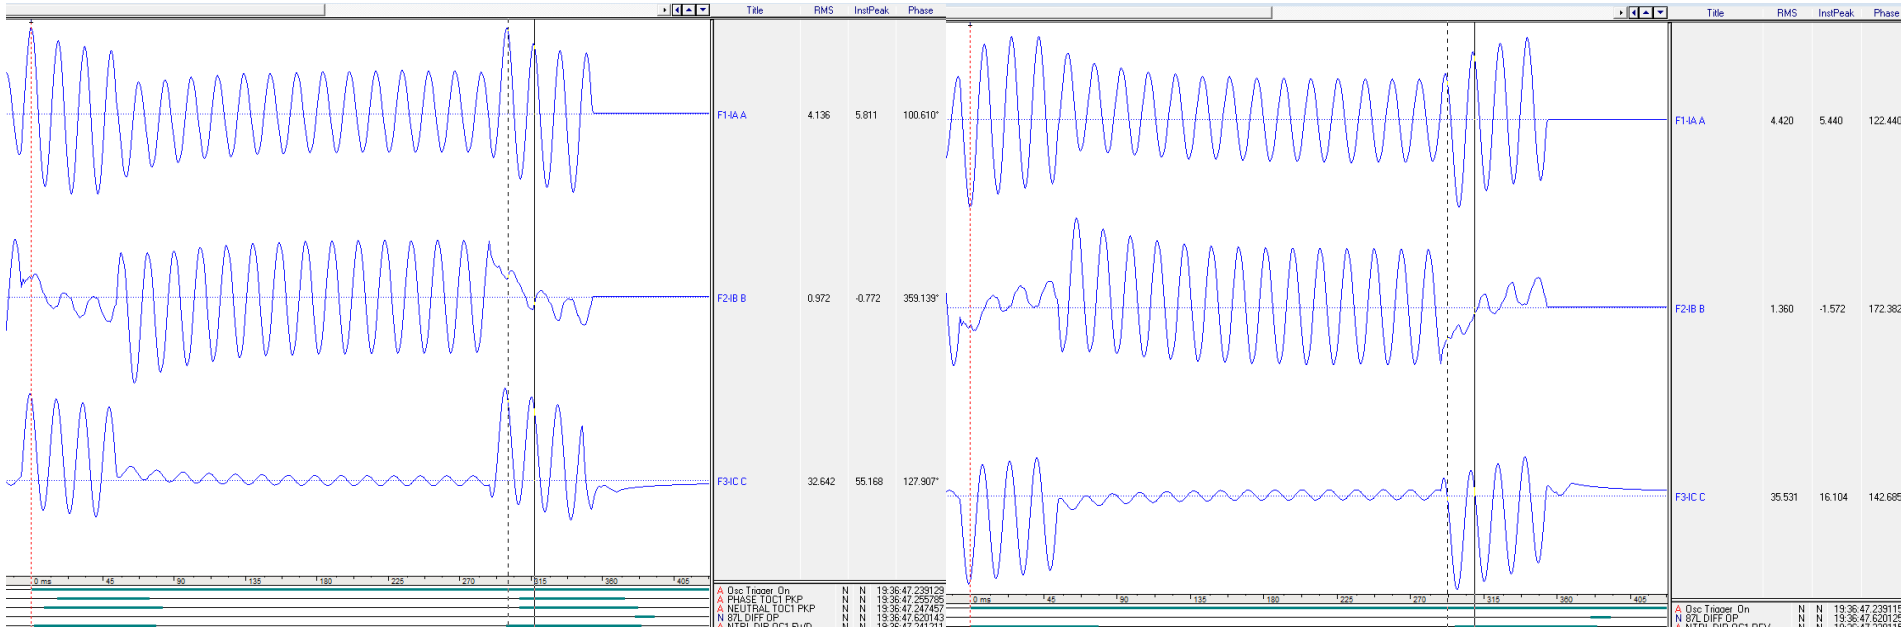
# RP T5 Lowside Lead Differential

L90 – 87T5 (Lowside T5 CT)

L90 – 87L-G3G (138kV Yard BCTs)

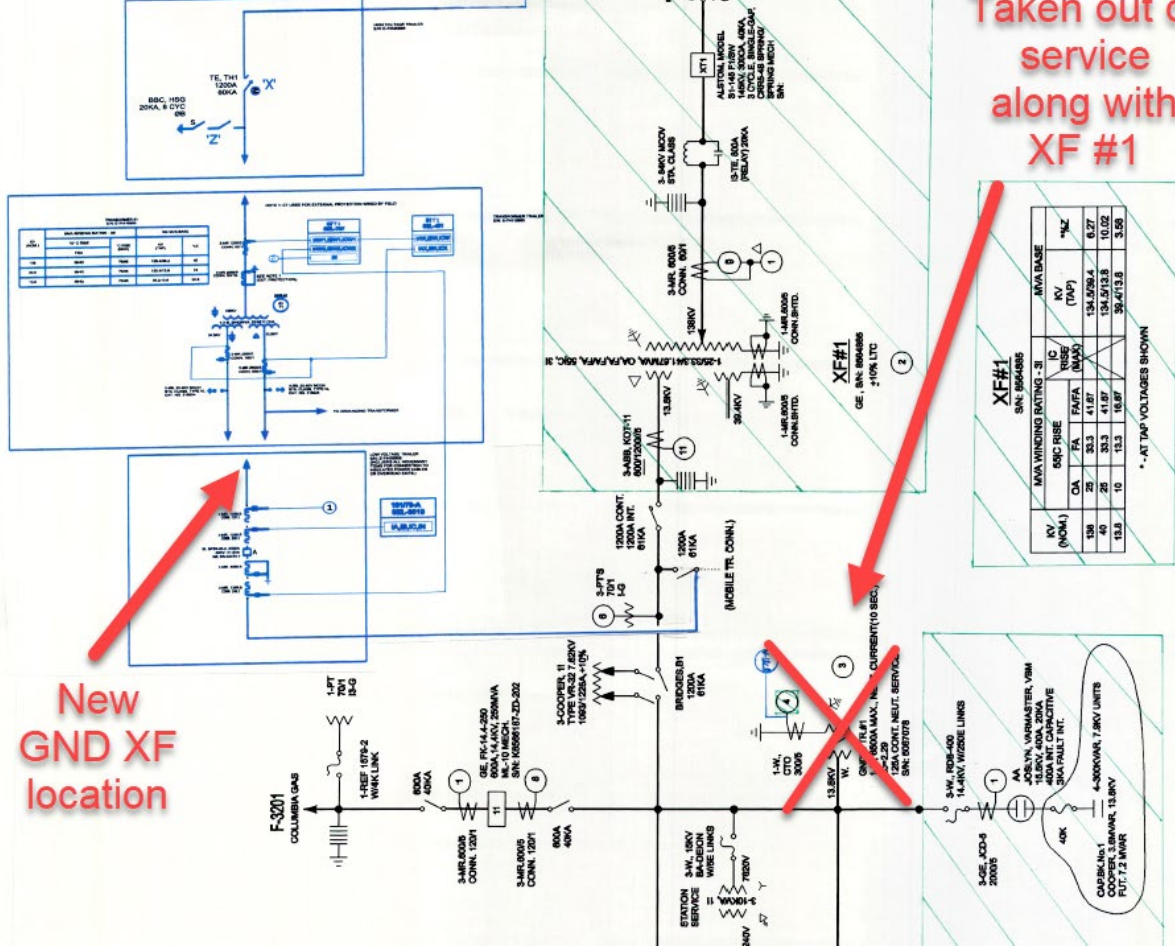
New  
GND XF  
location

- During the mobile installation, the plan changed
- Existing GND XF was no longer used (taken out for maintenance along with the main XF) and the GND XF that rides along with CSP-9 was used
- The position of where the GND XF was connected had been modified (bus before, but now between XF and LS CB)

- The SEL-787 XF differential was set based on the original plan with the GND XF outside of the XF differential zone.
- Since the low side winding was delta, the SEL-787 relay doesn't filter out zero sequence current in its low side CT because no zero-sequence current can flow through a delta.
- The fix was very simple:
  - Change the W2CTC setting from 0 to 12.
  - This still maintains the same angle compensation, but the 12 setting also filters out the zero-sequence current.

The WxCTC settings are used to match the phase shifting of the current signals and to remove zero sequence. WxCTC = 0 or 12 provides zero phase shift. If WxCTC = 12 is used then this selection removes the zero sequence. Each increment of WxCTC represents a 30 degree phase shift. For ABC phase rotation each increment in phase shift is in the counter clockwise direction. Reference the SEL787 instruction manual for more details.
