A Tale of Two Out-of-Phase Synchronizing Events at BC Hydro

Mukesh Nagpal and Lesley Gu, *BC Hydro*
 Ralph Barone, *Barone Technical Consulting Services Ltd*
 Ritwik Chowdhury and Michael Thompson, *Schweitzer Engineering Laboratories, Inc.*

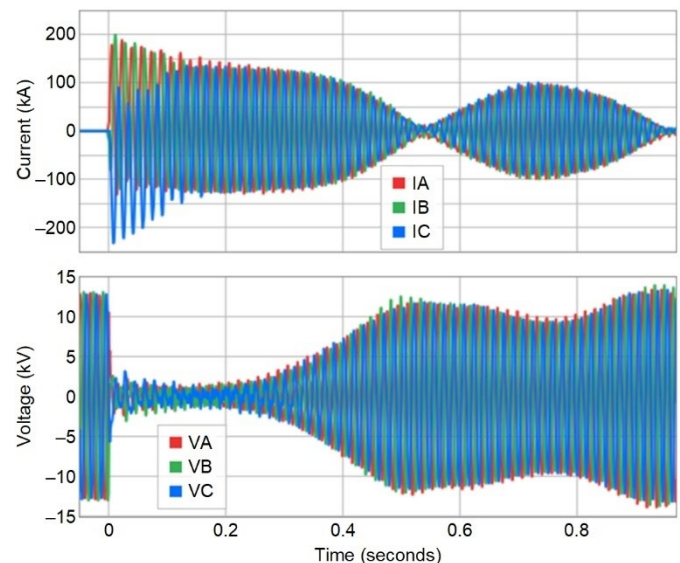
Fig. 2. Second OOPS event (December 7, 2021).

After the 30-hour-long T3 Heat Run Test completed, G3 was taken offline. The commissioning crew started to suspect that something had gone wrong, because there should have been minimal transient from the perfect manual closing via synchroscope. However, the transient data measured by the generator relay illustrated the opposite—a disturbance that was well beyond the size of a typical synchronization disturbance, with 232 kA peak current. This event report is shown in Fig. 2.

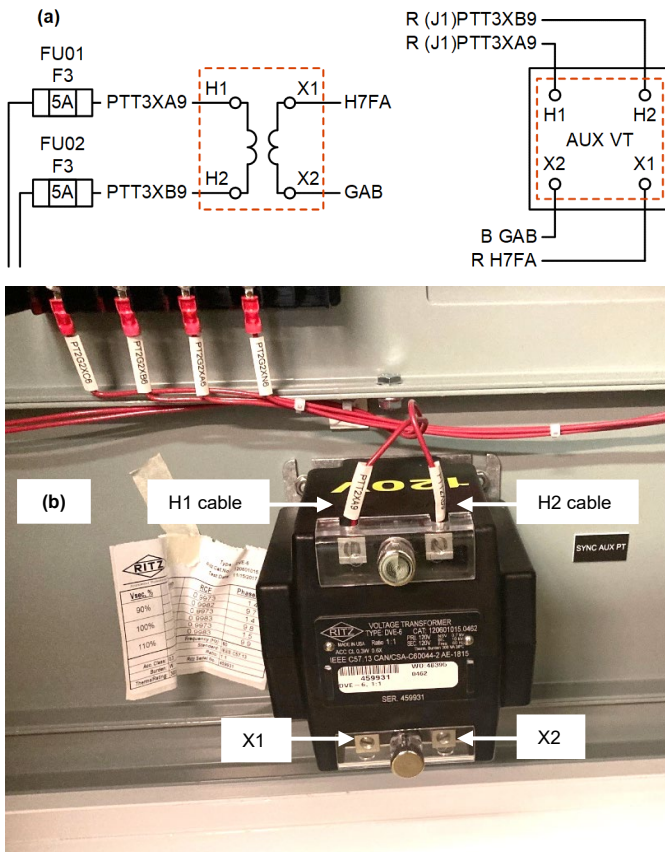
Fig. 3. Wiring drawing (a) and photo of terminal connections with error (b).

auxiliary VT replacement. It found that the polarities of the VTs had been connected backward. Unfortunately, all three devices (autosynchronizer, synchroscope, and sync-check relays) shared the same auxiliary VT source, which introduced a common-mode failure among all the synchronizing devices and caused them to fail simultaneously. The inverted polarities of the auxiliary VT resulted in a 180-degree OOPS event, despite an ideal synchronizing indication from the synchroscope.

The investigation then focused on why the wiring error occurred in the first place, and why it was not caught during commissioning. Fig. 3a shows the auxiliary wiring drawing and Fig. 3b shows a photograph of the auxiliary VT in the panel before the panel was installed. The VT is mounted at the bottom of the panel, which makes the terminal labels hard to see. The installer, instead of confirming the physical labels on the VT terminal block, assumed that the wiring drawing represented the actual physical layout. In the wiring drawing, X2 is below H1 and X1 is below H2. However, the physical layout on the VT terminal block is actually the other way around—X1 is below H1 and X2 is below H2.

- The synchronizer and any synchronism-check devices should be connected to independent circuits and separate VTs. This helps eliminate a common-mode failure from wiring and VT polarity errors.
- After modifications, wiring and polarity integrity should be verified before the synchronizing system is exercised for the first synchronization. The wiring and polarity can be checked by measuring the voltages at the terminals of the synchronization system (as supplied by VTs) when the unit is running and is synchronized using another system that is known to be functional.

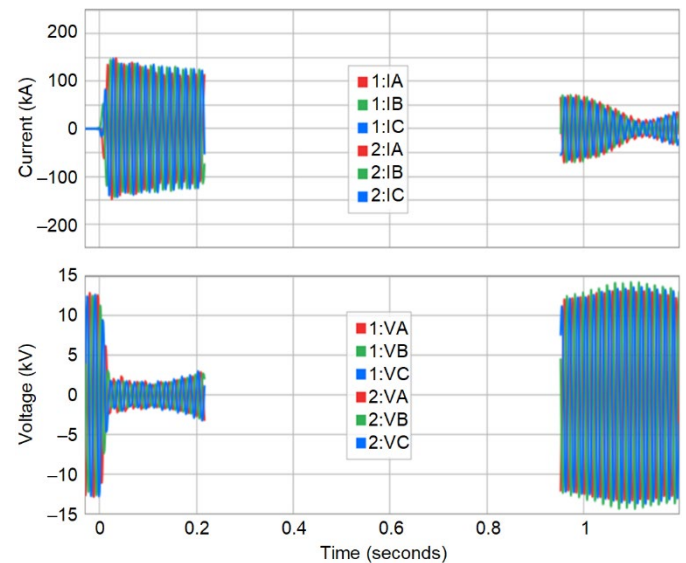
Fig. 4. First OOPS event (December 3, 2021).

The event data for the first event were from a filtered record, which does not capture the dc offset or harmonics. This event report is shown in Fig. 4. Because better data were required for some of the analyses, the event record for the second OOPS event (Fig. 2) is used for the rest of the discussions in this paper.

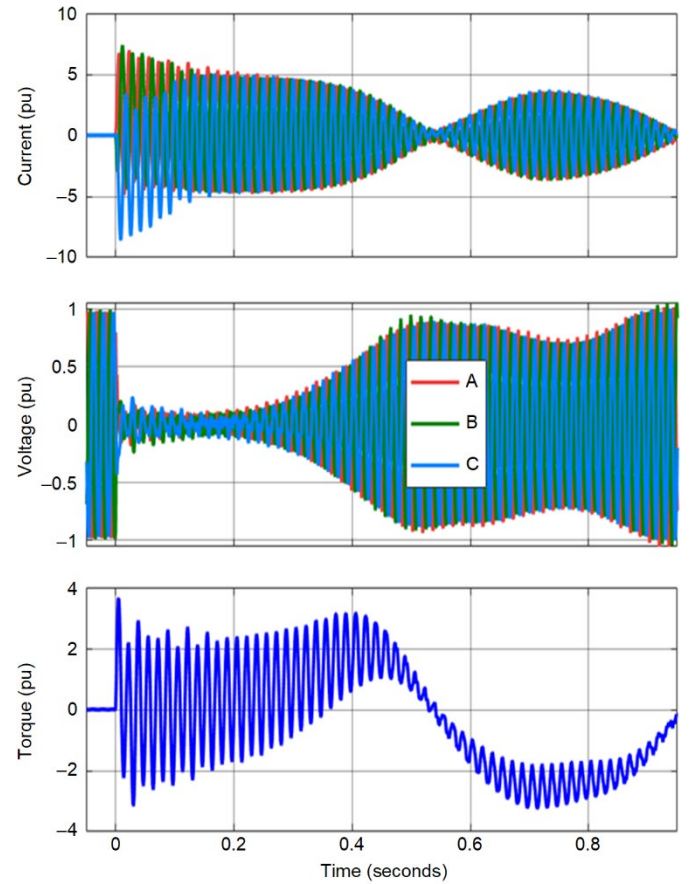
Fig. 8. Calculated torque during OOPS event.

With the use of the Z_{1SYS_MIN} parameter, the associated torque is 0.972 pu. If the system is made infinitely strong, with a Z_1 of 0 pu, then the associated torque is 1.06 pu. A 10-degree synchronizing angle, considering the impedances of the generator and the GSU, results in a transient torque that is very close to the generator rated torque. Therefore, using a per-unit torque calculation to get an indication of the severity of an OOPS event to the generator shaft and prime mover is a reasonable approach.

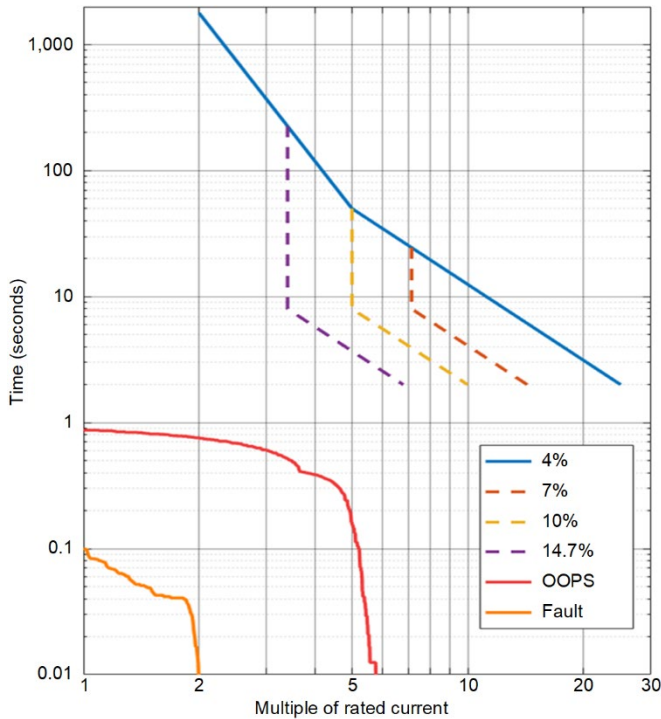
Fig. 9. Time overcurrent during events plotted, with respect to the standard Category IV transformer characteristics.

The standard characteristic in this figure, which the transformer is designed to withstand, has multiple curves for high currents because the transformer impedance limits the fault current from exceeding the upper values. For instance, for a transformer with a 10-percent impedance, the upper limit of the withstand characteristic ends at 10 times (100-percent voltage/10-percent impedance) the transformer rated current.

Considering the margin with the withstand characteristic, and considering through ground faults that can result in high fault currents in a GSU winding, this paper concludes that the torsional damage to the shaft is possibly a bigger concern [5] than overcurrent damage to the GSU winding during OOPS

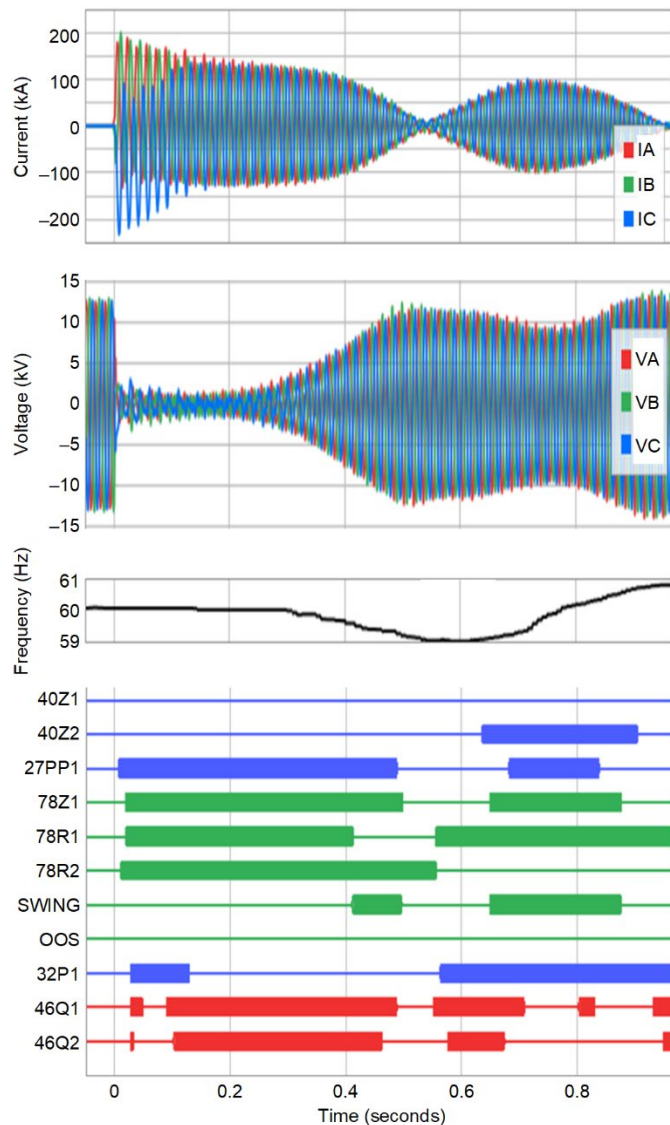
Fig. 11. Response of protection elements during OOPS event.

During both OOPS events, several of the common generator protection elements [9] [10] picked up. However, none of these elements tripped. The behaviors of the different generator protection elements are discussed in this subsection [11]. An event report with the response of the protection elements is shown in Fig. 11.

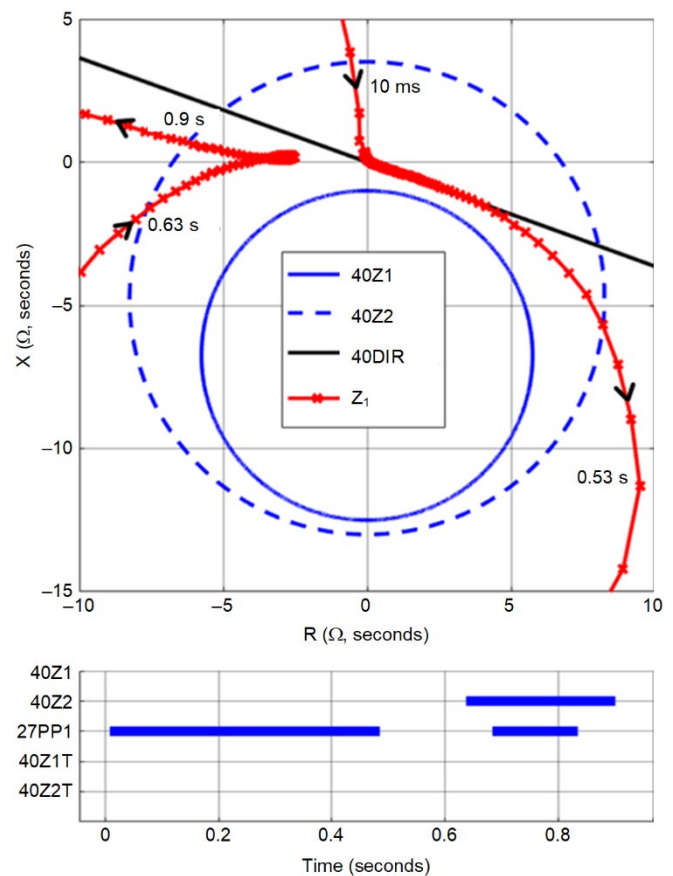
Fig. 12. Loss-of-field element response during OOPS event.

Immediately after the OOPS event, the impedance locus entered the Zone 2 mho characteristic but remained above the directional line; therefore, Zone 2 did not assert. If the directional line were set with a lower tilt of -10 degrees, then Zone 2 could have tripped on the accelerated path, because the undervoltage lasted about 0.47 seconds. The impedance locus never entered Zone 1.

After 0.63 seconds, the impedance locus entered Zone 2 from the left. This time, the directional check was satisfied, but the undervoltage condition lasted about 0.15 seconds; therefore, the element did not trip on the accelerated path.

This was not a loss-of-field event, and the protection element did not trip. However, it is clear that the element could have tripped on Zone 2 if the conditions were slightly different or if the directional element was set with a lower tilt of -10 degrees.

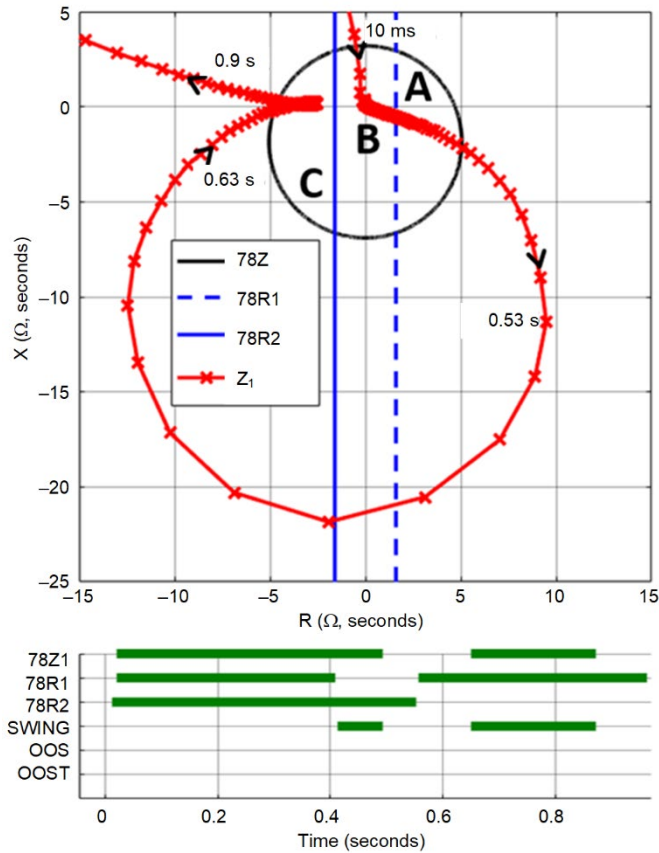
Fig. 13. Out-of-step element response during OOPS event.

The generator had no load prior to switching and was subjected to out-of-phase closing (the initial rotor position was 180 degrees). Immediately after the breaker closed, the impedance locus entered Region B from about 90 degrees. Even if it had entered from the right, the scheme requires the impedance locus to remain in Region A for at least three samples to ensure that it is a swing with slow trajectory and not a fault with fast trajectory. Because the initial change associated with the OOPS event was sudden, as it would be for a fault, the element did not classify it as a power swing.

After 0.65 seconds, the swing locus entered Region C. The impedance locus moved slowly and behaved like a swing; therefore, the SWING bit asserted. However, the characteristic never entered Region B and, therefore, was not classified as an out-of-step condition because the swing remained stable. This is also visible in the currents and voltages of Fig. 11, where the system recovered. If the swing had become unstable, and the associated impedance locus moved from Region C to Region B and then exited from Region A, the single-blinder scheme would have been expected to trip.

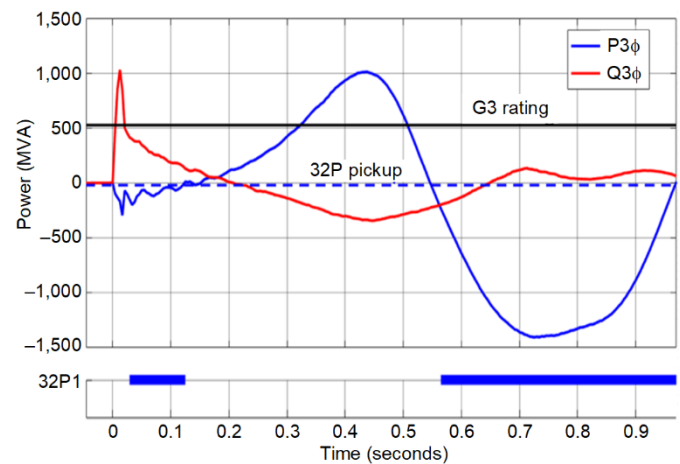
Fig. 14. Reverse power element response during OOPS event.

The reverse power element response is shown in Fig. 14. It asserted initially for about 100 milliseconds when the machine motored slightly. Then, after 0.56 seconds, when G3 absorbed nearly 3 pu real power, the element asserted for about 0.42 seconds. The element never timed out to alarm or trip during this event because of the oscillations.

The reverse power element did not trip during the transient, but it could trip later, during load, for OOPS events caused by other wiring errors. If the VTs used by the generator relay are inverted in polarity and the machine starts generating, it can appear as if the machine is motoring to a reverse power relay. However, this is not a reliable indicator. As was the case here, the VTs used by the generator relay could be wired correctly.

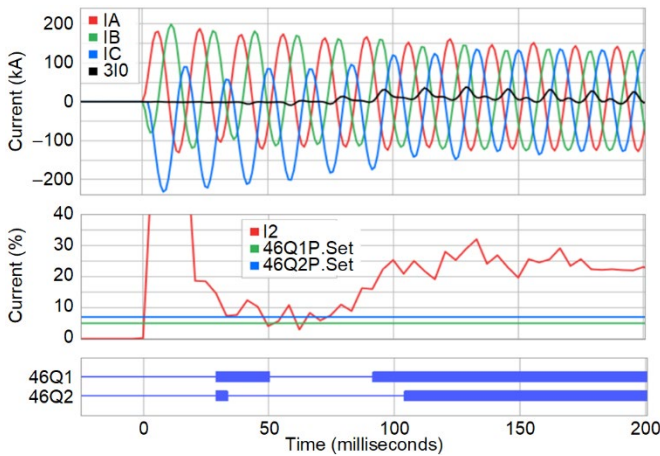
Fig. 15. Presence of I_2 and I_0 due to CT saturation during OOPS event.

The response of the element is shown in Fig. 15. This event had balanced currents, but there is evidence of dc CT saturation at about 50 milliseconds, where the C-phase current lost its dc component quickly. In this raw event record, the other set of phase CTs associated with the differential was not available, so the residual current ($3I_0$, shown in black in Fig. 15) was used to get a clearer indication of saturation. This is a sound approach for analysis because the high-impedance grounding meant that $3I_0$ was not expected. The $3I_0$ crept up when the CT saturated, as shown.

The I_2 magnitude associated with the saturation, ignoring the initial filter transient and pole scatter, increased to a value of about 30 percent of the generator rating, before it started to decrease and eventually dropped to zero at about 0.5 seconds (not shown). The protection worked correctly because it was intended to not operate on switching operations introducing I_2 transiently from unequal saturations of three-phase CTs. A value of about 30 percent is associated with a current unbalance element trip time of about a minute. CT saturation should not be relied on to detect this condition, even though (as explained later in Section IV.D) it sometimes causes a sympathetic trip during an OOPS event.
