Electromechanical Differential Relays Misoperation and Investigation. Part 2.

Alex Rangel, *Saber Power Services*

Abstract— In January 2022, an industrial site had a partial blackout due to an improper operation of one of its main electromechanical differential relays. The system was being upgraded and reconfigured, and a mistake was introduced during the demolition process. This paper describes the investigation into the nuisance trip and how careful demolition could have prevented this issue.

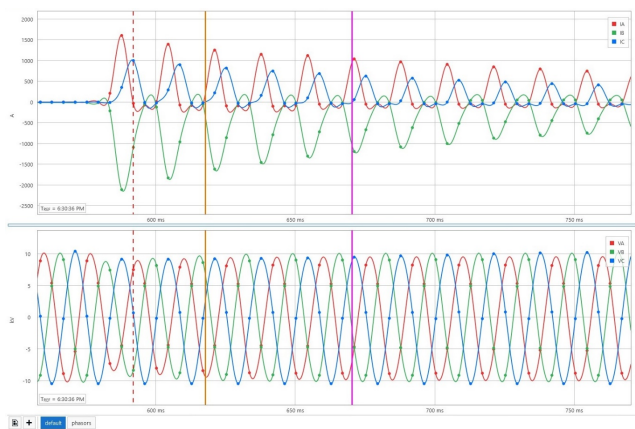
Fig. 2. Successful motor energization on feeder F6

One of our biggest challenges when performing this root-cause investigation was the electromechanical relays, which do not produce any event data; they only provide a physical flag in the tripped relays. However, the feeder breakers had been upgraded to new microprocessor relays, and because each feeder uses digital feeder protection, they are capable of producing event data. The relay at feeder F1 only produced a history report, while the relay at feeder F6 produced history and oscillography reports during the motor startup. The oscillography reports showed inrush current, which is typical during transformer and motor energization, and it was confirmed that no fault was present at feeder F6. Figure 2 shows the current and voltage waveforms during energization on feeder F6.

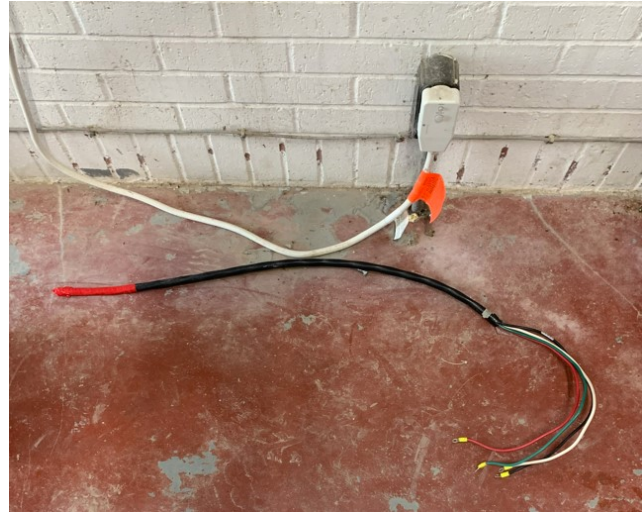
Fig. 3a. 4-wire bundle cut and left behind in the substation house

While performing a visual inspection into the 87T1 relay, site personnel noticed that a 4-wire bundle had been cut and left behind, as shown in Figure 3a. The bundle had 4 wires with colors red, black, green, and white, which are the colors used for current transformer (CT) circuits. Further inspection of the circuits showed that the bundle belonged to points 9C1 Δ , 9C2 Δ , and 9C3 Δ . For the remainder of this paper, we will call this bundle the 9 Δ bundle.

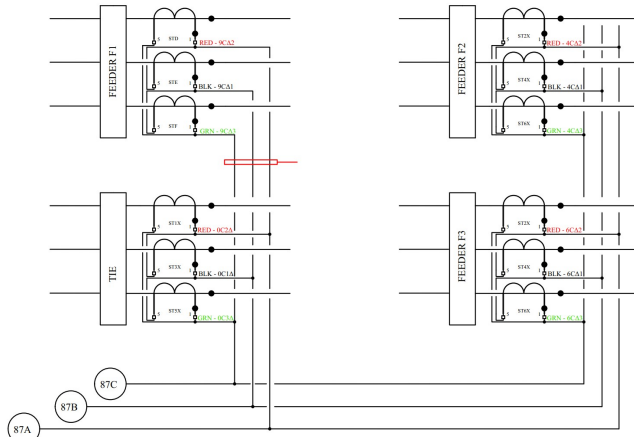
Fig. 4. Three line diagram, 87T1 relay, secondary circuits (simplified)

Site personnel examined the three-line diagrams to locate this bundle. The 87T1 relay schematics show that the bundle with wires 9C1Δ, 9C2Δ, and 9C3Δ is the CT contribution from feeder F1 into the 87T1 differential relay, as shown in Figure 4. At the time that the 9Δ bundle was removed from the system, feeder F1 was energized and the motor was running; however, the 87T1 relay did not trip then.

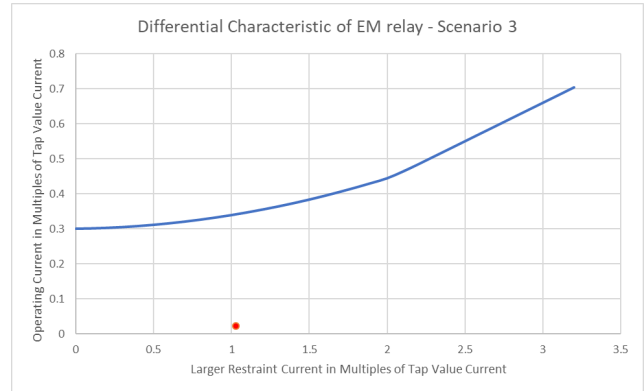
Fig. 8. Differential characteristic for scenario 3

Scenario 3. Scenario 3 is a critical scenario in which a safety concern is introduced, due to the risk of removing a CT circuit while the system is energized, effectively opening the CT. In the next section we will cover the safety concern; however, from the perspective of the 87T1 relay, it did not operate during this circuit removal. According to field personnel, prior to the removal, Bus A was carrying approximately 730 A, and after the cables were removed, the 87T1 relay lost its motor contribution (30 A). Figure 8 shows that, even though the contribution from primary and secondary sides was not equal, due the amount of load in the system, the operate current only increased slightly.

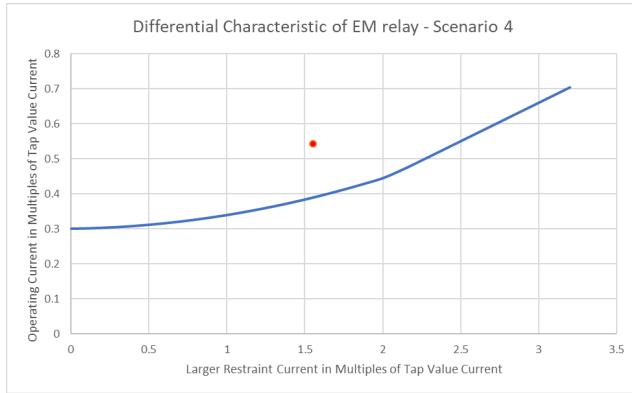
Fig. 9. Differential characteristic for scenario 4

Scenario 4. Field personnel stopped the motor (as required by the industrial procedures) and re-energized later the same day. This time, the 87T1 relay operated and tripped, taking Bus A out of service. During energization, the contribution to 87T1

from the primary side of the transformer would be 400 A larger @ 12.47 kV due to the motor's inrush current, and since the system was carrying 700 A already, the total contribution would be 1,100 A @ 12.47 kV, or 99.39 A @ 138 kV. Figure 9 shows that the resulting plot is above the curve, and therefore the relay sends a trip signal.

$$I_{OP(pu)} = |I_{RT_1(pu)} - I_{RT_2(pu)}| = |1.55 - 1.01| = 0.54 pu \quad (4.3)$$

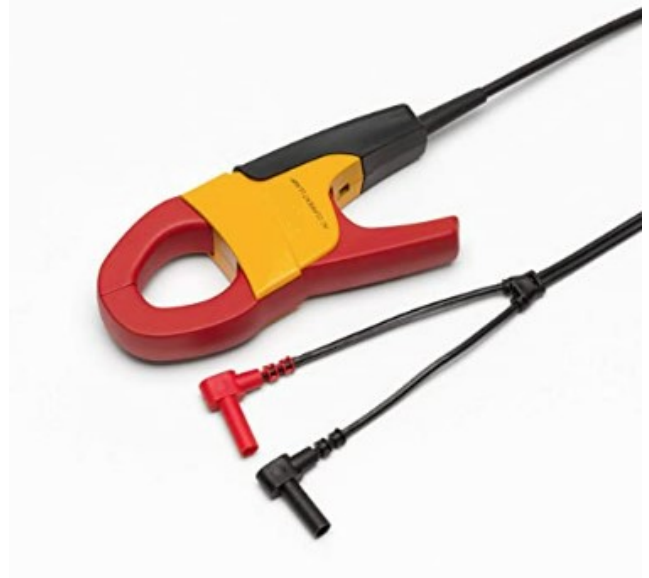
Fig. 10. Amp clamp meter to verify de-energization of a CT circuit

Energizing a CT that is open circuited (on the secondary side), typically referred as an “open CT”, represents a very critical safety concern. As D. Costello explains in detail in [3], an open CT will create a condition of extreme saturation and develop an extremely high excitation voltage, which will damage equipment such as CTs, relays, wiring insulation, and it will expose electrical workers to severe injury, such as loss of limb, or death. Verification of the lack of current flowing through a CT wire can be easily performed using an amp clamp meter, such as the one shown in Figure 10. In this case, the feeder F1 current transformers for the 87T1 relay were damaged and replaced at a subsequent outage.
