**ELECTROMECHANICAL DIFFERENTIAL RELAYS
MISOPERATION AND INVESTIGATION
PART 2**

**BY: ALEX RANGEL, P.E.
SABER POWER SERVICES**

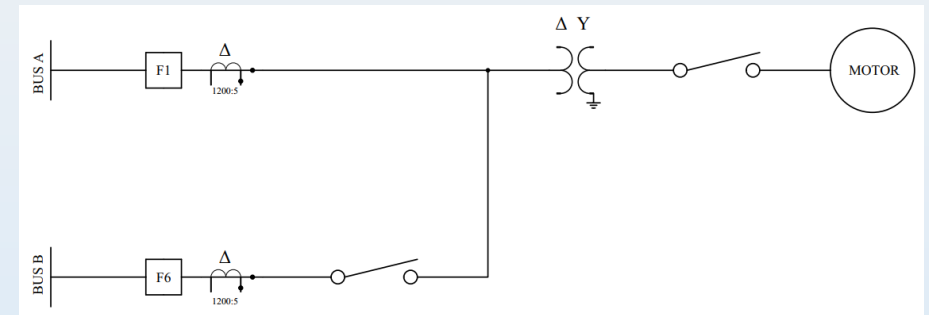
- On January 13, 2022, the site experienced a partial blackout.
- Sequence of events
 - The motor was running, it was stopped as part of the process
 - Motor start attempt. 87T1 trip and bus A got de-energized
 - Switching to bus B performed. Motor start attempt and the motor remained energized.

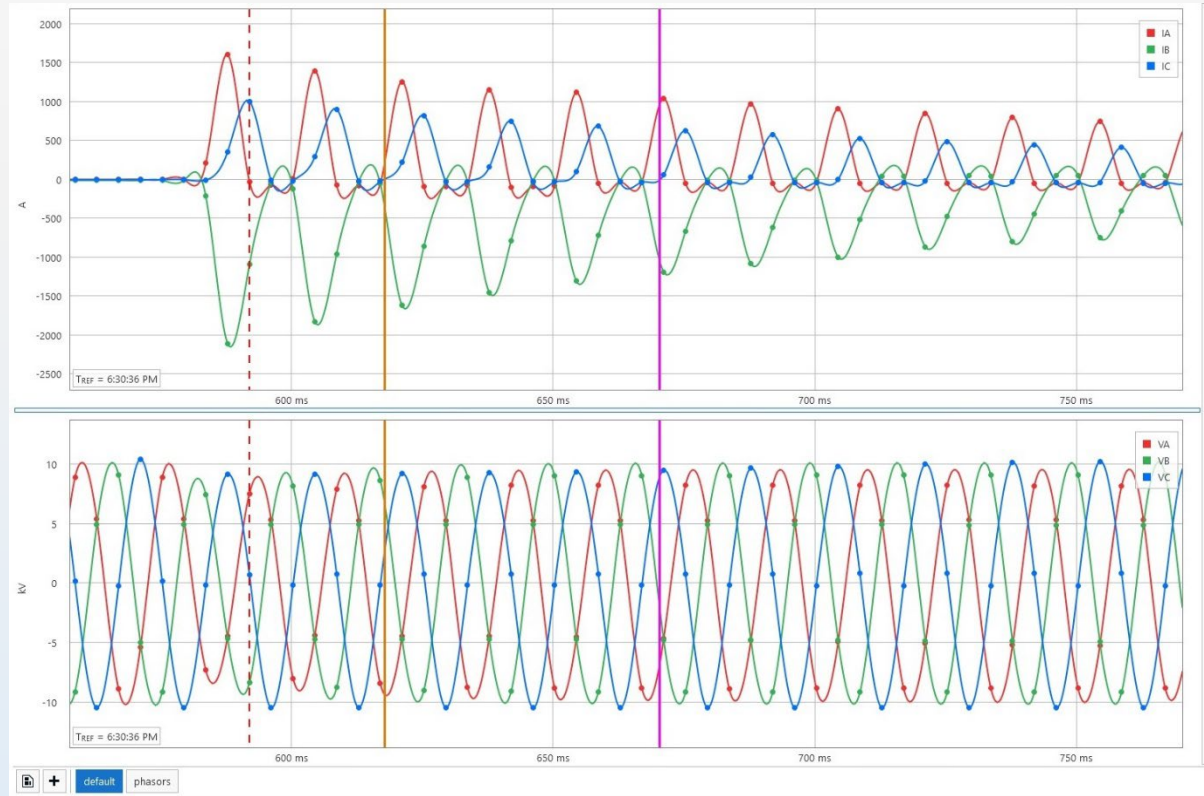
- Electromechanical relays do not produce event data
- Transformer 1 had been working properly (no fault suspected)
- Feeders 1 and 6 had been upgraded – digital relays
- Inrush report from feeder 6

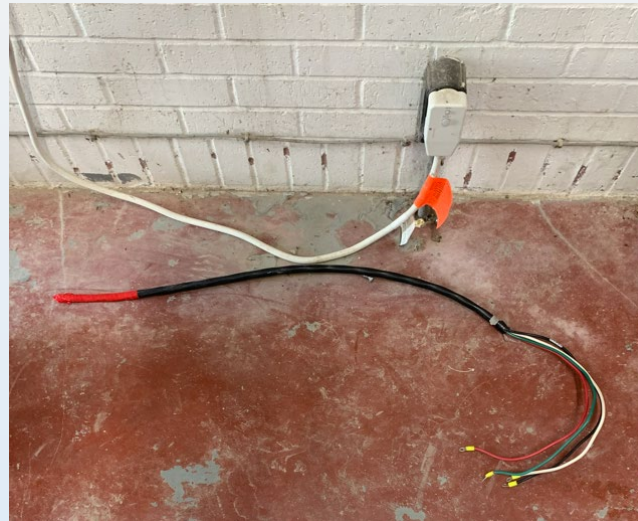
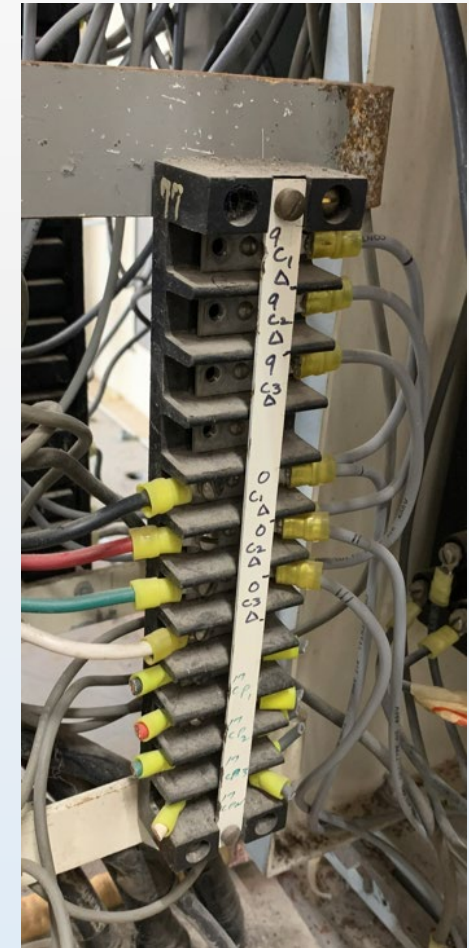
- Visual inspection at the substation house
- 4-wire bundle had been cut and left behind. Colors: red, black, green, white
- Cable belongs to terminal points 9C1 Δ , 9C2 Δ , and 9C3 Δ

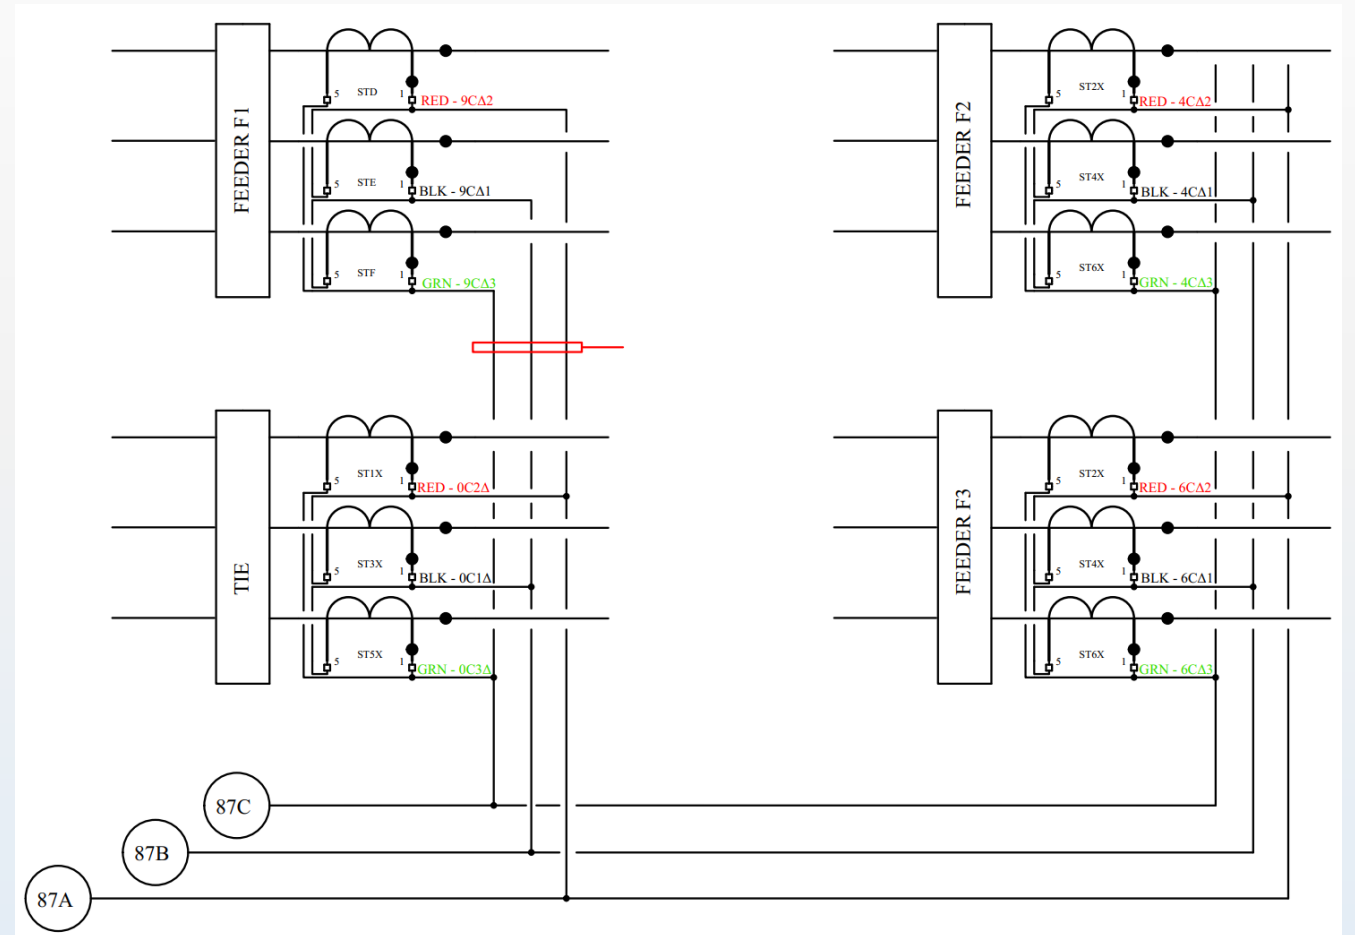
- Schematics review
- Colors matched CT circuits code
- Bundle belongs to feeder F1 contribution to 87T1

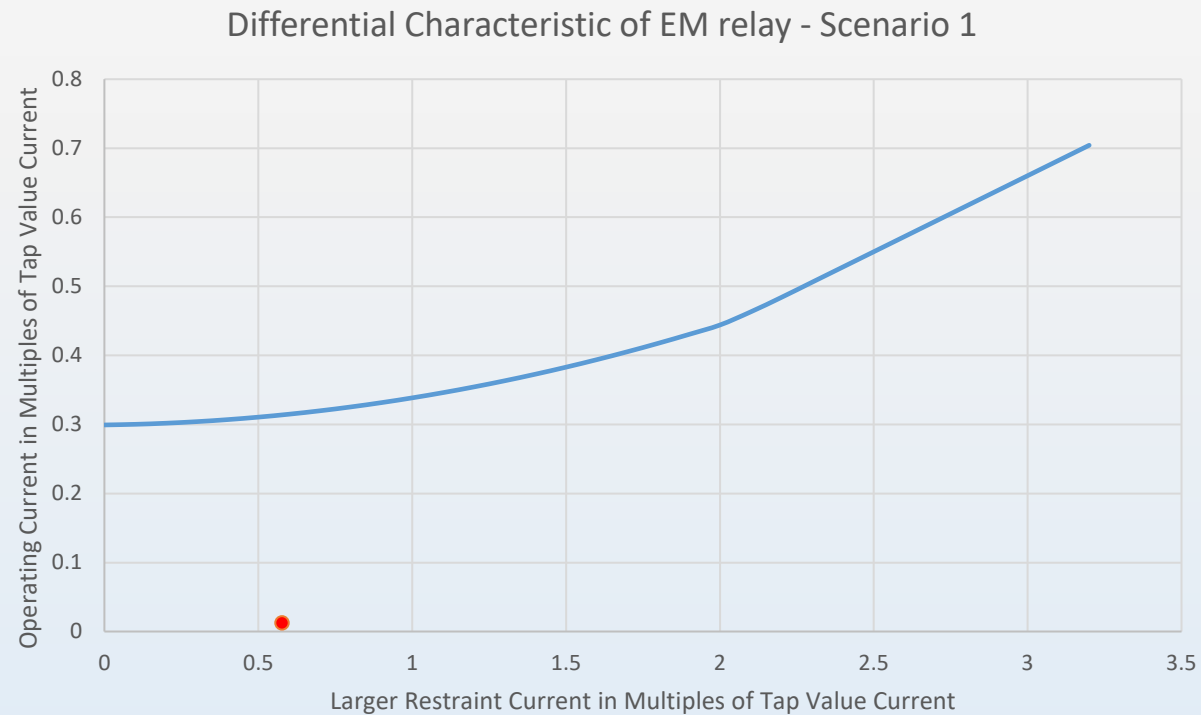
$I_{RT_1(pu)} = \frac{I_{138kV}}{CT_{W1} * TAP_1} = \frac{36.1}{20 * 3.2} = 0.564 pu$	(Equation 1.1)
$I_{RT_2(pu)} = \frac{I_{12.47kV} * sqrt(3)}{CT_{W2} * TAP_2} = \frac{400 * 1.732}{240 * 5} = 0.577 pu$	(Equation 1.2)
$I_{OP(pu)} = I_{RT_1(pu)} - I_{RT_2(pu)} = 0.564 - 0.577 = 0.013 pu$	(Equation 1.3)

- Scenario 1. Motor gets energized, all wires connected properly

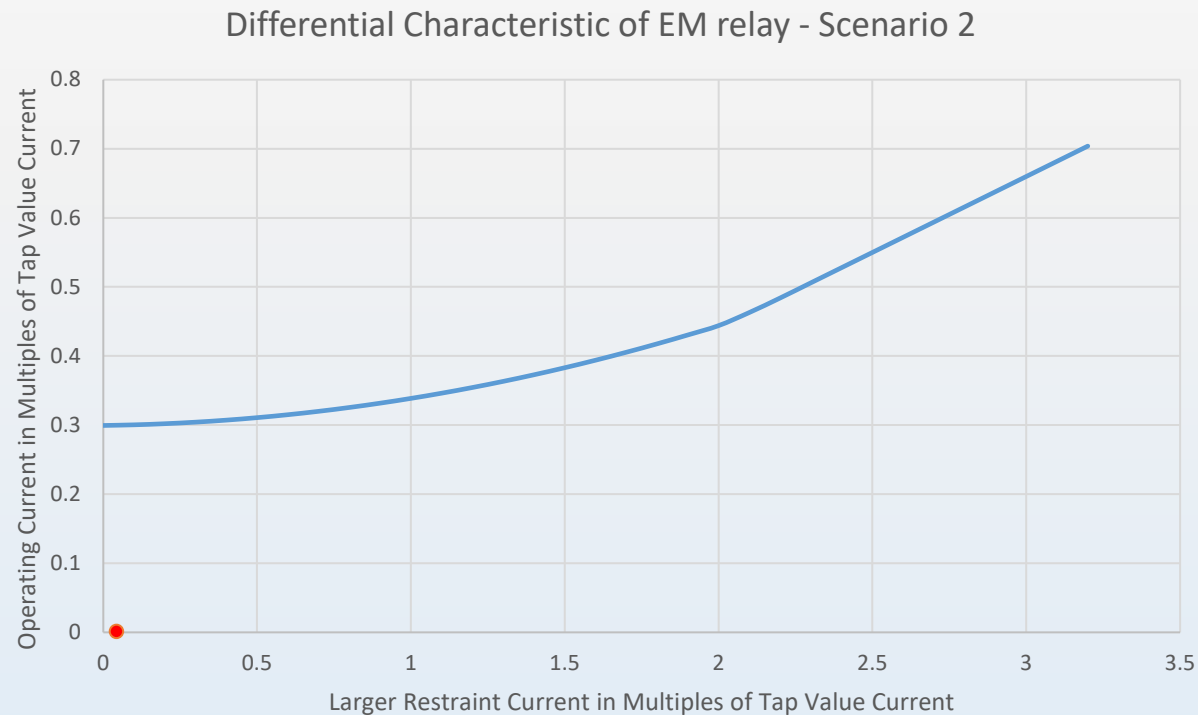
$I_{RT_1(pu)} = \frac{I_{138kV}}{CT_{W1} * TAP_1} = \frac{2.71}{20 * 3.2} = 0.042 pu$	(Equation 2.1)
$I_{RT_2(pu)} = \frac{I_{12.47kV} * \text{sqrt}(3)}{CT_{W2} * TAP_2} = \frac{30 * 1.732}{240 * 5} = 0.043 pu$	(Equation 2.2)
$I_{OP(pu)} = I_{RT_1(pu)} - I_{RT_2(pu)} = 0.042 - 0.043 = 0.001 pu$	(Equation 2.3)

- Scenario 2. The motor is running, all wires connected properly

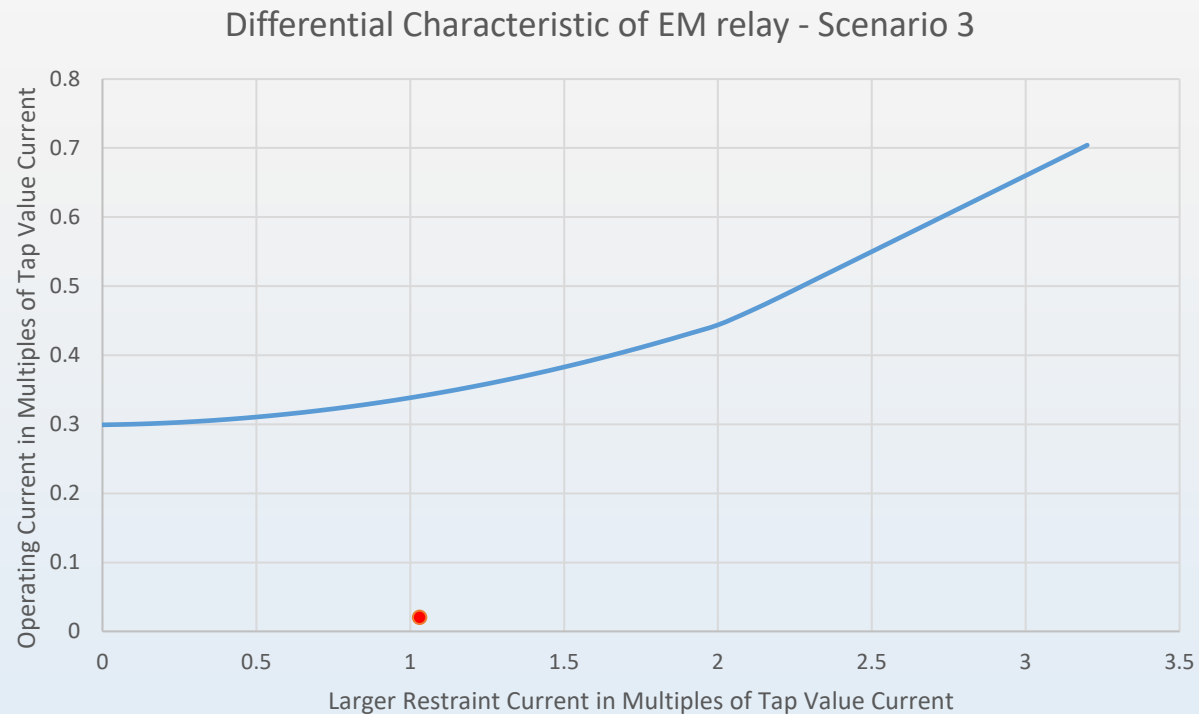
$I_{RT_1(pu)} = \frac{I_{138kV}}{CT_{W1} * TAP_1} = \frac{65.96}{20 * 3.2} = 1.03 pu$	(Equation 3.1)
$I_{RT_2(pu)} = \frac{I_{12.47kV} * sqrt(3)}{CT_{W2} * TAP_2} = \frac{700 * 1.732}{240 * 5} = 1.01 pu$	(Equation 3.2)
$I_{OP(pu)} = I_{RT_1(pu)} - I_{RT_2(pu)} = 1.03 - 1.01 = 0.02 pu$	(Equation 3.3)

- Note: Prior to removal of wires, Bus A was carrying ~730 A. After the removal, the relay lost the 30 A motor contribution.

- Scenario 3. The motor is running, the 9 Δ wires were removed from the system

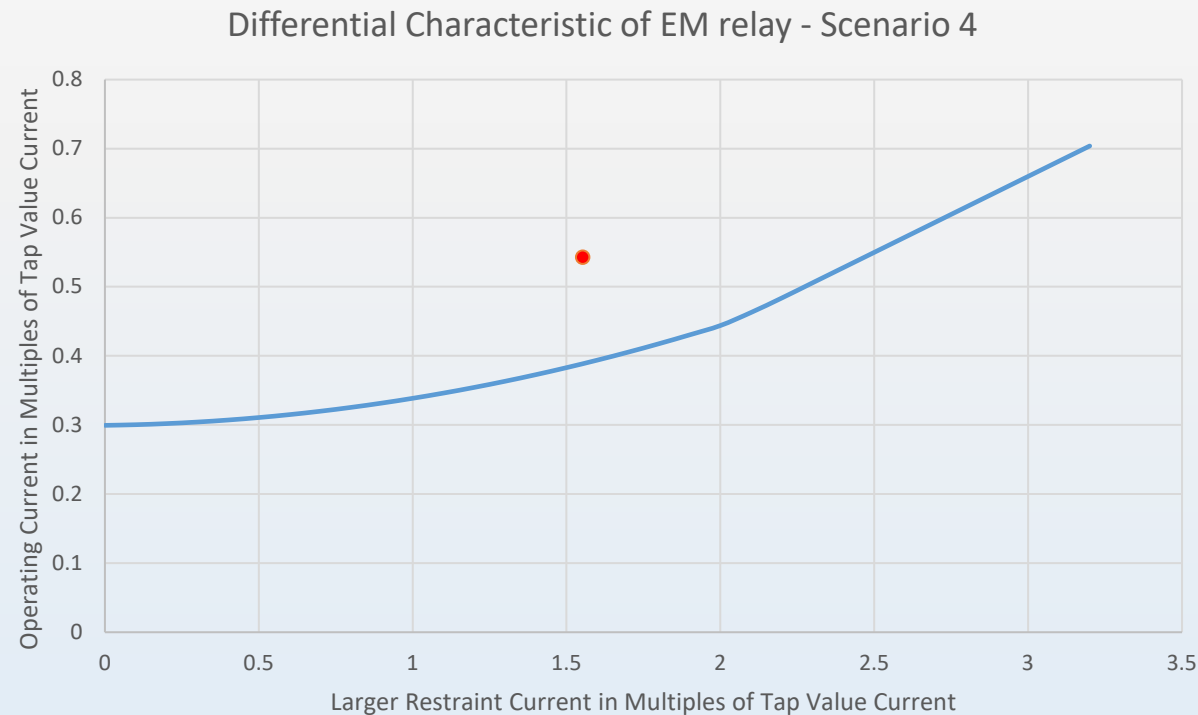
$I_{RT_1(pu)} = \frac{I_{138kV}}{CT_{W1} * TAP_1} = \frac{99.39}{20 * 3.2} = 1.55 pu$	(Equation 4.1)
$I_{RT_2(pu)} = \frac{I_{12.47kV} * sqrt(3)}{CT_{W2} * TAP_2} = \frac{700 * 1.732}{240 * 5} = 1.01 pu$	(Equation 4.2)
$I_{OP(pu)} = I_{RT_1(pu)} - I_{RT_2(pu)} = 1.55 - 1.01 = 0.54 pu$	(Equation 4.3)

- Note: Primary side contribution is 1,100 A on the 12.47 kV side (400 A + 700 A) reflected to 138 kV.

- Scenario 4. The motor is stopped and gets re-energized with the 9Δ wires lifted

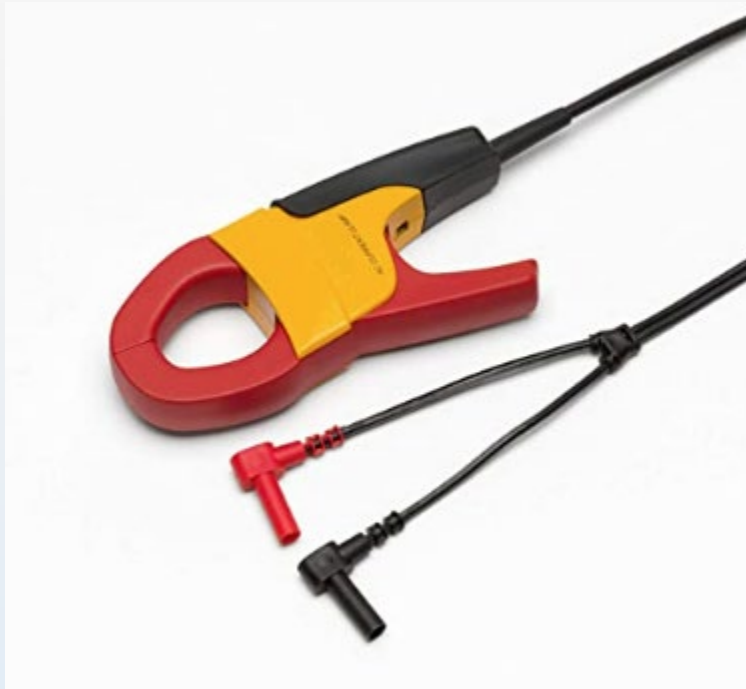
- Current verification through amp clamp meter.
