High-Speed Reclosing, Switching Surges, and Bus Differential Protection Security – A Case Study

Jeff Iler, *American Electric Power*

Ryan McDaniel, *Schweitzer Engineering Laboratories, Inc.*

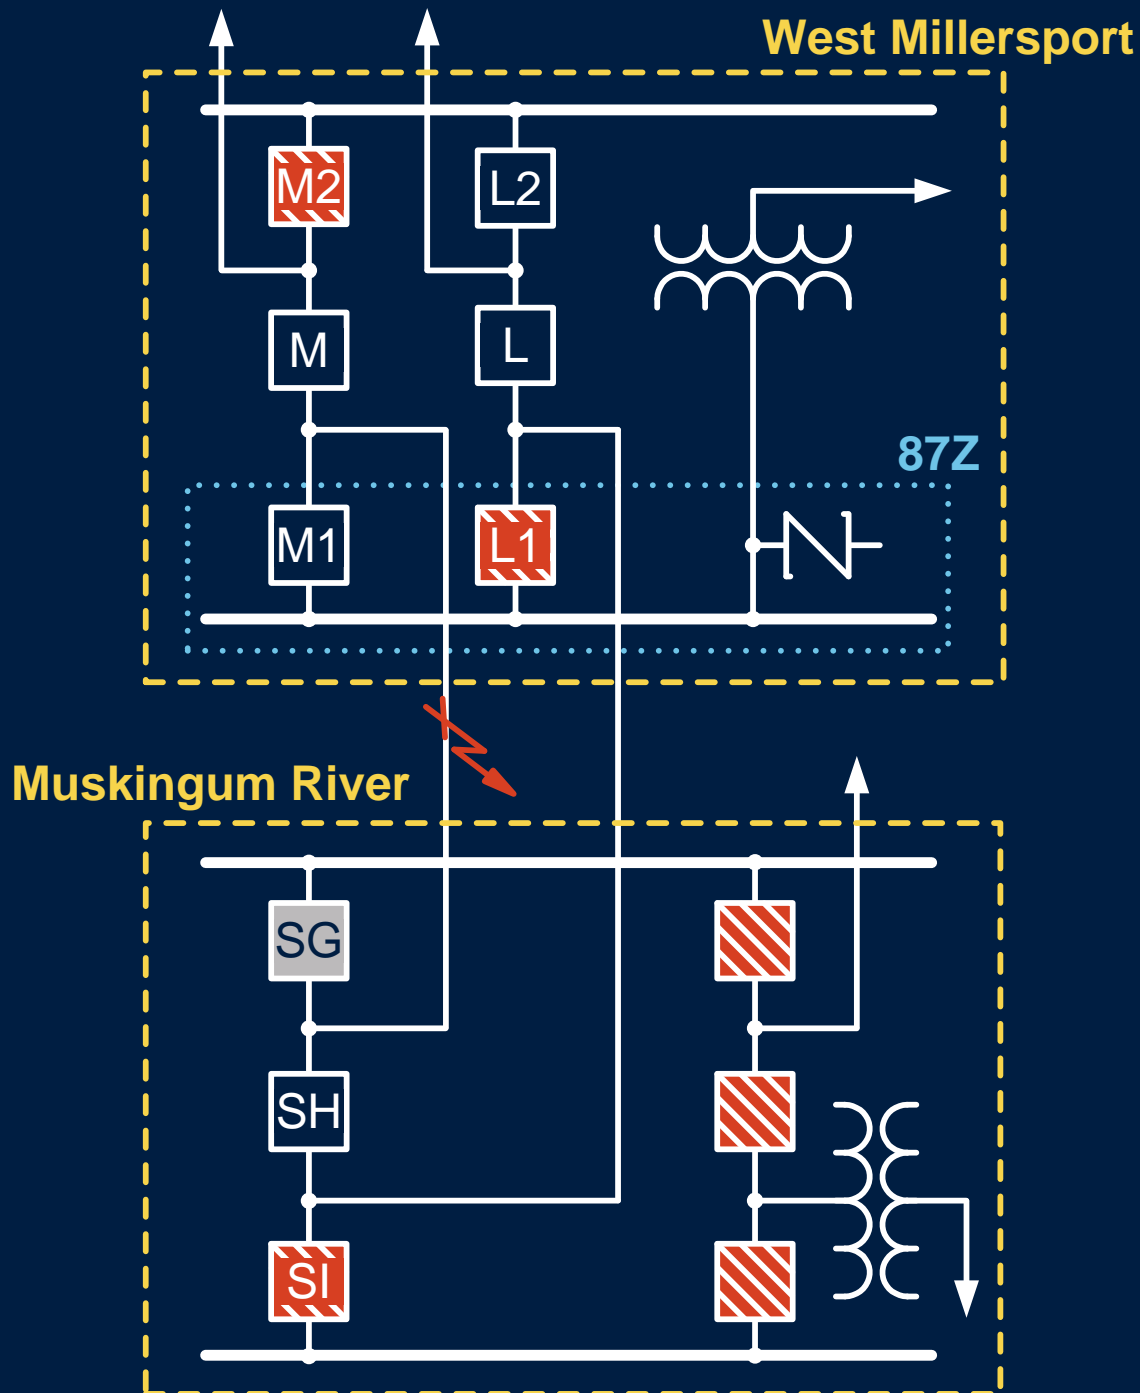
January 28, 2009

- Phase-A-to-Phase-B fault on Line 2 that clears via DCB scheme
- Reclose from Breaker SG at Muskingum River
- Unexpected 345 kV Bus 1 differential at West Millersport operation

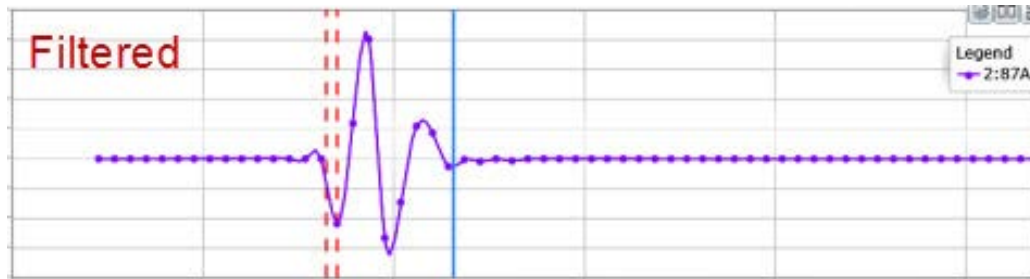
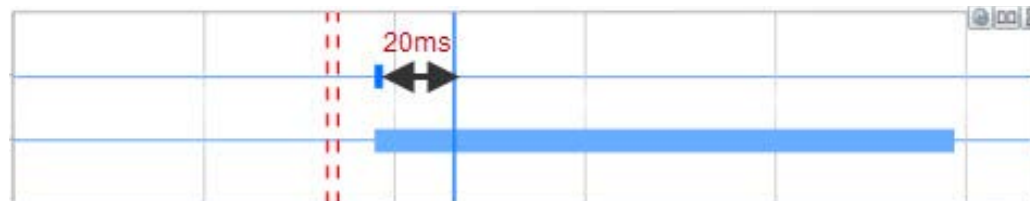
Bus Differential – West Millersport Bus 1

- 87A1 asserts for one-eighth of a cycle (6:15:42.287 p.m.)
- Fault clears before operation of lockout relay

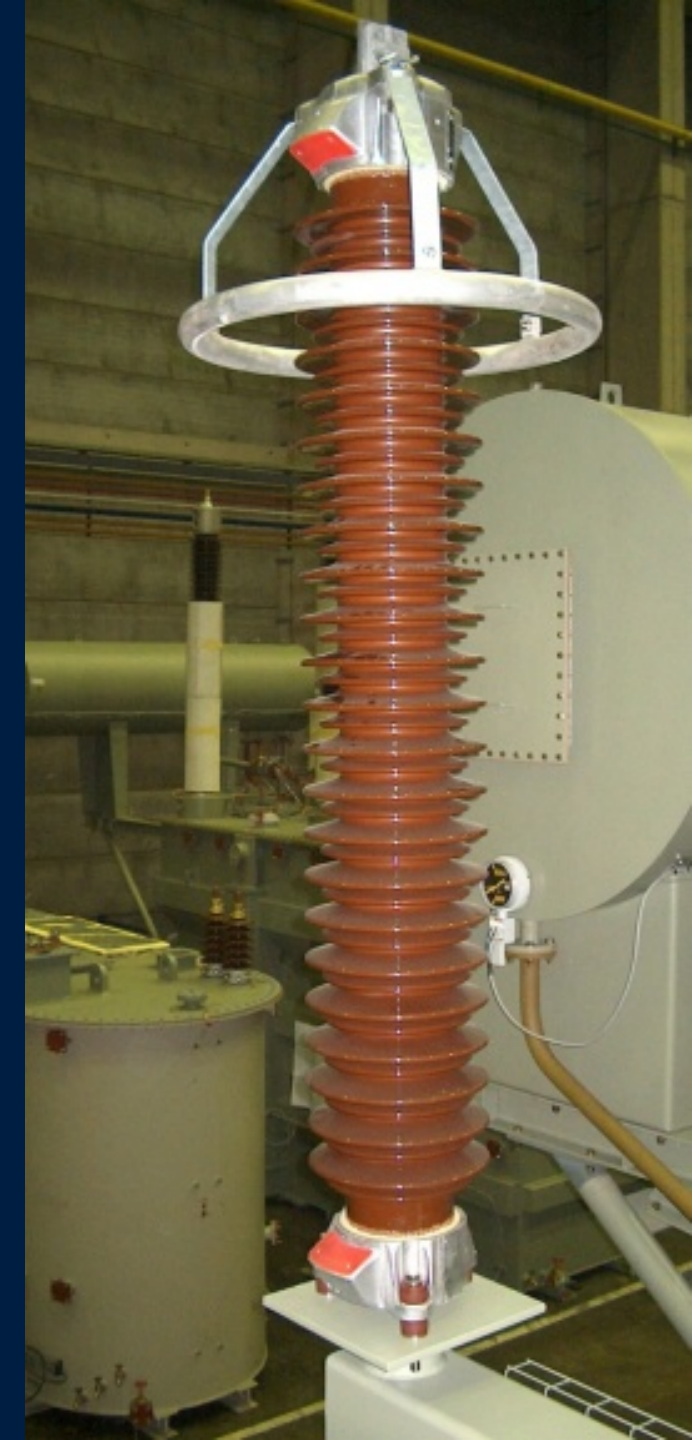
H1 Bushing Surge Arrester Counter Indicates Operation

Why does the surge arrester operate?

Arr Counter Readings

Station: **WEST MILLERSPORT**

Equip: **BANK 1** 4289

Location	Date	Count	mA	Cat #	Mfg	Unit-kV	Type
▶ H1	2/2/2009	12	0.8	9L11MHA258	GE	1-258	ALUG-G
H1	1/19/2009	11	0.8	9L11MHA258	GE	1-258	ALUG-G
H1	12/4/2008	11	0.8	9L11MHA258	GE	1-258	ALUG-G
H1	11/3/2008	11	0.7	9L11MHA258	GE	1-258	ALUG-G
H1	10/17/2008	11	0.7	9L11MHA258	GE	1-258	ALUG-G
H1	9/9/2008	11	0.5	9L11MHA258	GE	1-258	ALUG-G

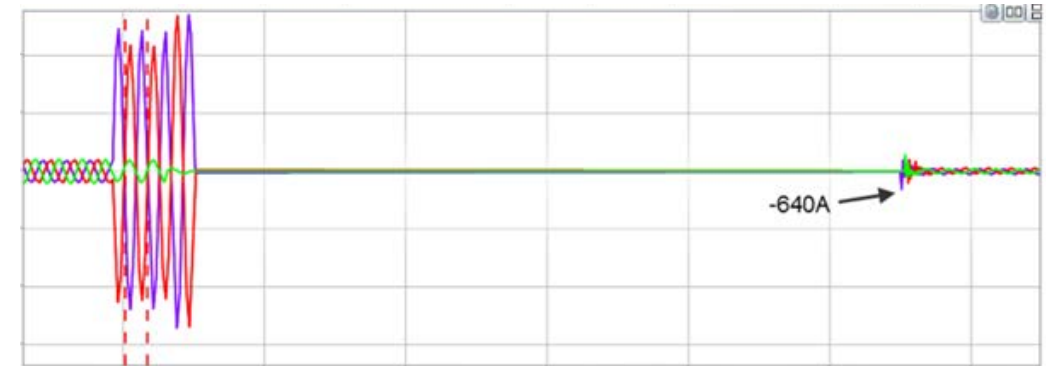
- DCB scheme clears Phase-A-to-Phase-B fault on Line 2
- Air blast breaker at West Millersport Line 2 chops current on Phase B
- Muskingum River Line 2 recloses and sees over 600 A of inrush current
- West Millersport Line 2 sees brief 2.5 pu peak-to-ground overvoltage

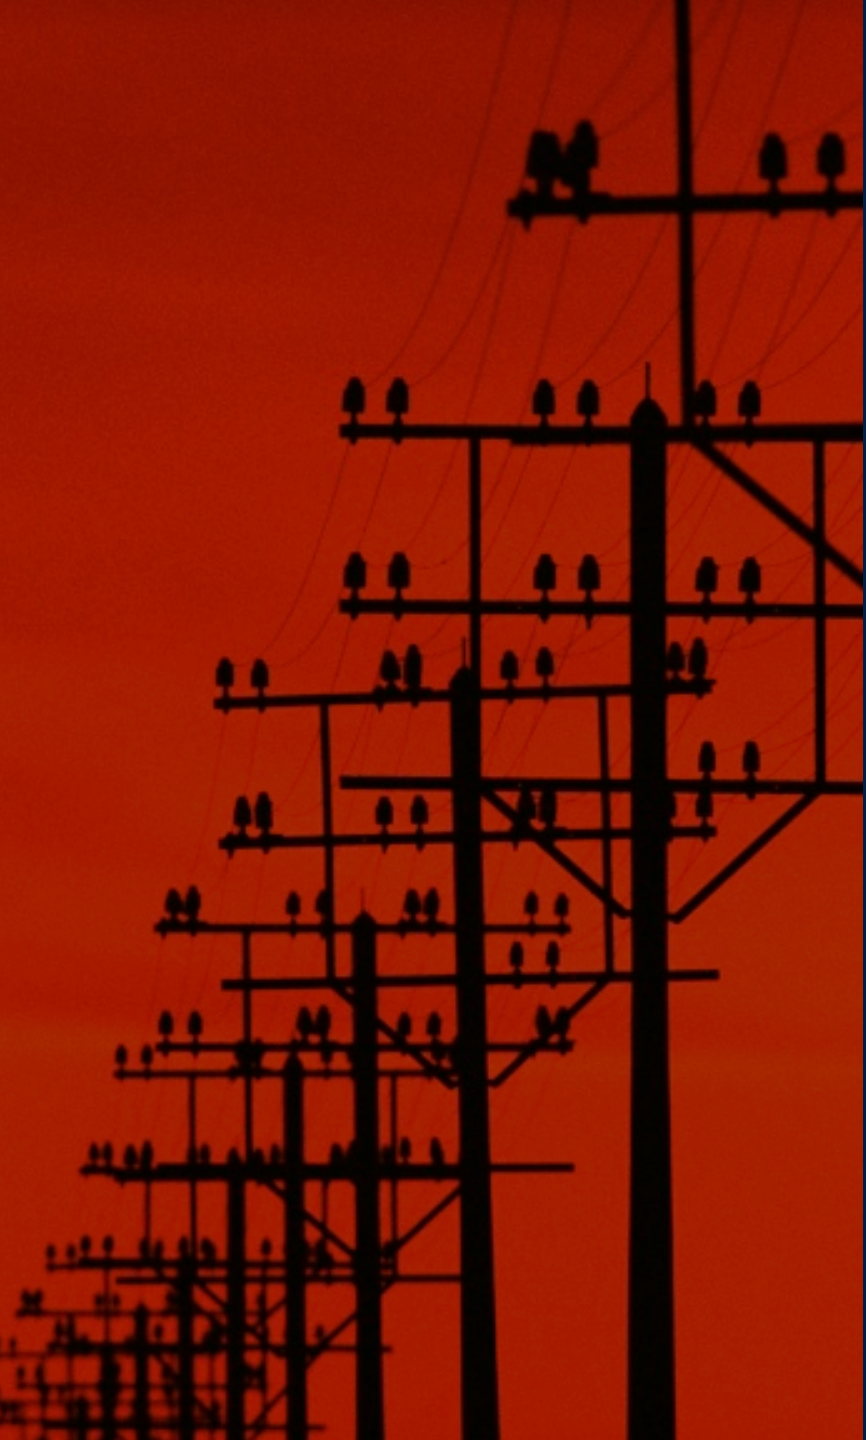
Further Investigation

- Why is there a voltage transient?
- How does reclose at Muskingum River lead to overvoltage at West Millersport?

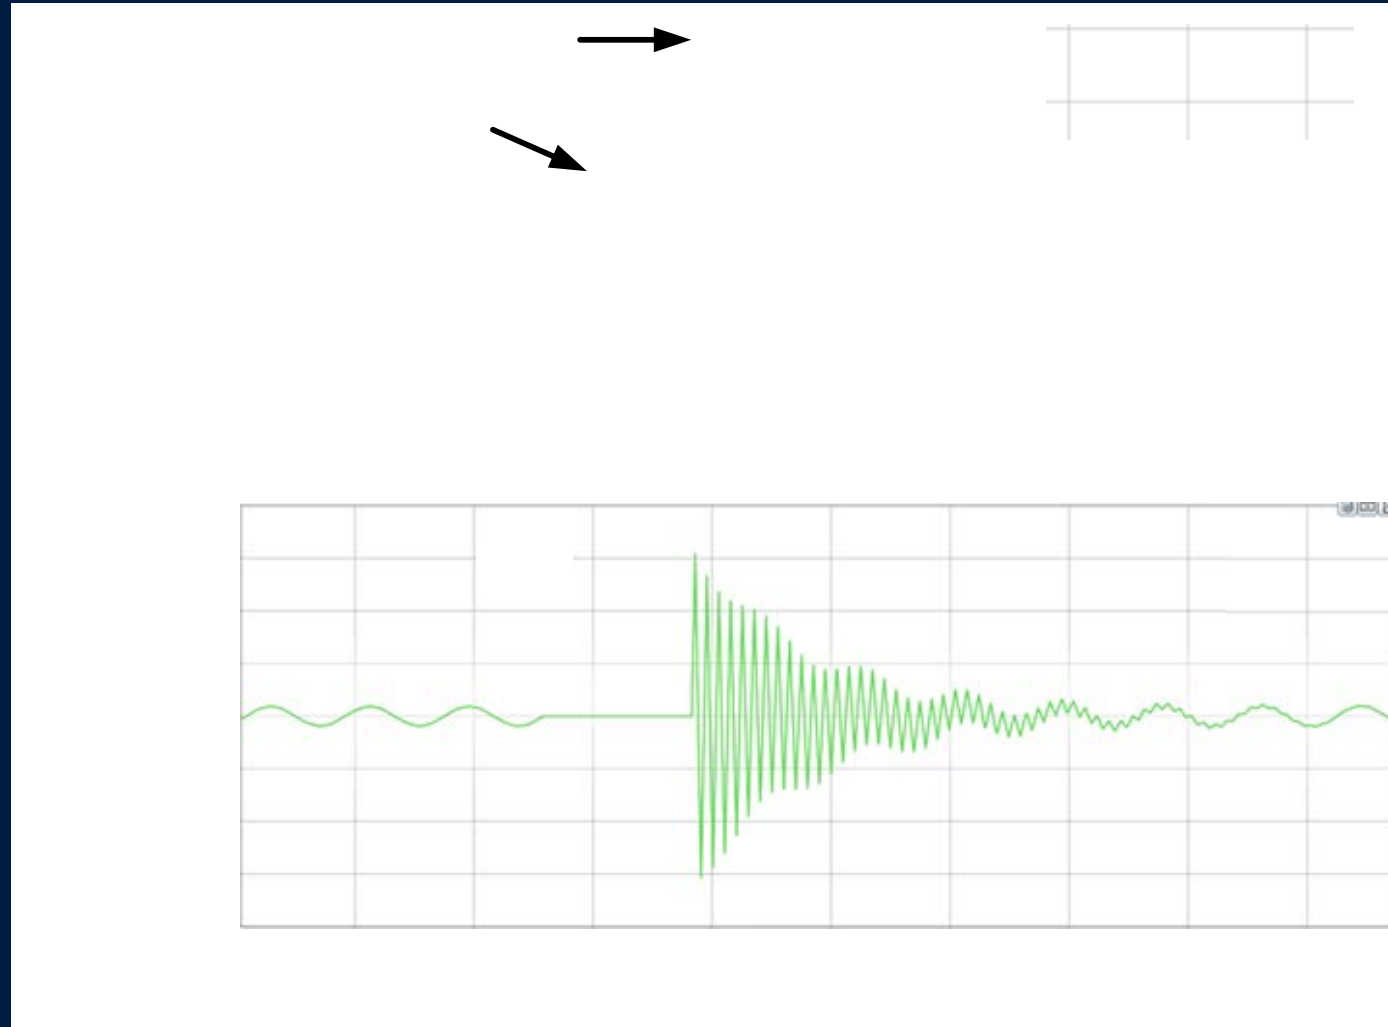
Natural Frequency Response

$$V_c = V_c(0) + (V_m - V_c(0))(1 - \cos \omega_o(t))$$

$$V_c = (-)1 + (1 - (-)1) \cdot (1 - (-)1)$$

$$V_c = 3$$

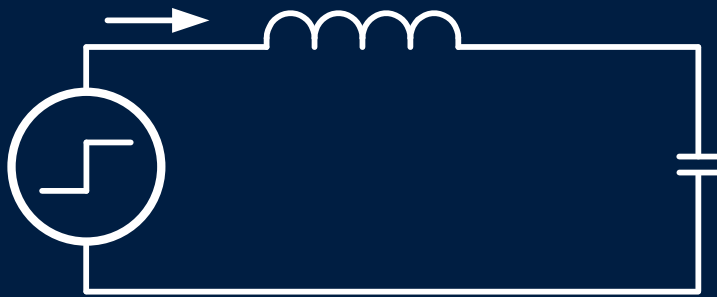
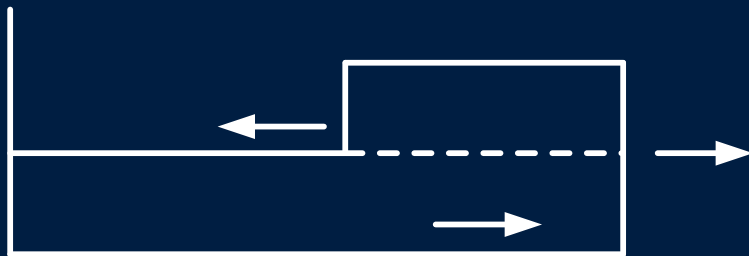
Traveling Wave Representation

- Voltage doubling effect at open terminals

$$V_3 = \frac{[2 \cdot Z_B]}{[Z_B + Z_A]} \cdot V_1$$

- -1 pu trapped charge
 $+ (2 \text{ pu step}) \cdot 2 = 3 \text{ pu}$

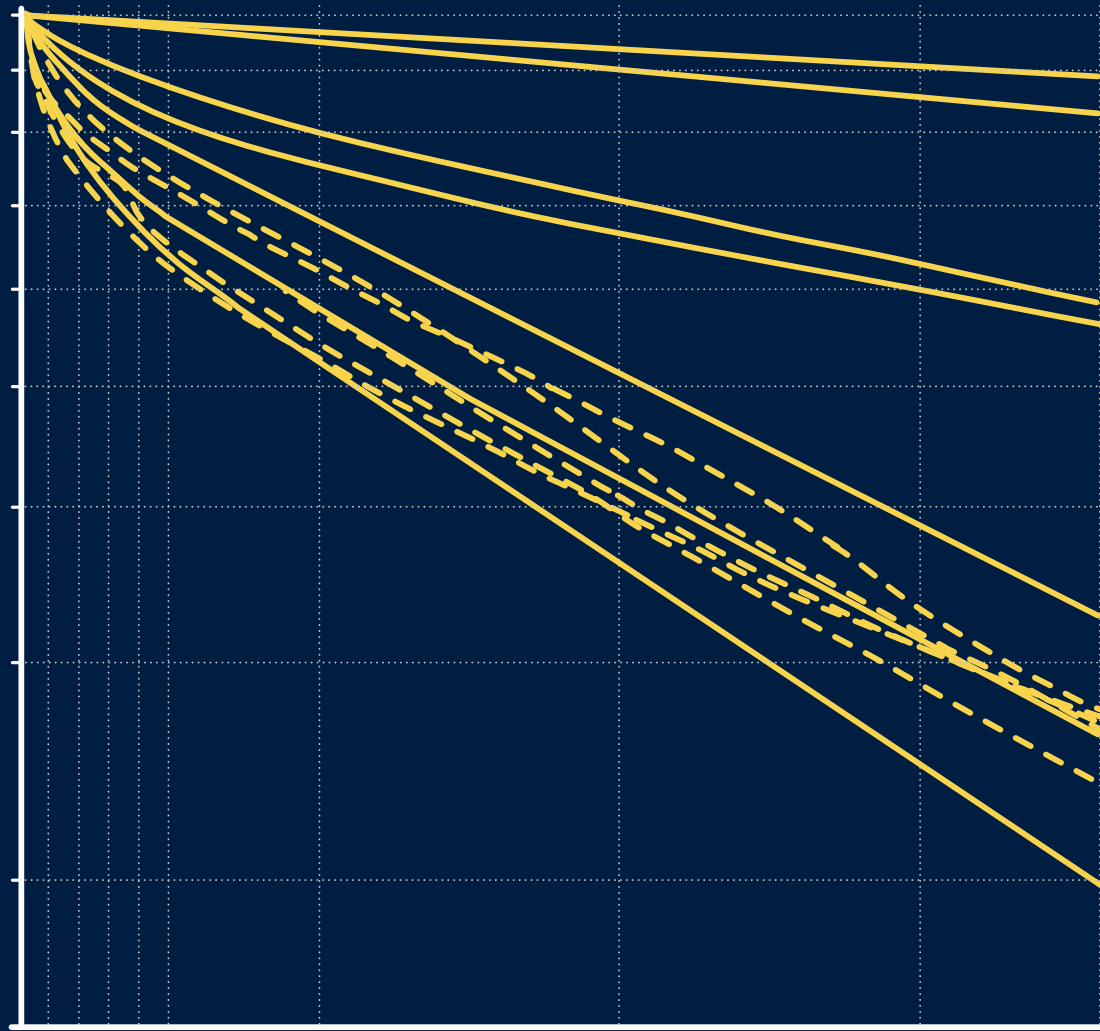
AEP Trapped Charge Testing

After 30 cycles,
0.6 pu trapped charge
is possible on
transmission lines
even in sleet conditions

Data: "Weather, Corona, and
the Decay of Trapped Energy
on Transmission Lines"

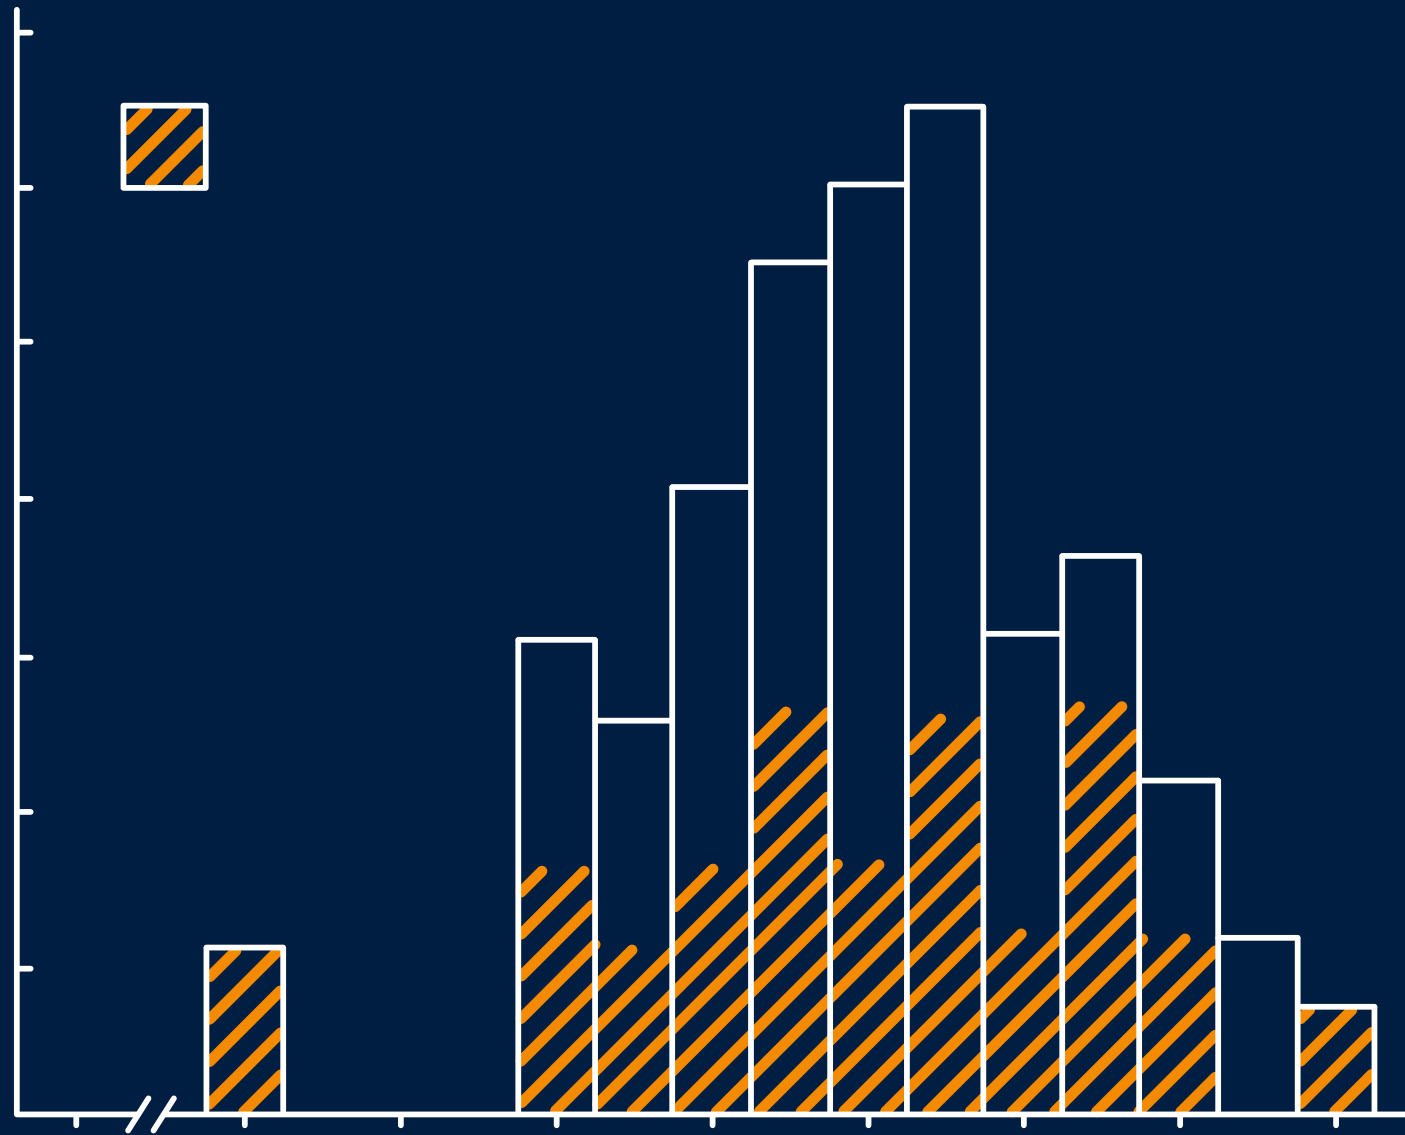
AEP Field Measurement of Switching Surges

- Statistical study was carried out in early 1960s
- Receiving end of reclosed line could expect average of 2.4 pu overvoltage

Data: "Field Measurement of Switching Surges on Unterminated 345-kV Transmission Lines"

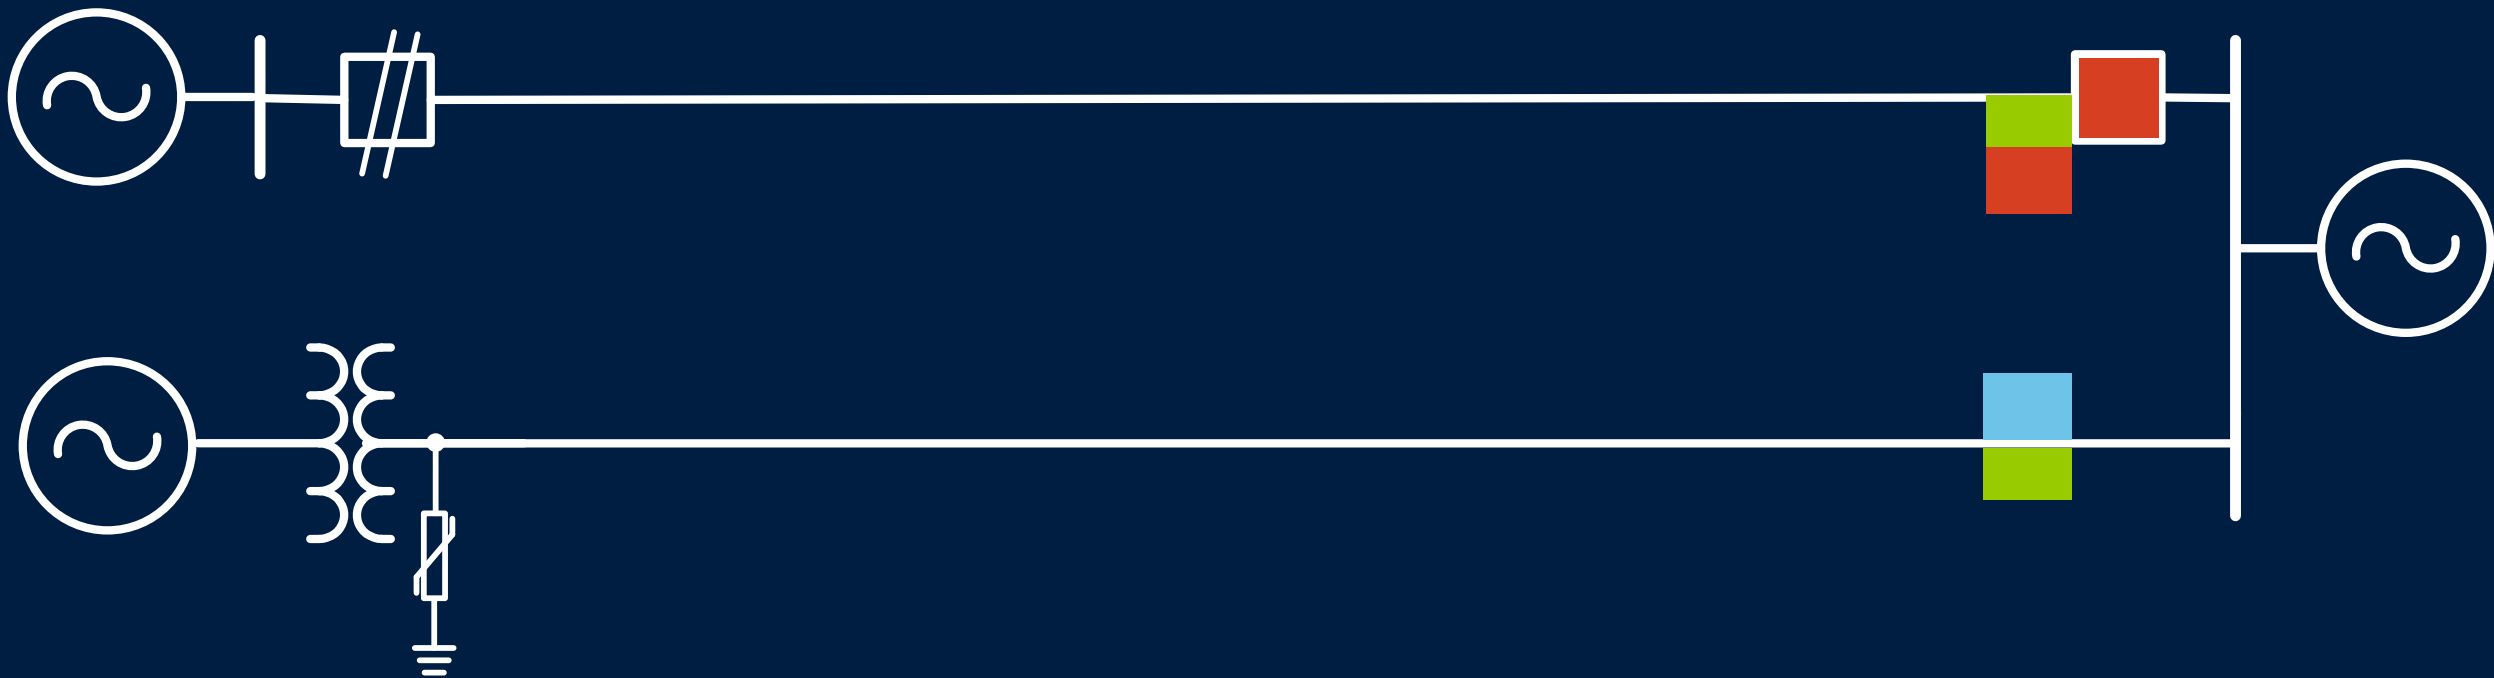
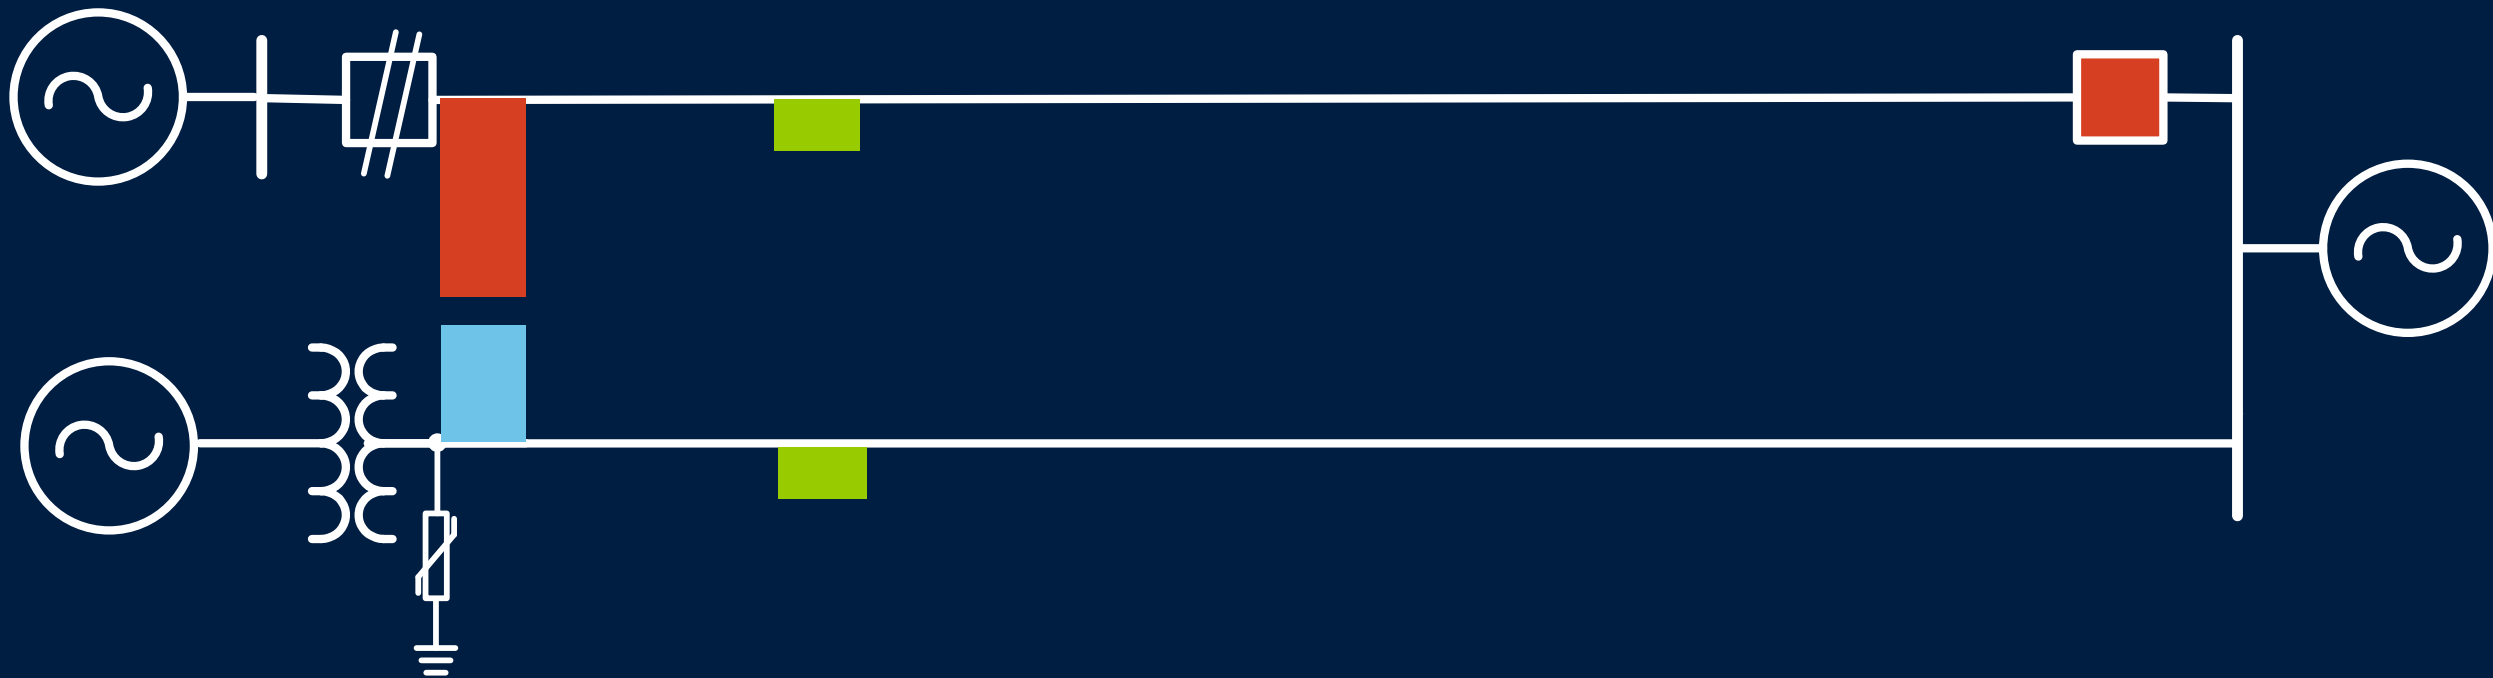
Simulation Results

- Shows trapped charge on line
- Validates surge arrester operation during reclose
- Provides view of wave propagation
