Evaluation of 13kV Dry-Type Shunt Reactor Protection following Near-Miss

Gary L. Kobet, P.E.,
Tennessee Valley Authority
Chattanooga, Tennessee, U.S.
glkobet@ieee.org

Abstract—At the end of a bird-caused fault sequence, the protection scheme for a 13kV dry-type shunt reactor left the reactor energized and carrying load current on two phases, which resulted in a more severe fault when the field operator attempted to clear the shunt reactor using manually operated disconnect switches. The operator was not injured but given his proximity to the fault and arc, the result could have resulted in serious injury or much worse. In order to avoid such situations, this paper evaluates the protection scheme for 13kV dry-type shunt reactors, highlighting deficiencies, compares company practices against one industry guide, and describes planned improvements.

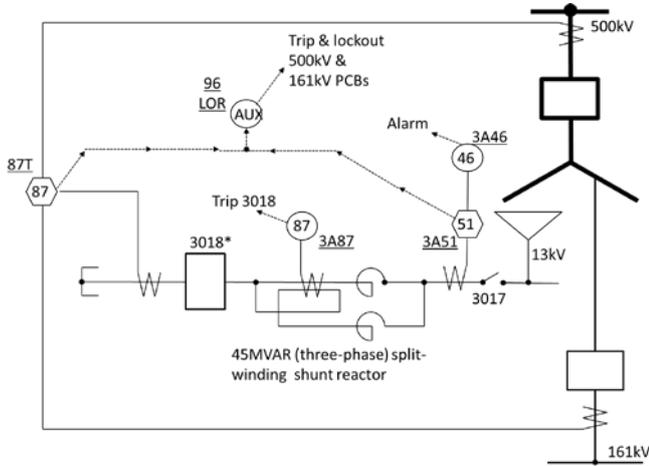
Fig. 1. Shunt reactor installation

Similar to 17 other 500kV substations, the particular substation involved in this event (designed in 1996) has three 13kV shunt reactor banks, each rated 45MVAR three-phase (about 2000 amps at 13kV). Each bank is connected to the 13kV tertiary buswork of the 500/161/13kV transformer bank through dual-blade, non-ganged, manually operated (via hotstick) single-phase disconnect switches. The reactors are switched in/out of service using 13kV vacuum breakers located at the neutral end of the reactors. The reactors are split winding, with each reactor phase consisting of two 8.4 ohm (nominal) inductor coils in parallel (Figure 1). Note there are two stingers per phase, one from split winding, connected to the CTs.

*Only 3018 shown, 3028 & 3038 reactor banks similar

One set of CTs is located between the disconnect switch 3017 and the reactors. Time overcurrent relays (device 3A51) are fed from this set of CTs that provide phase fault protection and trip the transformer bank. Note the time overcurrent pickup is necessarily set higher than rated reactor load current. Also fed from this set of CTs is a negative sequence overcurrent relay (device 3A46) that only sends an alarm.

Another set of CTs is located between the reactors and the neutral breaker (PCB 3018). These CTs receive the two neutral end leads of each split phase reactor. The CTs feed split phase overcurrent relays (3A87) that trip the reactor breaker PCB 3018.

In addition, the 13kV reactor banks are also included in the transformer bank differential zone (see Figure 1)

With these protection changes, the event discussed would have resulted in tripping the transformer bank via breaker failure in less than one second (15 to 20 cycles), deenergizing the arc along with the associated shunt reactor bank. Compare Figures 17 and 18 with Figure 1.

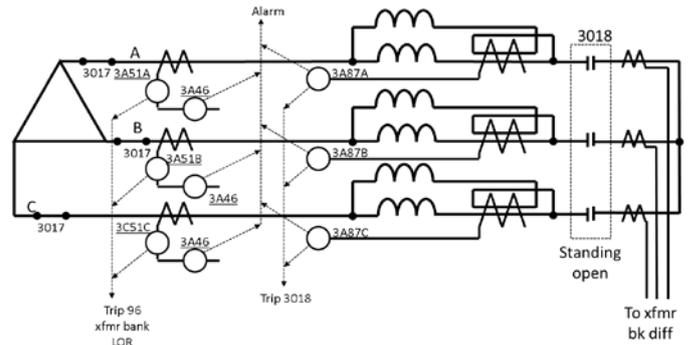
Fig. 2. Shunt reactor protection

Protection for each shunt reactor consists of current transformers (CT) and relays that together provide fault and abnormal condition (e.g., turn-to-turn short circuit) protection for each reactor winding.

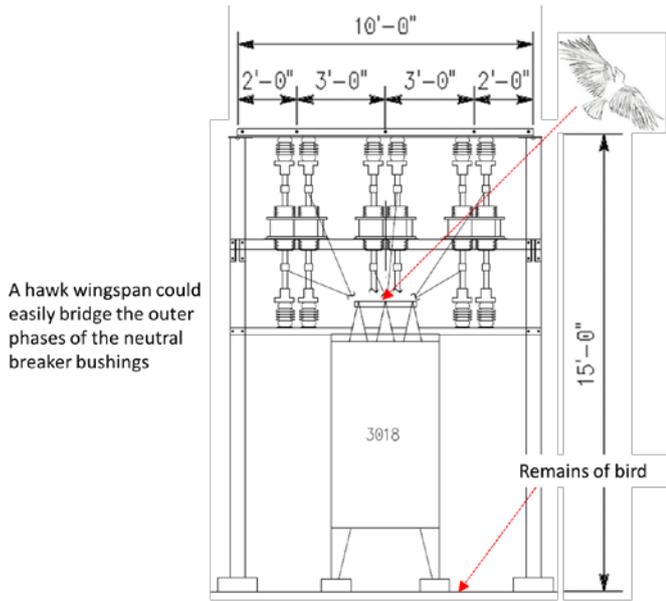
Fig. 3. Facing breaker (reactor behind), with dimensions

500/161/13kV transformer bank. The wings of the bird bridged the reactor-side bushings completing the neutral (Figures 3 & 4). This bridging of the neutral is normally contained within the PCB.

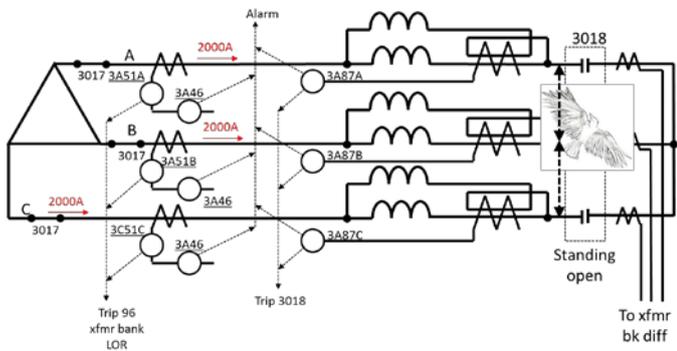
Fig. 4. Sequence - 15:44 Bird lands on 3018 bridging phases between reactor and breaker

On the afternoon of Friday, May 19, 2017, a bird attempted to land on 13kV Power Circuit Breaker (PCB) 3018 feeding a 45MVAR shunt reactor connecting it to the tertiary of a

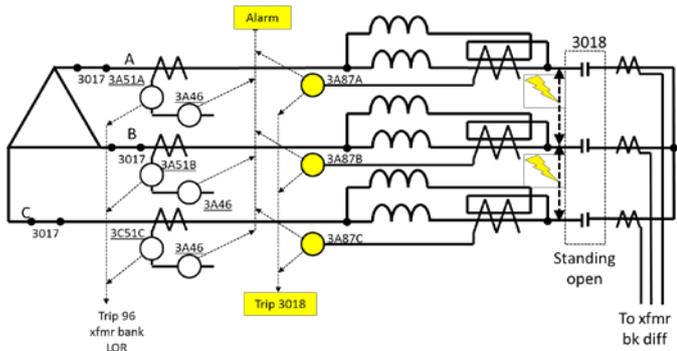
Fig. 5. Sequence - From 15:44 to 15:58:53 Split winding differential relays operate---sending a trip signal to 3018---which is already open

However, what resulted was an external arc of 2000 amps, which began flowing through the wings of the bird and eventually expanded into the surrounding air. With no means of extinguishing this uncontrolled arc in what became ionized air, the arc continued burning at least 16 minutes. During this time the split winding differential relaying operated, sending a trip signal to the 13kV PCB as designed, but this accomplished nothing as the PCB was already open (had been standing open at least a month) (Figure 5).

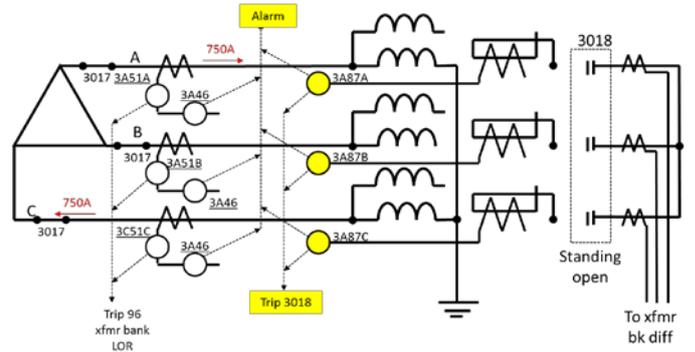
Fig. 6. Sequence - By 16:00:50 (16 minutes later) Split winding CTs and buswork destroyed, leaving A- and C-phase stingers laying on grounded support steel

After the arc burned itself out, the split-winding CTs and all but two stingers were completely destroyed. A single A-phase stinger and a single C-phase stinger remained, laying on grounded support steel, which completed a circuit for current to flow through the two outer phases (A and C), with no current in B-phase (Figures 6 & 7). In Figure 7, notice two stingers, one from C-phase (furthest reactor), and one A-phase (nearest reactor), both laying across horizontal support beam below damaged CTs. The A-phase stinger was still laying on grounded support steel; the C-phase stinger fell off later. Remains of the bird were found on the ground on the side of the breaker (side nearest camera angle).

Neither the TOp nor the field electrician/operator was aware the switch was carrying approximately 750 amps of current ($13kV/(2*8.4\Omega)$) (Figure 6). When the field/electrician operator opened A-phase, the switch flashed over. The resulting three-phase fault directly over the head of the field operator was determined to be approximately 82 kA (Figure 10). The transformer bank protection operated properly within 100 milliseconds (5.5 cycles, normal & acceptable) to clear the

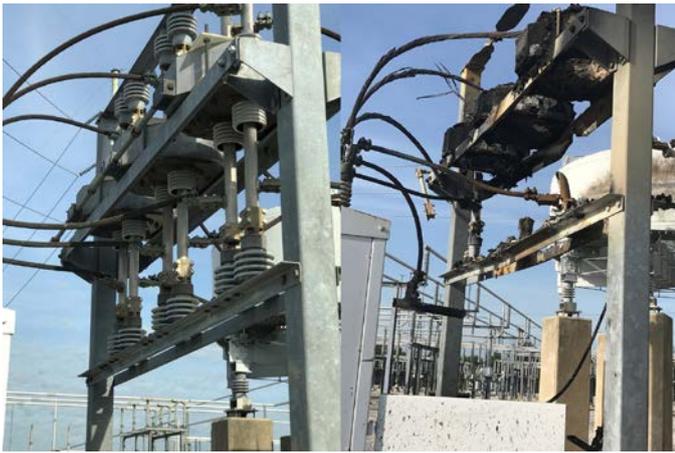
Fig. 8. Good installation vs damaged installation

On arrival at the station, the field operator noted extensive damage between the reactor and the PCB, but the arc had extinguished. Following discussion with the Transmission Operator (TOp), the field operator checked the PCB open and then proceeded to attempt to clear the reactor/breaker by opening the isolating disconnect switches 3017 (one-at-a-time) on the transformer side of the reactors, using a hotstick, which is normal operating procedure.

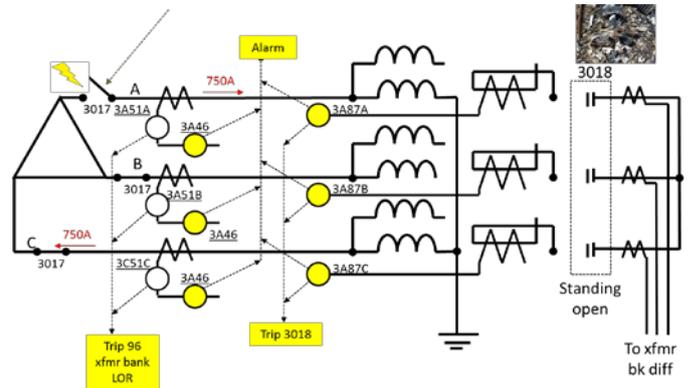
Fig. 10. Sequence - 18:21:38 Operator attempts to open 3017A under load using hotstick

fault. The operator was not injured, but was badly shaken and could have been seriously injured or much worse, given he was only 15 feet directly beneath the severe arc and fault.

- When performing routine or emergency switching on any 13/26kV tertiary bus equipment in 500kV substations, de-energize the 13/26kV yard by de-energizing the 500kV transformer first, perform switching and then re-energize the transformer bank.
- Launch projects to modify shunt reactor protection (16 sites plus 2 future)

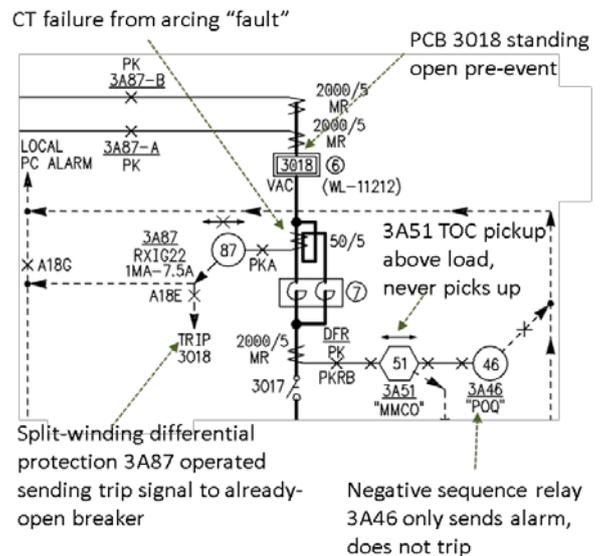
Fig. 11. Location of damage and relays that operated

1. Reactor protection 3A87 (split-winding differential) operated at 15:44 but only trips 3018 which was already open;
2. Even though 3018 showed open, two phases were tied together through broken conductors resting on structural steel, between the reactor and the CTs/breaker so that load current was flowing;
3. Negative sequence relay 3A46 only sends alarm, does not trip;
4. Both 3A87 and 3A46 relays indicated a “fault” between the high-side reactor CTs below 3017 and the open 3018 breaker; 3A51 overcurrent relay pickup is 3000A and so this relay never operated during the event
5. Load current flowing on two phases, not enough to operate the transformer bank differential relays

6. Disconnect switch 3017 opened under load
7. Switch flashes over three-phase (82kA)
8. Transformer bank differential relaying trips transformer bank in 100ms (5.5 cycles), deenergizing 13kV switchyard and severely damaged shunt reactor bank 3018.

Figure 11 shows the location of the fault and the relays that operated.

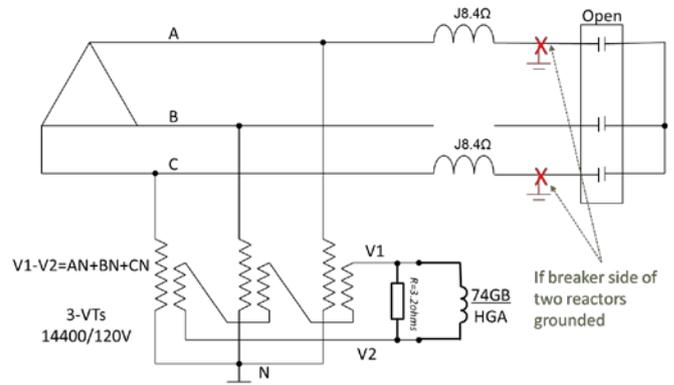
Fig. 14. Tertiary ground detector - circuit diagram two reactors grounded

The tertiary ground fault alarm relay 74GB did not operate during this event. It was initially thought this alarm would have activated given the nature of damage. However, all components

of this scheme tested successfully with no issues found, including the grounding bank PTs and resistor, the GE HGA relay itself, and the local and SCADA alarms. As a result, it was concluded that a single-phase-to-ground condition did not occur during this event. Either all three phases between the reactor and breaker were grounded, or at least two phases were grounded. Calculations indicated the 74GB would not pickup for two phases grounded (only 188 volts applied to the HGA relay having a 325 volt pickup).

Also regarding tertiary bus ground fault detection, there was some discussion of lowering the pickup from 325 volts to somewhat less than 188 volts, so that the scheme would also pickup on double-line-to-ground faults on the tertiary bus. But it was noted that any such fault between the transformer bank bushings and the reactors would be detected and cleared by the transformer bank differential relaying, and any such "fault" between the reactors and the reactor breaker would be detected and cleared by the revised protection scheme (i.e., negative sequence along with subsequent breaker failure). Thus, the 325 volt pickup will remain the setting for this scheme, as it only needs to detect single-line-to-ground faults.

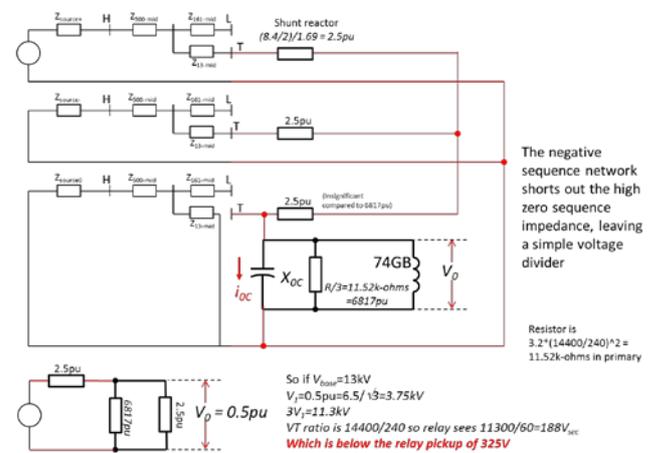
Fig. 15. Tertiary ground detector - circuit analysis two reactors grounded

NOTE: Source connected to transformer terminal L neglected

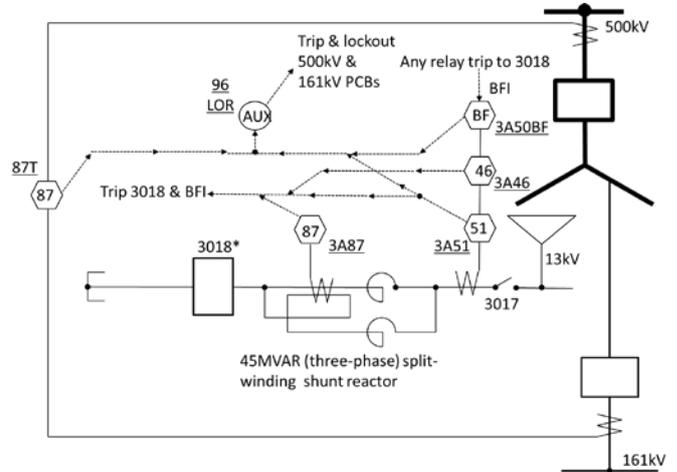
Fig. 17. Revised standard for split-winding shunt reactor protection

Figure 17 shows a functional diagram for the revised standard for split-winding shunt reactor protection.

The revised standard includes redundant primary (A-set/B-set) microprocessor relays capable of all functions listed in Tables I and II and illustrated in Figures 17 and 18.

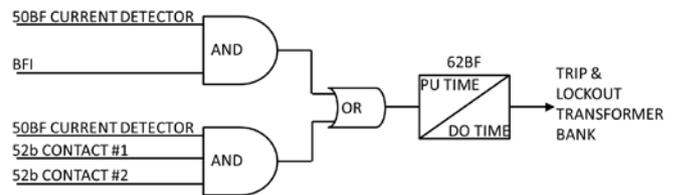
Fig. 18. Breaker failure logic include 50BF current detector and breaker position

Note the reactor breaker failure logic will be based on both phase current (50BF) and reactor breaker status (52b) (see Figure 18). Note for the event described in this paper, the reactor breaker was standing open, so current detectors alone would not be sufficient. The lower AND gate in Figure 18 would be necessary for this event, so that with the breaker standing open, any current flow would start the breaker failure timer and proceed to trip and lockout the transformer bank, deenergizing the shunt reactor. Two separate 52b contacts are used for security.
