# Line Current Differential Relay Response to a Direct Lightning Strike on a Phase Conductor

**Abstract**—This paper describes an event in which lightning struck and discharged current into the phase conductor of a 345 kV transmission line. The magnitude of the lightning discharge was insufficient to lead to a flashover (line insulation breakdown). The paper examines and explains the response of two different line current differential protective relays to this event that was inside their zone of protection.

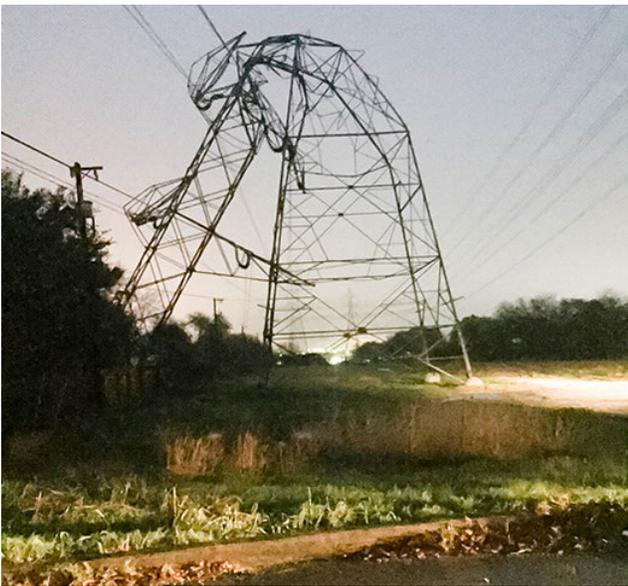
On February 19, 2017, powerful storms and tornadoes swept through the state of Texas, damaging homes and properties in their path and leaving thousands of residents without power [1]. At the height of the storm, severe wind gusts bent at least one high-voltage transmission tower in half, as shown in Fig. 1.

Fig. 1. High-voltage transmission tower damaged during storm

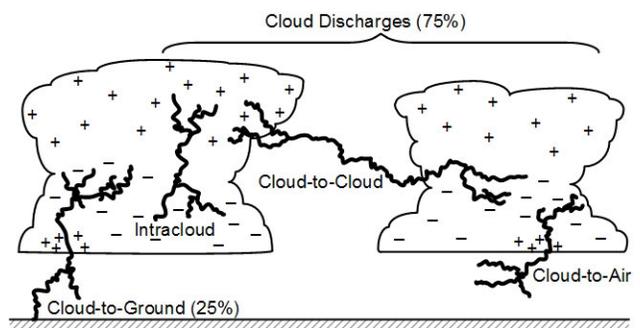
Lightning occurs when electric charges separate inside a thundercloud, also known as a cumulonimbus cloud. The upper parts of the thundercloud contain positive charges while the lower parts of the cloud contain negative charges, with a small pocket of positive charge at the base (see Fig. 2) [2].

Fig. 2. Types of lightning discharges

Lightning discharge can occur between the different charge regions inside a single thundercloud (intracloud lightning), between two thunderclouds (intercloud lightning), between the cloud and air, or between the cloud and earth (cloud-to-ground lightning). Intracloud, intercloud, and cloud-to-air discharges are collectively referred to as cloud flashes.

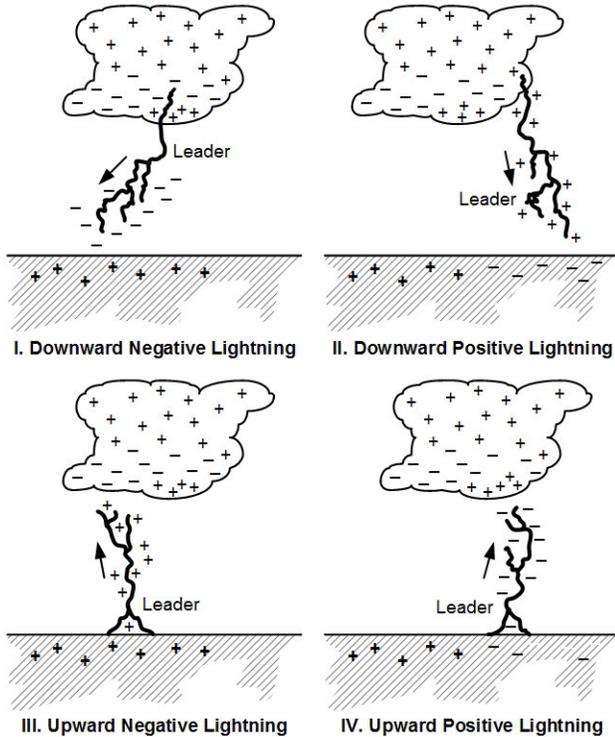
Fig. 3. Types of cloud-to-ground lightning

Almost 90 percent of all cloud-to-ground lightning strikes belong to Category I (negative downward), where an initial breakdown inside the cloud leads to a strong concentration of negative charge at the base of the cloud. The negative charge starts ionizing the air and a column of negative charge, referred to as the leader, starts moving from the cloud toward the ground. As the leader approaches ground, it induces streamers of opposite charge to rise from the ground toward the stepped leader. When the leader and streamer meet, the path between the cloud and ground is complete and a high-discharge current, known as the return strike, flows between the cloud and the ground. The median current value of the first strike is typically around 30 kA. The initial strike may be followed by several subsequent strikes that do not necessarily land at the same location as the original strike. The median current value of subsequent strikes is much lower than the first strike, typically 12 kA. A flash, which is a collection of three to five strikes, can last up to half a second.

Positive downward cloud-to-ground flashes (Category II) deliver a positive charge to the ground and are not very common. Tall objects with sharp corners at the top or mountain peaks can often initiate upward moving leaders, which can be positive or negative (Category III or Category IV). When those leaders reach the cloud, a lightning discharge follows. Since transmission lines and substations do not have sharp corners at the top, it is more common for them to experience downward flashes [5].

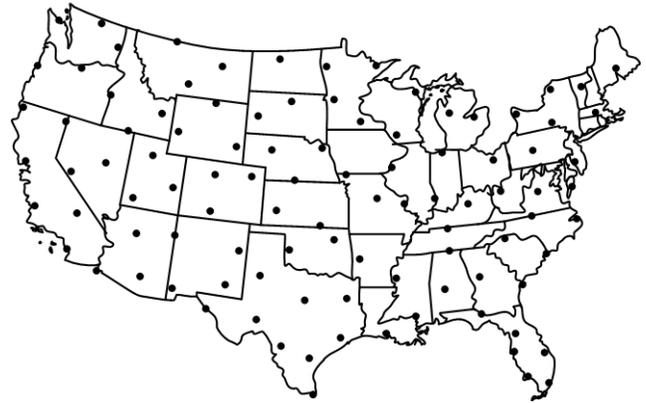
Vaisala, Inc., owns and operates the NLDN, which monitors all lightning activity in the U.S. 24 hours a day, 7 days a week. It does so by deploying more than 100 lightning detection sensors at strategic locations across the U.S., as shown in Fig. 4.

Fig. 4. Lightning sensors deployed by Vaisala across the U.S. [6]

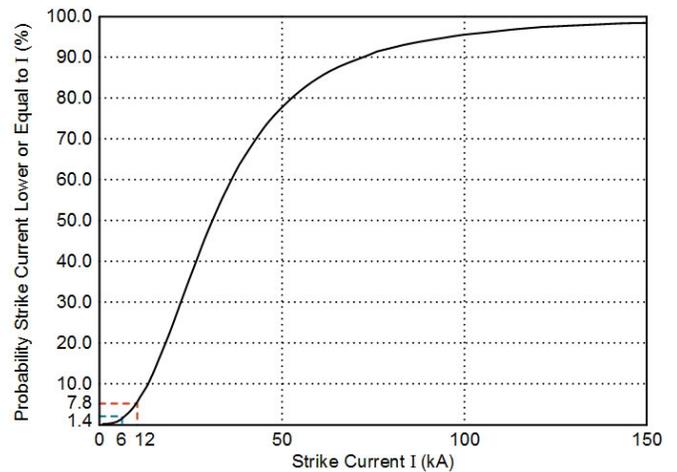
Comparing this result with the strike current distribution given in [12] and shown in Fig. 6 allows us to determine that lightning strikes with current lower than or equal to 6 kA occur in approximately 1.4 percent of all lightning strikes. With the cutoff limit set to 12 kA (critical flashover current level  $I_C$  calculated for this line), the probability curve climbs to 7.8 percent.

Fig. 6. Lightning strike probability as a function of strike current

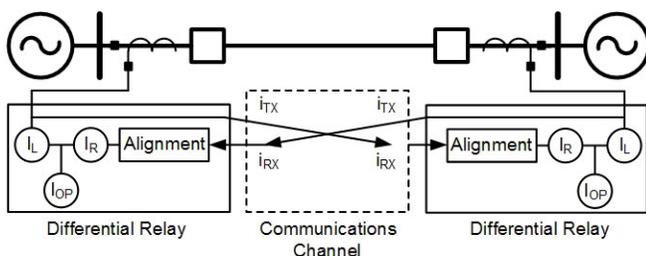
When applied to transmission lines, current differential protection requires a communications channel to receive currents from the remote terminals. Fig. 7 shows differential protection being applied to a two-terminal transmission line. One relay measures current at the local terminal while the other relay measures current at the remote terminal. The two relays then exchange current information over the communications channel to calculate the difference current ( $I_{OP}$ ). If  $I_{OP}$  is greater than a pickup threshold and the ratio of the remote current to the local current plots outside the restraining region shown in Fig. 8, the relay operates. Refer to [14] for more information about differential relay principles and their application.

Fig. 7. Example two-terminal system

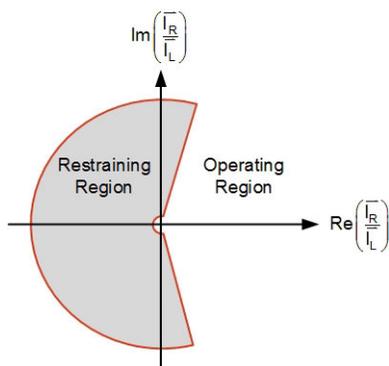
Fig. 8. Line current differential relay characteristic

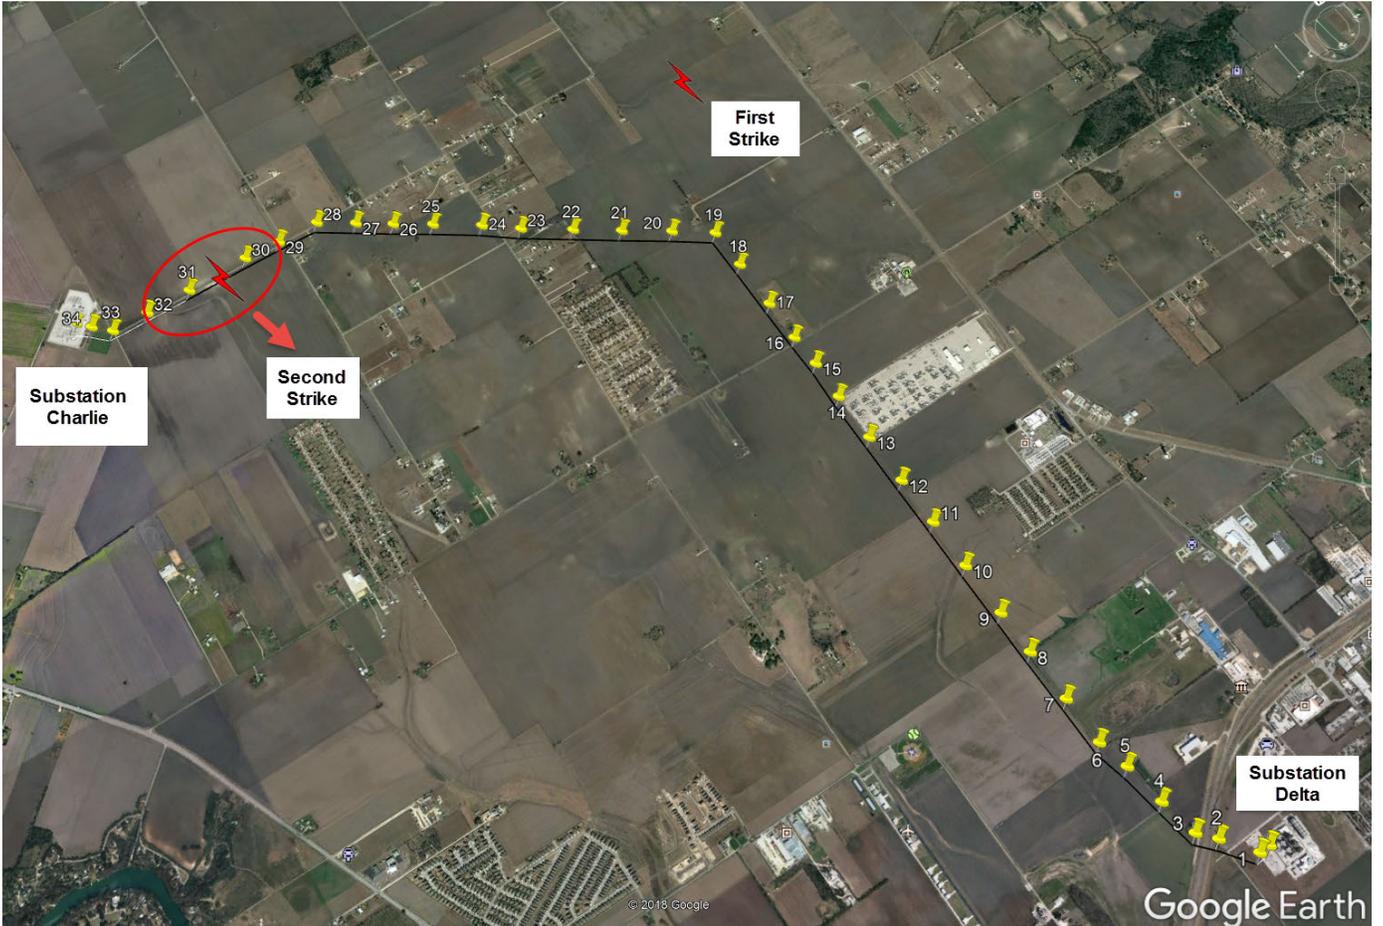
Fig. 11. Lightning activity detected at the time of the relay operation (double-circuit towers carrying Lines T1 and T2 are shown as yellow pushpins)

One strike occurred at 23:29:06.798 at a location far from the transmission line, as shown in Fig. 11. The peak current delivered by the strike was reported to be 12 kA,  $\pm 15$  percent. The 15 percent median error of the sensors in estimating the peak current was reported in [20]. Another strike occurred at 23:29:07.196. The peak current delivered by the strike was reported to be 6 kA,  $\pm 15$  percent. The second strike was found to have contacted the ground somewhere inside the detection ellipse drawn to match the NLDN 99 percent confidence level.

Because transmission line towers 29 to 32 are within the confidence ellipse, it is clear that the second strike played a key role in the relay operation. This theory is corroborated by the time stamp of the relay operation at 23:29:07.116028, which coincides with the second event. The lightning strike location estimate from the TWFL in the Type B relay is 0.5 miles. This translates to a location between Tower 31 and Tower 32, which falls inside the detection ellipse drawn in Fig. 11 and further backs up the theory.

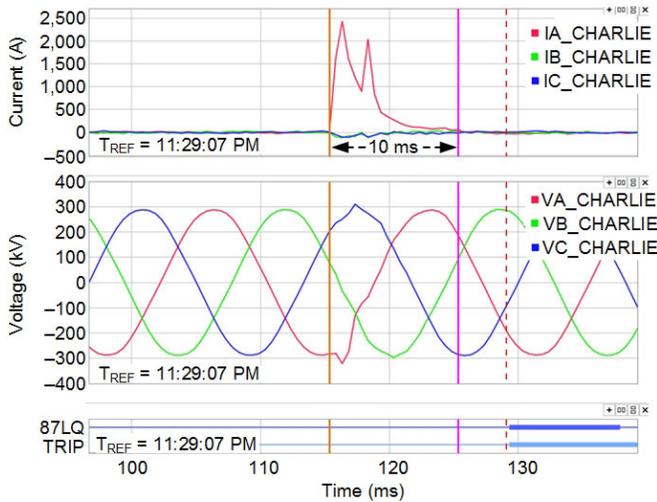
Because the generating station at Substation Delta was offline at the time of the event, we look at the raw data captured by the Type B relay at Substation Charlie. The voltage and current waveforms are shown in Fig. 12. The Type B relays in this event were programmed to save data at 2 kHz (these relays allow users to save data at a sampling rate of up to 8 kHz). While the lower sampling rate is adequate for analyzing 60 Hz events, it is not ideal for visualizing fast transients.

Fig. 12. Event data recorded at Substation Charlie with a resolution of 2 kHz

Starting at 23:29:07.116028, the relay at Substation Charlie observed a high current on Phase A for a very short duration. The negative-sequence differential element (87LQ) operated on this unbalance and tripped the line 14 milliseconds later. The current spike lasted for about 10 milliseconds and was not followed by a 60 Hz current, meaning that the lightning strike in this event did not flash over and cause a power system fault. This is further corroborated by the increase in Phase A voltage at the time of the current spike. For a conventional 60 Hz short-circuit fault, we expect the voltage of the faulted phase to sag, not swell. The result is also consistent with the theory that lightning strikes with currents less than the critical current do not cause a flashover. Recall that the NLDN reported the peak current of the lightning strike to be approximately 6 kA,  $\pm 15$  percent, which is less than the critical current for this line (12 kA).

The waveform of the Phase A current leaves quite a few unanswered questions about the real nature of the event. Correlating the time stamp of this event with the NLDN report in Table II allows us to say with confidence that this event had something to do with lightning. But, it also leaves us with the realization that the 2 kHz recording in Fig. 12 does not contain sufficient information about the lightning strike. To make things more confusing, lightning strike current is normally much shorter than the recorded 10 millisecond spike. As with any natural process, lightning current varies a lot but is typically represented with an exponential wave having a 1.2  $\mu$ s rise time and 50  $\mu$ s fall time. This duration is almost 200 times shorter than the event recorded in Fig. 12.

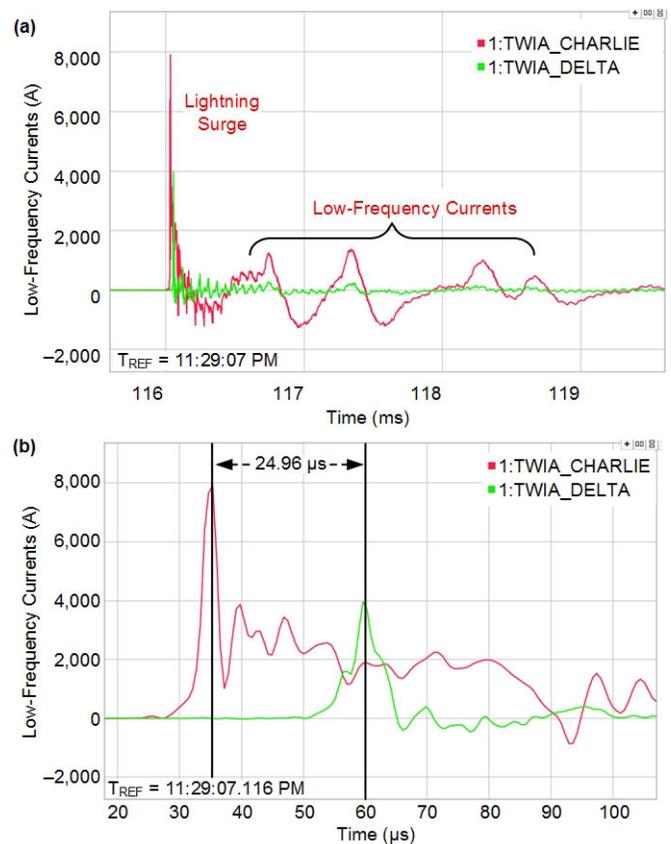
Fig. 13a shows the Phase A traveling-wave currents that the Type B relays recorded at both ends of the line. For ease of use, they have been plotted on the same graph. Data are synchronized via GPS with submicrosecond accuracy, allowing an accurate representation of the wave travel times. Fig. 13b zooms into the initial wave received at both terminals. Notice that both terminals recorded a high-current pulse on Phase A. Traveling waves on Phases B and C had lower magnitudes and polarities opposite to those of Phase A, confirming that this was a direct strike to the Phase A conductor (shielding failure) [21].

Fig. 13. Phase A traveling-wave currents at both line ends (a) and a zoomed-in view of the first strike (b)

Another point of interest is that the current traveling waves (TWIA) recorded at either terminal of the transmission line have the same polarity, and the time difference ( $\Delta t = 24.96 \mu$ s) between the arrival of the two current TWs at their respective terminals is less than the traveling-wave line propagation time (TWLPT = 31.15  $\mu$ s). This indicates that the lightning strike was inside the zone of protection between the line terminals.

We now focus our efforts in understanding the succession of low-frequency traveling-wave currents seen by the relay at Substation Charlie (see Fig. 13a) after the initial lightning strike. The currents get slowly damped but remain visible for a full millisecond. Additional discussion showing how a 50  $\mu\text{s}$  lightning impulse got converted into a low-frequency transient lasting long enough (10 milliseconds) for the protection elements to pick up is given in the next subsection.

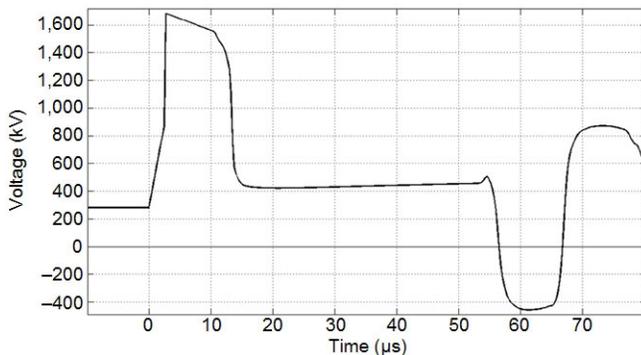
A lightning strike into the Phase A conductor was simulated using a CIGRE (International Council on Large Electric Systems) lightning current source model. The peak magnitude of the injected current is 8 kA. The line characteristic impedance ( $Z_C$ ) for the simulated lightning strike, simulated by a 1.2/50  $\mu\text{s}$  pulse, is approximately 350  $\Omega$ . Therefore, an 8 kA, 1.2/50  $\mu\text{s}$  lightning strike develops a peak voltage of approximately 1,400 kV. The lightning strike was simulated to occur at the same instant the positive peak voltage occurred on Phase A ( $\approx 280$  kV). Therefore, the peak instantaneous voltage is approximately 1,680 kV. The simulated lightning strike was injected at the same location as the second lightning strike shown in Fig. 11. The voltage profile at the point of current injection over a period of 80  $\mu\text{s}$  is shown in Fig. 14.

Fig. 14. Voltage profile at the current injection point.

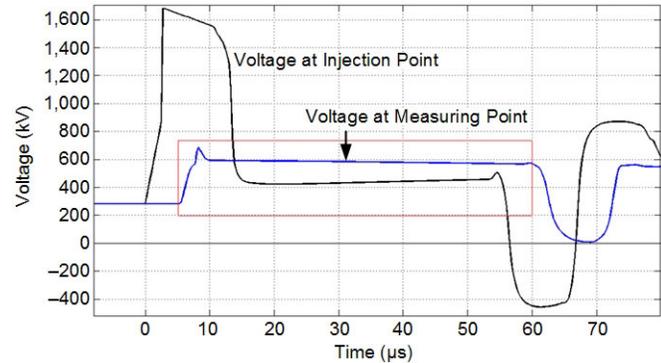
Before the voltage traveling wave reaches the line terminal, it passes a surge arrester. The arrester clips and clamps the magnitude of the voltage traveling wave and diverts some of the injected current to ground. The voltage profile at Substation Charlie is shown in Fig. 15 (blue). The voltage at the injection point (black) is also shown.

Fig. 15. Voltage profile at the current injection point (black) and at Substation Charlie (blue)

From Fig. 15, the impact of the surge arrester can be seen; it clamps the magnitude of the voltage traveling wave to approximately 600 kV. Since the line is very short (31.15  $\mu\text{s}$ ), the arrester action is soon seen along the entire line length. Note that the voltage shown in Fig. 15 is the sum of the incident and reflected voltage. The power system impedance behind the relay measuring point at Substation Charlie determines how much of the incident voltage and current traveling waves are transmitted and reflected. The other terminal of the transmission line, Substation Delta, is effectively open. As a result, nearly all of the incident voltage at Terminal Delta is reflected into the line. The step change in terminal voltage at Substation Charlie, shown inside the red box in Fig. 15, is short-lived but stimulates (excites) the power system (resistors, inductors, and capacitors) behind the Substation Charlie line terminal. The low-frequency traveling-wave currents seen by the relay at Substation Charlie (Fig. 13a) are the response of the power system to that voltage stimulus. Since the generating plant end of the line (Substation Delta) is effectively open, we can see that there is no low-frequency current exiting this end of the line. Therefore, all of the low-frequency current measured at Substation Charlie is seen by the relays as differential current (difference between the red and green traces) originating inside the T1 line protection zone.

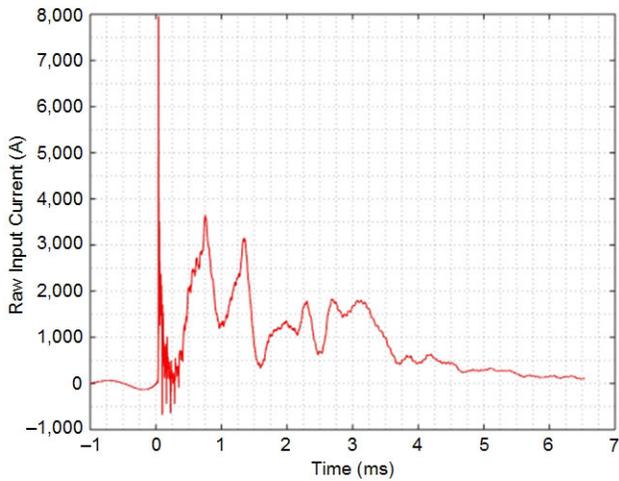
To understand the relay response, we attempted to reconstruct the actual current waveform on the power system and at the relay inputs before any kind of filtering. To do this, we upsampled the 2 kHz raw current data to 1.5625 MHz and combined it with the traveling-wave data. The result is shown in Fig. 16.

Fig. 16. Current measured by the relay at Substation Charlie before any filtering

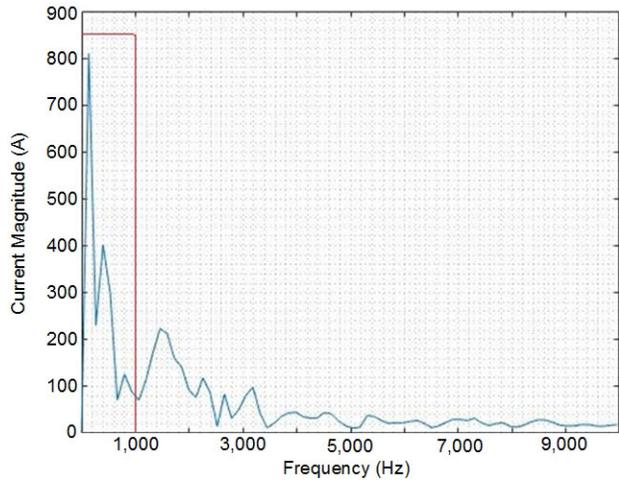
If we do a frequency spectrum of the current in Fig. 16, we obtain the data shown in Fig. 17.

Fig. 17. Frequency spectrum of the current measured at Substation Charlie (note magnitude of the current below 1 kHz, shown inside the red box)

From this we can verify that the response current caused by the voltage stimulus contained frequencies from dc to tens of kilohertz, with portions of the higher frequency current transient being diverted by the surge arrester. The relays' analog and digital antialiasing filters effectively attenuate frequencies above 1 kHz. However, currents below 1 kHz (inside the red box in Fig. 17) pass through the antialiasing filters unaffected. Fig. 18 shows the output after the current in Fig. 16 has passed through the digital antialiasing filters in the relay.

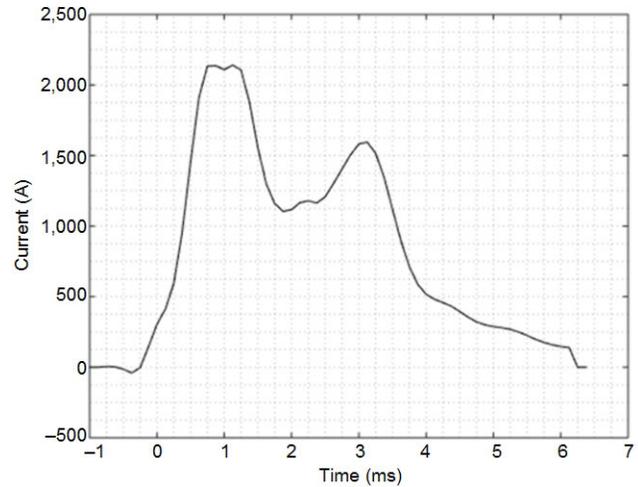
After the current has passed through the digital antialiasing filter, the currents are input into a DBPF, and from this the nominal frequency component of the signal is extracted (in this case, nominal frequency is 60 Hz). Fig. 19 is the output of the 60 Hz DBPF at Substation Charlie. As noted earlier in this section, the line terminal at Substation Delta was open. This means there was very little current measured at this line terminal. Therefore, the phase differential current and the resulting negative-sequence differential current are approximately equal to the current measured at Substation

Fig. 18. Current after being filtered by the antialiasing filter (current is fed into DBPF)

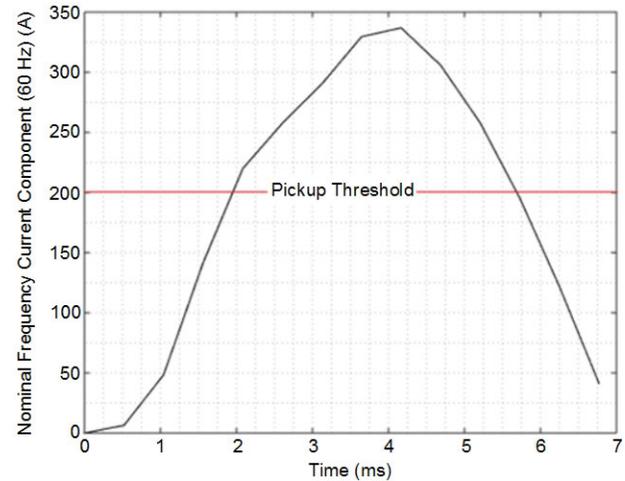
Charlie, as shown in Fig. 19. Because the pickup of the negative-sequence differential element was set very sensitively at 200 A primary, the measured negative-sequence differential current exceeded the pickup. We study the relay operation in more detail using the filtered event report in the following subsection.

Fig. 19. 60 Hz output from the DBPF

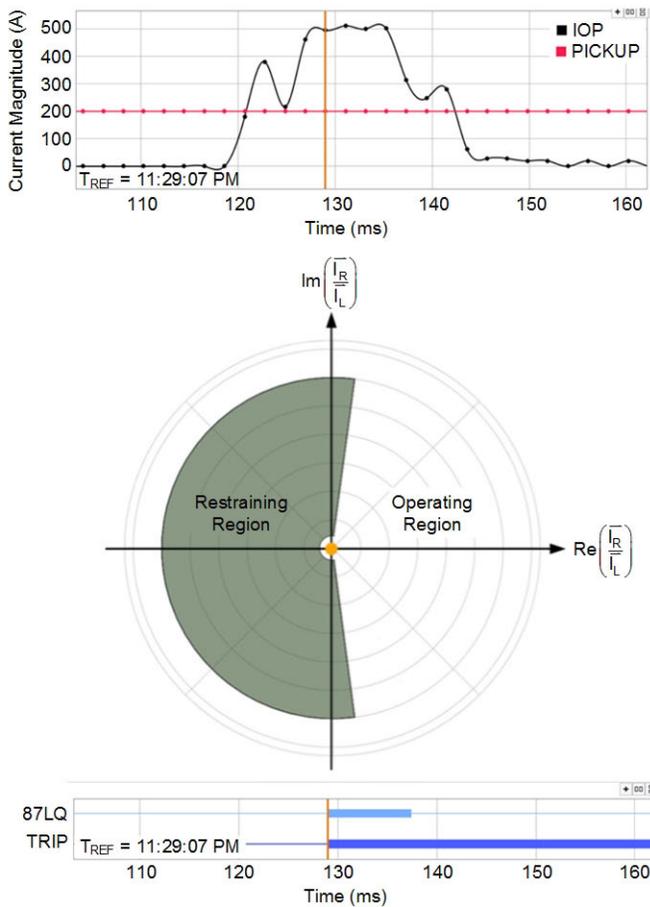
We use the filtered event report to explain the trip issued by the Type B line current differential relay. The lightning strike was inside the zone of protection. As a result, the external fault detector did not assert and the element continued to be in the normal/sensitive mode. Because the negative-sequence differential current ( $I_{OP}$ ) measured by the relay during the disturbance was greater than the pickup setting of 200 A and the current ratio plotted outside of the restraining region, as shown by the orange point in Fig. 20, the negative-sequence differential element (87LQ) asserted instantaneously and caused a trip.

The Type A relays also measured the same negative-sequence difference current, but the inherent time delay in the negative-sequence differential element logic prevented the Type A relays from operating.

Fig. 20 Analysis of the Type B relay operation

If the relay action is judged to be incorrect, the following two setting changes will prevent the negative-sequence differential element from tripping the line for similar events in the future.

- Increase the pickup of the negative-sequence differential element. To do this, the user will have to study the impact of a direct lightning strike to a phase conductor that does not result in a flashover (lightning strike below 12 kA for this line) under different power system configurations, determine the maximum negative-sequence current possible for all the scenarios, and set the pickup above this level. This is a nontrivial task and requires some detailed study. Furthermore, the task cannot be generalized and is highly dependent on the line construction, line length, terrain, and the lightning risk in the area. It is also important to point out that increasing the pickup could lead to losing dependability for high-resistance faults.

- Delay the negative-sequence element by half or one power system cycle, the only caveat being the purposeful delay of the negative-sequence element for internal faults. This may be an acceptable compromise because the purpose of the negative-sequence element is to detect high-impedance faults. For these fault types, sensitivity is more important than speed because these faults do not impact power system stability or damage power system equipment.
