Lessons Learned From Generator Destructive Testing

Calvin Howard, Beth Andrews, and Douglas Taylor, *Avista Utilities*
 Normann Fischer, Dale Finney, and Matchyaraju Alla, *Schweitzer Engineering Laboratories, Inc.*

Abstract—Avista Utilities, an energy company primarily servicing eastern Washington and northern Idaho, has been in the process of upgrading a set of 8.8 MVA, 4 kV, 48-pole, 60 Hz generators at one of their hydroelectric facilities on the Spokane River. The authors took this unique opportunity to perform destructive testing on one of these generators prior to its scheduled upgrade. The testing was performed during the fall of 2018. This paper describes the planning and execution components of this destructive testing and also discusses the lessons learned throughout the entire process.

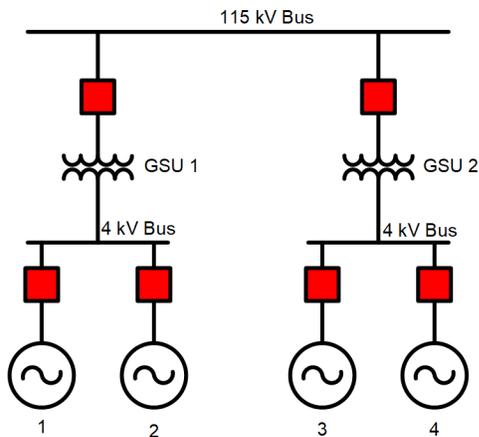
Fig. 1. Simplified one-line diagram of Little Falls generation station.

The generation station consists of four hydro generation units connected to the power system through two GSU transformers, as shown in Fig. 1. Unit 4 was the final generator in the station scheduled for an upgrade and was the unit that testing was performed on. Unit 3 had recently been upgraded. Avista did not want to risk damaging the unit; therefore, no tests were performed while Unit 3 was online.

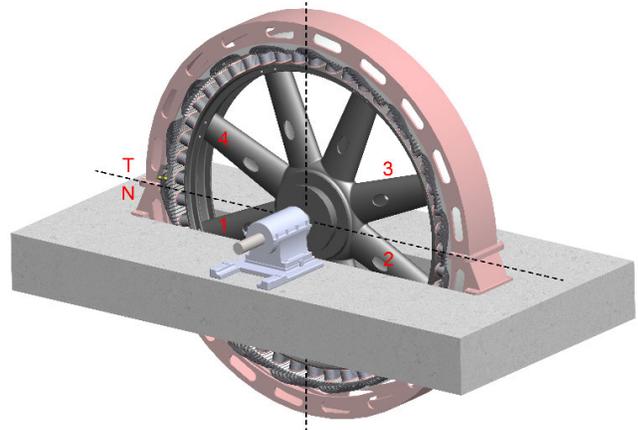
Fig. 2. Physical representation of the generator at Little Falls, showing the four quadrants of the generator and the location of the winding neutral (N) and terminal (T) connections. Note that this is a horizontal hydro generator.

- The physical representation of the generator, as shown in Fig. 2.
- A winding configuration and terminal connection diagram of the generator, as shown in Fig. 3.
- The partial winding layout, winding span (coil pitch), coil configuration, and grouping for the Little Falls generator, as shown in Fig. 4.

Fig. 3 shows that each generator phase is composed of four windings (branches). Reflecting this back onto Fig. 2 demonstrates that the generator is divided into four quadrants. Each quadrant contains a set of three phase windings or branches. Fig. 4 shows that an individual phase winding branch is made up of 12 coil groups of 6 turns (i.e., 3 coils of 2 turns each per group), yielding a total of 72 turns per branch per phase. The location of each winding's terminal and neutral connections is also shown in Fig. 4. With an examination of the physical layout of the machine (i.e., when we map Fig. 4 onto Fig. 2), we can perform a fault survey and thereby establish where and which types of faults are most likely. A few interesting observations are as follows:

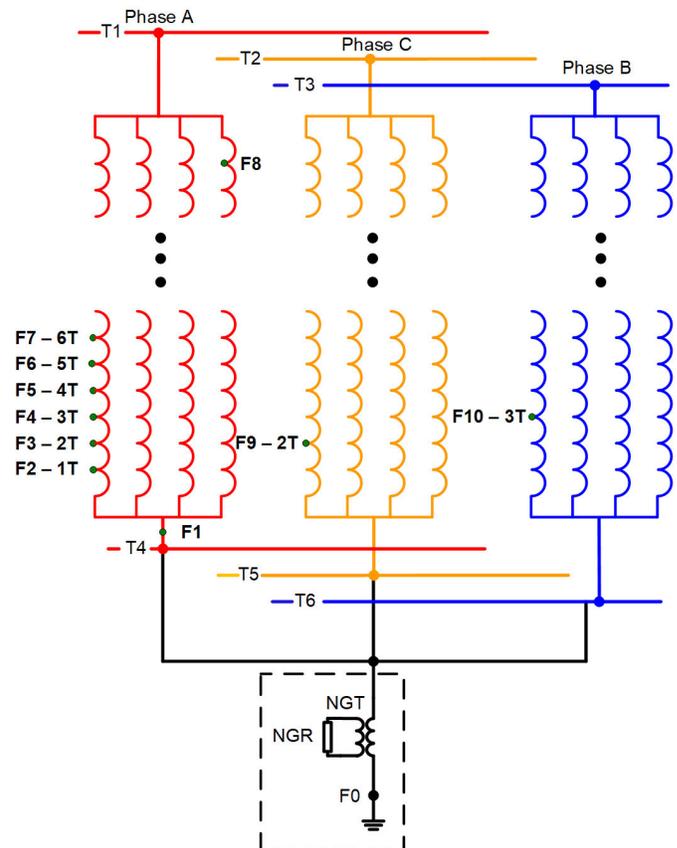
Fig. 3. Winding configuration and terminal connection diagram showing the location of fault points.

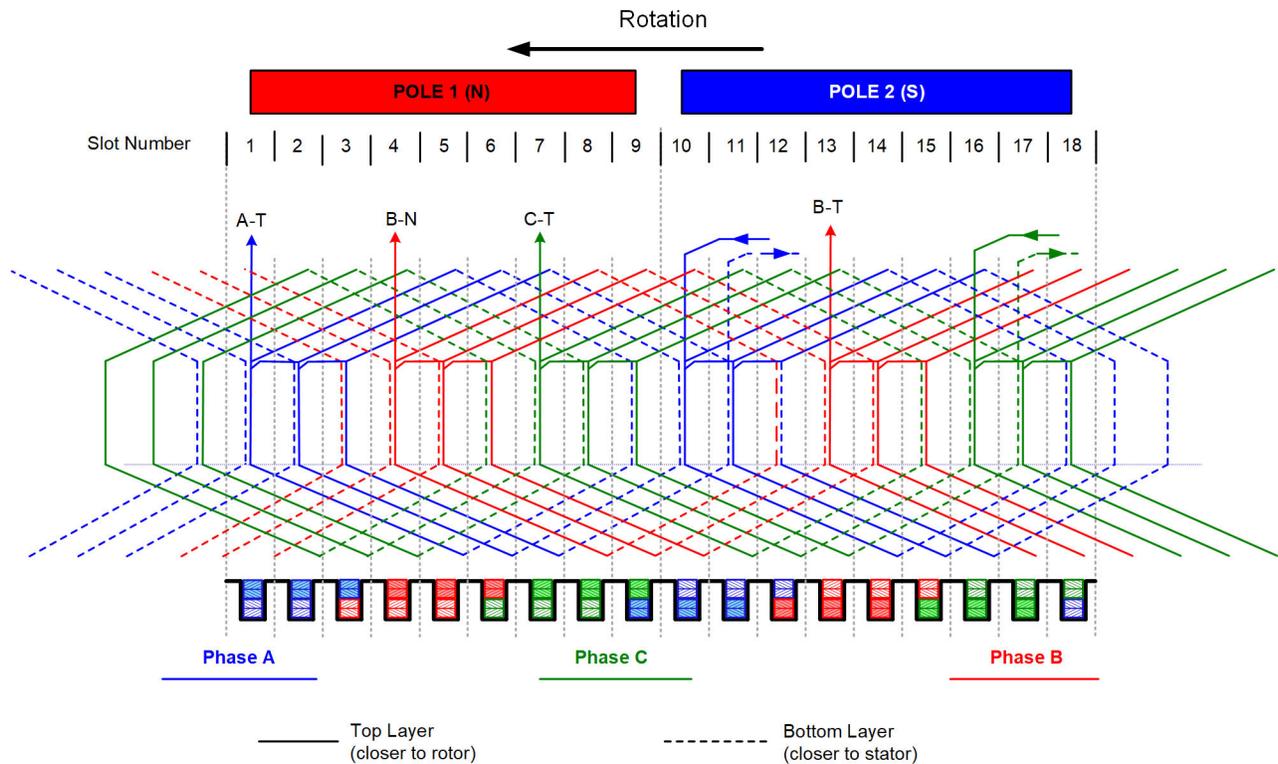
Fig. 4. Partial winding layout diagram for the Little Falls generator showing the coil pitch and coil groups.

- The terminal connection for one winding is almost adjacent to the neutral connection of another winding. In Fig. 4, the A-phase terminal connection of Branch 1 in slot 1 is two slots away from the B-phase neutral connection of Branch 4 in slot 4. The letters T and N in Fig. 1 illustrate the fact that the neutral connection from Branch 1 is adjacent to the terminal connection of Branch 4. Therefore, phase-to-phase faults in the end-winding are possible.
- Coils from the same phase but from a different branch share the same slot. Furthermore, these coils are from different locations on the winding (i.e., in some cases, one coil is located close to the neutral connection and the other coil is located close to the terminal connection). For example, in Fig. 4 slot 13, a coil that

connects to the terminal connection of Branch 1, B-phase shares the slot with a coil close to the neutral terminal of Branch 4 B-phase. From the survey, we identified 12 possibilities for this type of inter-branch fault.

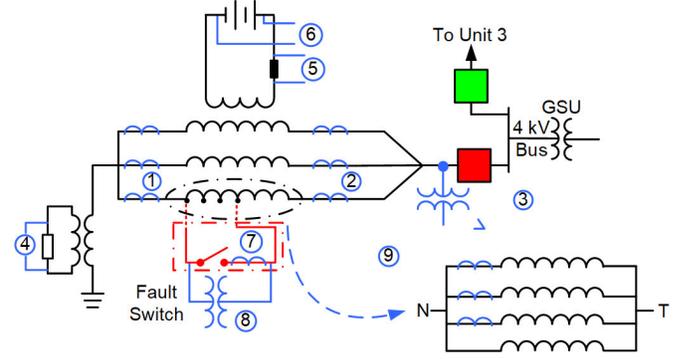
Fig. 5. Measuring points for the destructive testing of the Little Falls generator.

Instrumenting the generator is a critical task during testing since it ensures that we capture all relevant data. A simple schematic of the generator and the locations of the instrument transformers and the recording points is shown in Fig. 5.

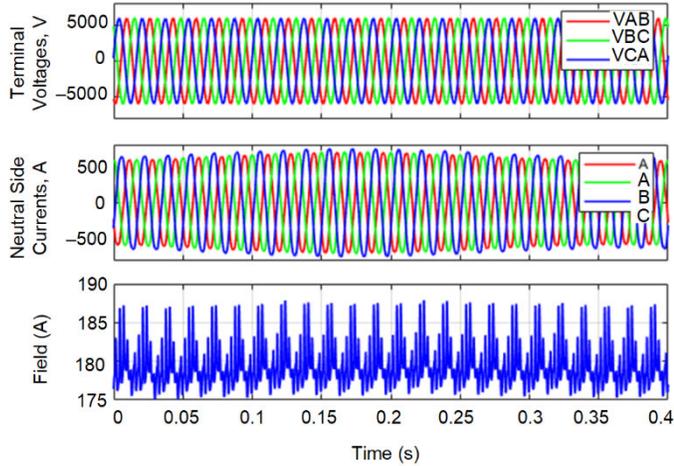
Fig. 7. Generator terminal voltages, phase currents, and field current during a rotor turn-to-turn fault on the generator.

A rotor turn-to-turn fault involving a few turns is not readily observable by monitoring the voltage terminals, the phase currents, or the field current, as can be seen by examining Fig. 7.

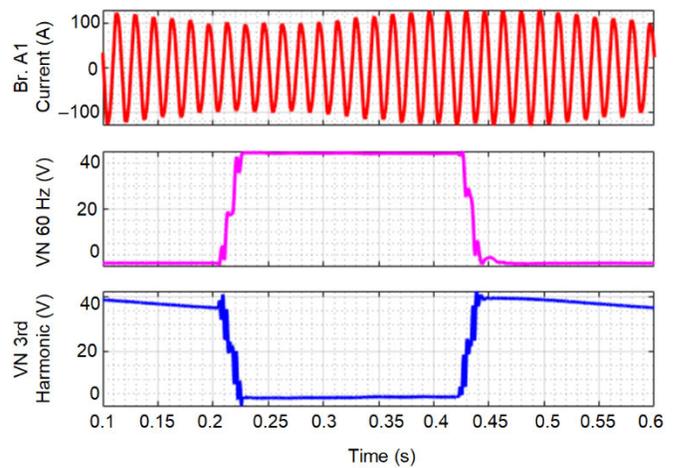
Fig. 9. A-phase Branch 1 current, neutral fundamental voltage magnitude, and third harmonic voltage magnitude for a stator turn-to-ground fault three turns from the neutral of the generator.

The results for a turn-to-ground fault three turns from the neutral of the generator (at 4.16 percent of the winding) are shown in Fig. 9.

If we examine Fig. 8 and Fig. 9, we can make the following observations. The closer the ground fault is to the neutral of the generator, the larger the collapse of the third harmonic voltage at the neutral of the generator and the lower the fundamental voltage drop developed across the grounding resistor of the generator. The further the ground fault is from the neutral, the smaller the collapse of the third harmonic voltage at the neutral of the generator and the higher the fundamental voltage developed across the grounding resistor of the generator. These results are as expected and help give the team confidence in the equipment and the test methodology. As expected, there were no changes in the faulted branch current.

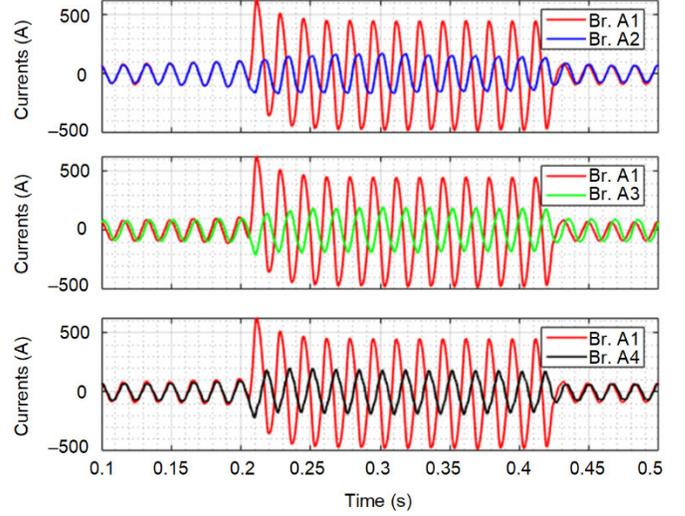
Fig. 12. Plot of the current in the faulted branch versus the current in each of the unfaulted branches for a turn-to-turn fault involving four turns.

Because of their nature, turn-to-turn faults cannot be readily observed by observing the phase current, i.e., by using the current information supplied by the terminal and neutral-side CTs of the phase that experiences the turn-to-turn fault. For this reason, on multi-branch generators, split-phase protection is employed where CTs are installed in each of the branches that make up a phase. During normal operation of the generator, the current in each of the branches is shared almost equally. The small difference in current or standing current between the branches is caused by the slight differences in the inductance of the different branches [11] [13]. In this test series, we created turn-to-turn faults on Branch 1 of the A-phase of the generator. The branch current of the faulted branch is plotted against that of an unfaulted branch for a turn-to-turn fault involving four turns in Fig. 12. Before the fault at $t = 0.21$ s, the branch currents of the four branches are almost identical. However, when the turn-to-turn fault occurs, the branch currents in all four branches change. The faulted branch experiences the highest increase in current (3.9 times the pre-fault current) and is of opposite polarity to the currents of the unfaulted branches.

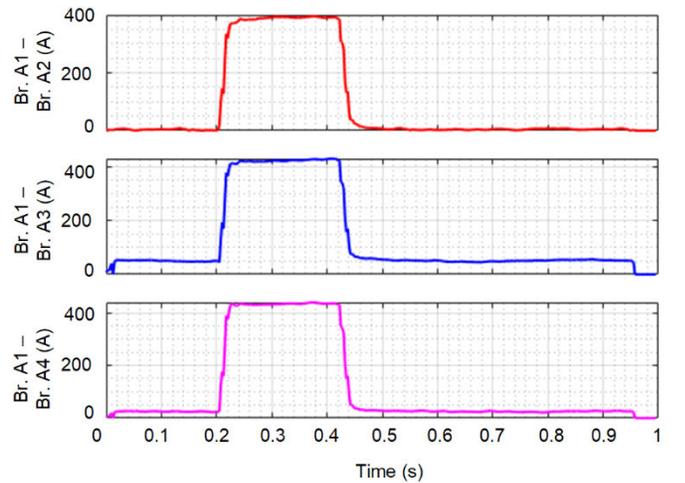
Fig. 13. Plot of the differential current magnitude between the faulted branch and the unfaulted branches for a turn-to-turn fault involving four turns.

The magnitude of the difference in the branch currents is shown in Fig. 13.

The average circulating current magnitude observed in the test increased by 0.3 pu, as shown in Fig. 13.

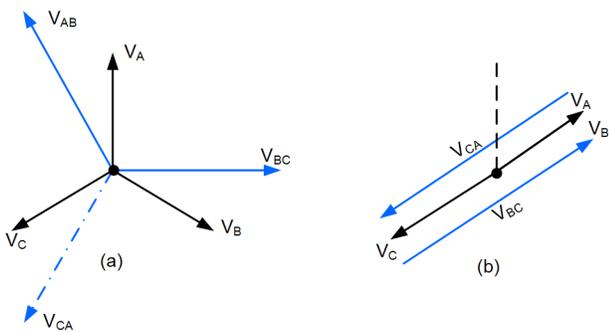
Fig. 17. Plot of the pre-fault phase-to-neutral and phase-to-phase voltages (a) and the fault phase-to-neutral and phase-to-phase voltages (b).

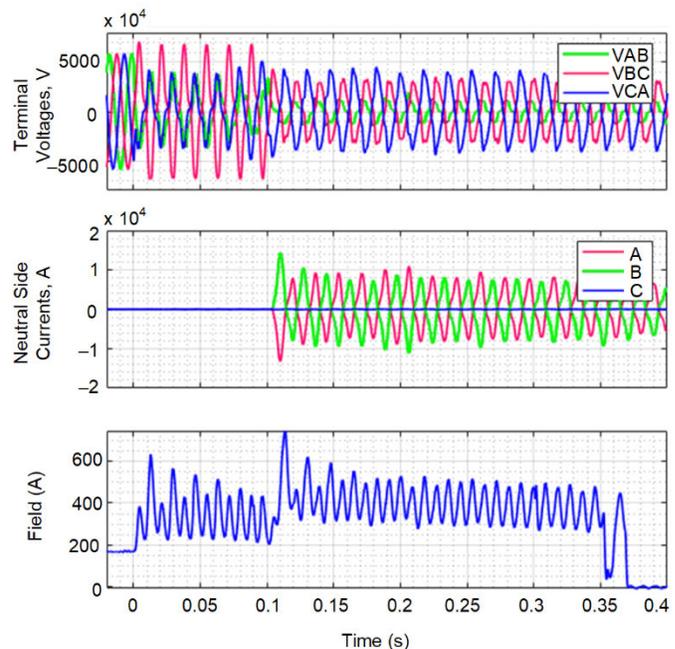
Fig. 18. Plot of the terminal voltages, neutral-phase CT currents and the field current for a double-phase-to-ground fault.

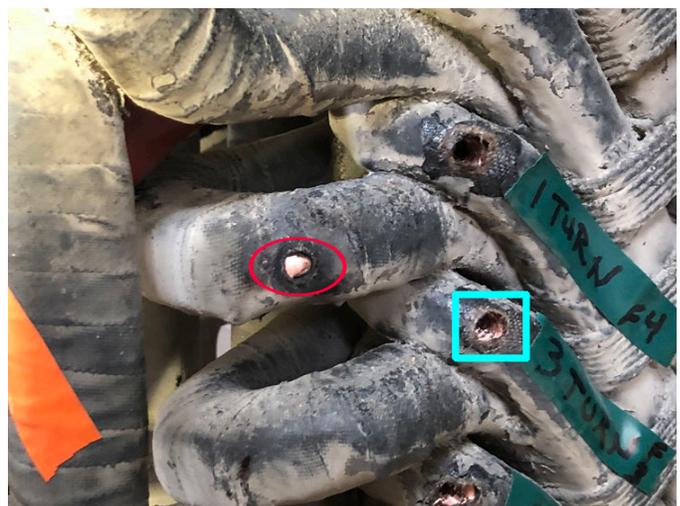
Fig. 19. Photograph showing the tapped fault point in the stator winding (blue rectangle) and the remainder of a sheared-off bolt (red oval).

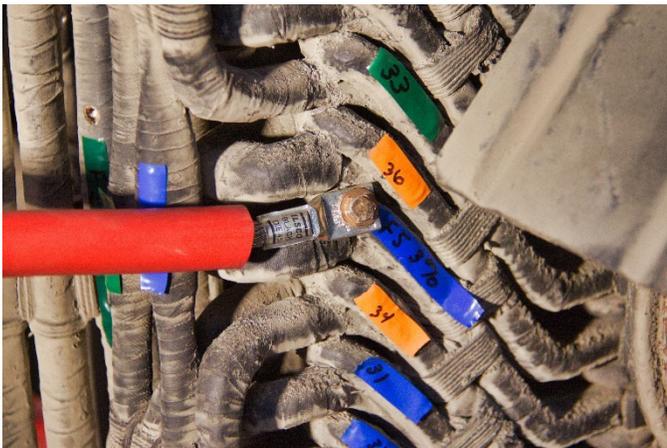
Fig. 20. Photograph showing the fly lead used to connect the fault point to the fault switch and the copper bolt used to secure the fly lead to the fault point.

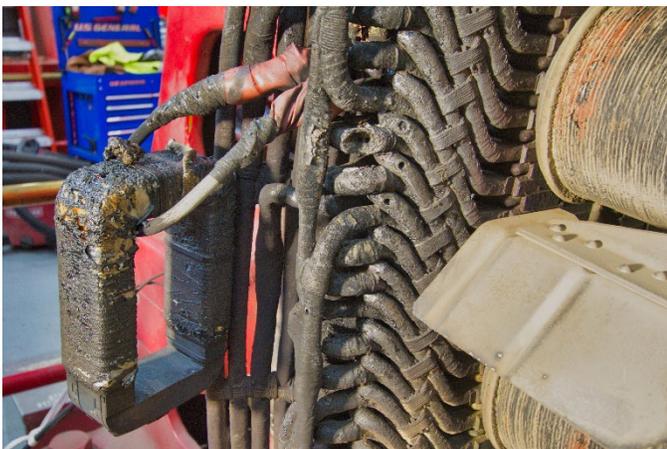
Fig. 21. Photograph showing the damage to the stator windings and one of the branch CTs after a branch fault evolved into a phase-to-phase fault.

the B-phase winding) was located only two slots above Fault Points F8 and F2. When the fault evolved into a phase-to-phase fault, current flowed in the A- and B-phase CTs located at the neutral side of the generator. The generator differential relay (an electromechanical relay) tripped and cleared the fault in 250 ms. The damage caused by this evolving fault is shown in Fig. 21.

The damage to the generator stator winding was so extensive that we could not resume testing at this point, thus prematurely ending the destructive testing. We still intended to perform an open branch test, where we would have open-circuited one of the phase branches to observe how such a fault would manifest itself and how such a fault could be identified. The safety precautions implemented ensured no injuries or unexpected damage was caused beyond the generator stator winding.

The second major lesson we learned is to not leave an unused fault point exposed because, if for some reason a fly lead breaks loose or a piece of metal breaks loose and vaporizes, that vapor can become a plasma which can then result in an unanticipated fault condition. During the inter-branch fault, we did not anticipate that a sheared-off copper bolt could vaporize and create a plasma that would change the inter-branch fault into a phase-to-phase fault. This omission in our planning resulted in a premature end to the destructive testing.

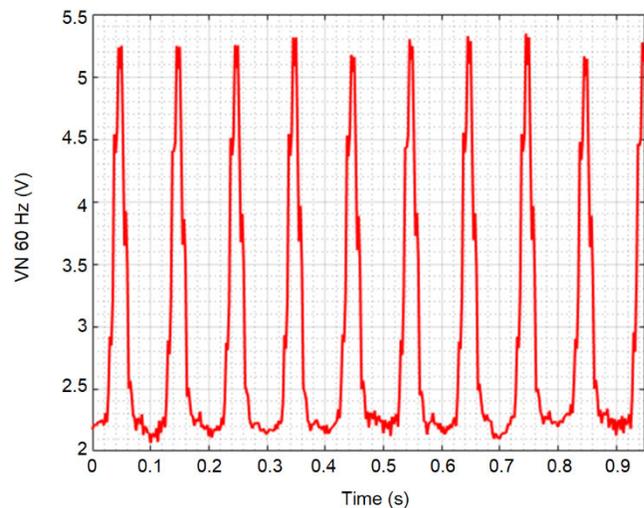
Fig. 22. Magnitude of neutral fundamental voltage during a 2 percent rotor turn-to-turn fault on the generator.

During the rotor turn-to-turn fault testing, we observed that the voltage across the generator grounding resistor (shown in Fig. 22) followed the same pattern as the branch currents shown in Fig. 6. The magnitude of the voltage across the generator grounding resistor spiked periodically at an interval of every 100 ms.

The authors hypothesize that a rotor turn-to-turn fault may appear as a stator ground fault. Therefore, the authors recommend also inspecting the rotor upon any generator trip caused by a perceived stator ground fault.

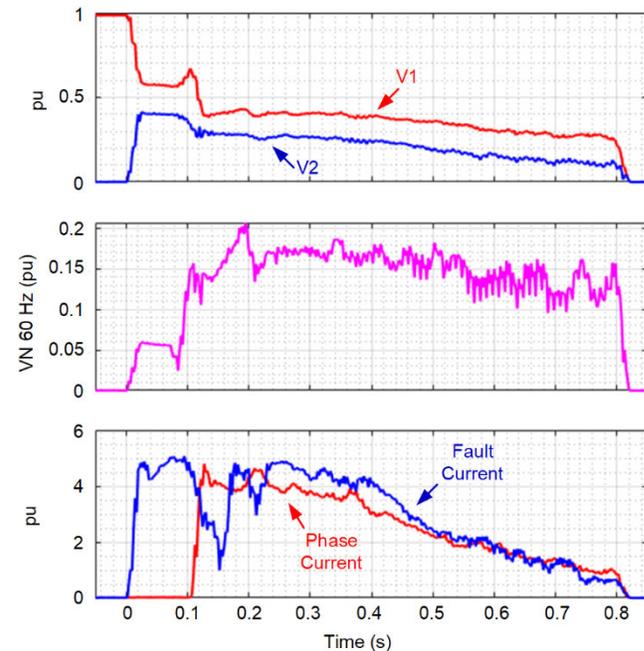
Fig. 23. Positive-, negative-, and neutral fundamental voltages along with currents during branch-to-branch fault.

voltage (V_N) measured during the branch fault (double-phase-to-ground fault) is 0.06 pu, which corresponds to the voltage developed for a stator ground fault 6 percent from the neutral, as shown in Fig. 23. However, if we consider the speed at which this stator ground fault protection operates (i.e., several hundreds of milliseconds), the generator will be exposed to severe stress and potential damage. Examining Fig. 23, we can see that if the V_N and negative-sequence voltage (V_2) are above a set threshold, then the generator is experiencing an inter-branch fault or a double-phase-to-ground fault and tripping can be accelerated.

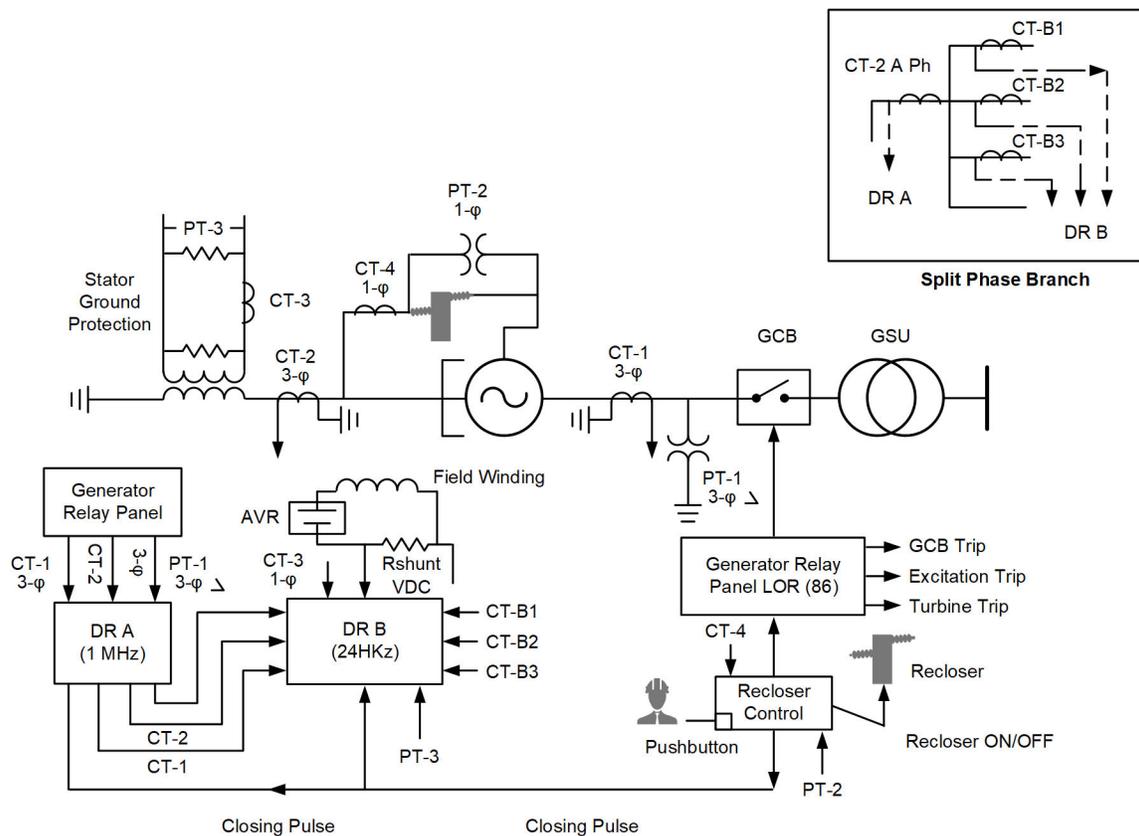
Fig. 24. Layout of test and measuring devices for the Little Falls destructive testing.

The layout of the test equipment and measuring points for the destructive testing of the Little Falls generator is shown in Fig. 24, which also shows all the measuring points and where and at which rate the data were acquired.
