Recent Utility Experience with High Impedance Fault Detection

Jeffrey Chai	Jason Parsick	Thaddeus Potter	Ilia Voloh	Tirath Bains	Mark Adamiak
Potomac Electric Power Company			GE Grid Automation		Adamiak Consulting LLC

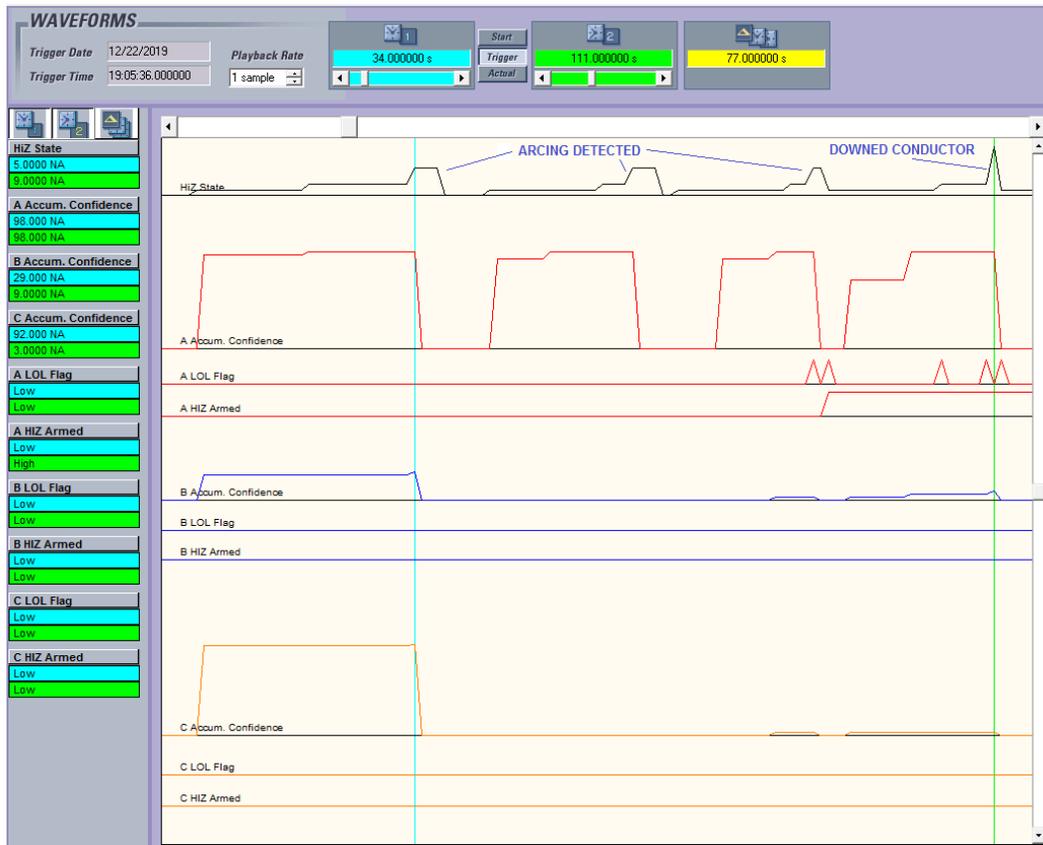
Figure 2. HiZ oscillography for a True Downed Conductor Operation of F60 Hi-Z element.

The case under consideration is an actual Pepco event where the Hi-Z algorithm correctly declared a "Hi-Z Downed Conductor-A" (i.e., downed conductor in phase A) on a 13kV overhead radial distribution feeder. For this event, downed wires were found on the feeder with the conductor down on the ground in a right-of-way.

The Hi-Z oscillography retrieved for this scenario is shown in Figure 2. It can be seen that Hi-Z element declared "Hi-Z Arc Detected-A" (Hi-Z State=5) three times within a window of one minute before declaring "Hi-Z Downed Cond-A" (Hi-Z State=9). More details about the outputs of F60 Hi-Z element to this scenario is explained with the help of Figure 3.

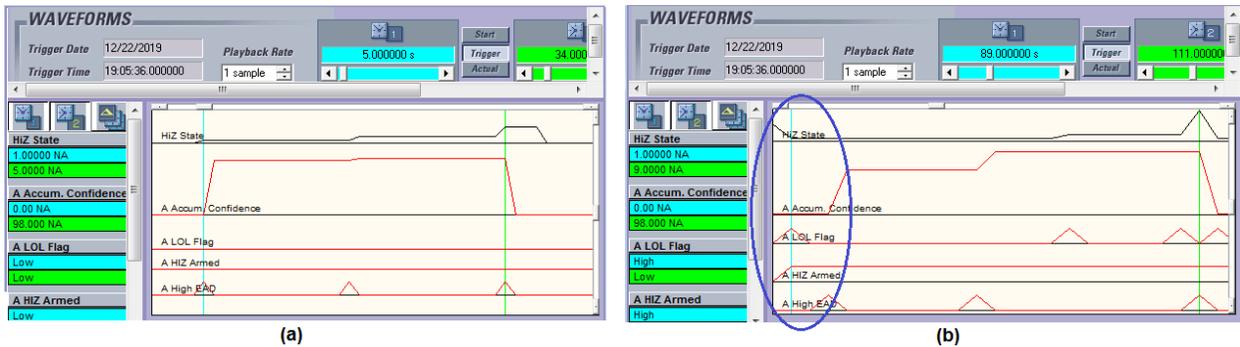
Figure 3. Hi-Z element output "Hi-Z Arc Detected-A" (a), Hi-Z element output "Hi-Z Downed Cond-A" (b).

Figure 3 shows the sections of Hi-Z oscillography when: Hi-Z element output "Hi-Z Arc Detected-A" (a), Hi-Z element output "Hi-Z Downed Cond-A" (b). It can be seen from Figure 3 (a) that when Hi-Z element detected a signature of a Hi-Z event, the Hi-Z State went from 0 (Normal) to 1 (Co-ordination timeout) and then to 2 (Armed). Also, during this time period Hi-Z element started building-up the Accumulated Confidence.

It can be observed that the accumulated confidence built-up and crossed threshold rapidly. However, the Hi-Z event was only declared after the threshold of 3 EADS was met. The key point to note in Figure 3 is that Hi-Z State =1 (Co-ordination timeout) was triggered by a "HighEAD" in (a), while Hi-Z State =1 (Co-ordination timeout) was triggered by a Loss of Load (LOL) event in (b). It can be seen in Figure 3 (b) that when LOL triggered the Co-ordination Timeout state, it also armed the DNC logic of phase-A (A HIZ ARMED in the figure). That is precisely the reason why when conditions were met for declaring an Hi-Z event, the output in Figure 3 (a) was "Hi-Z Arc Detected-A" (Hi-Z State=5), while in Figure 3 (b) it was "Hi-Z Downed Cond-A" (Hi-Z State=9).

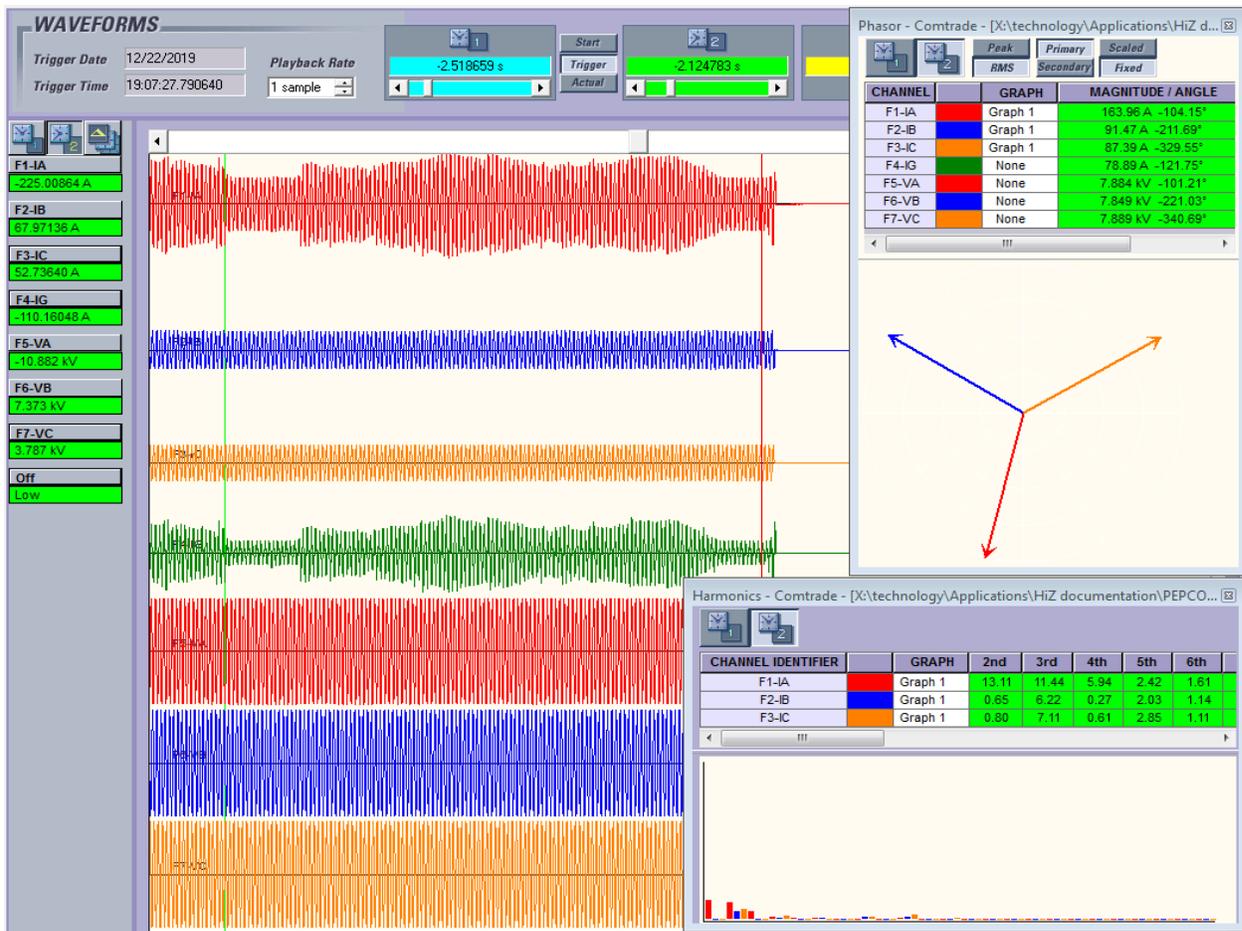
Figure 4. Waveforms of currents and voltages for the Downed Conductor Event along with estimated phasors and harmonics.

From the waveforms captured by F60 shown in Figure 4, it can be seen that the current in phase-A was relatively higher than the other phases. The phase-A current also had relatively higher harmonic content. The current waveform of phase-A also shows a typical Loss of Load (LOL) event in the region followed by green cursor line in Figure 4.

- Voltages do not show any distortion and appear normal
- Currents in healthy phases appear to be very steady with low harmonic content.
- The faulted phase current exhibits erratic behavior with a significant content of harmonics; 13.1% of the 2nd harmonic, 11.4% of the 3rd harmonic, 5.9% of the 4th harmonic, etc.

The most important observation here is with the envelope of the phase-A and neutral currents after the loss of load. We can see that current goes up and down, satisfying energy randomness algorithm and leading to the growing confidence that this is a true phase-A downed conductor event.

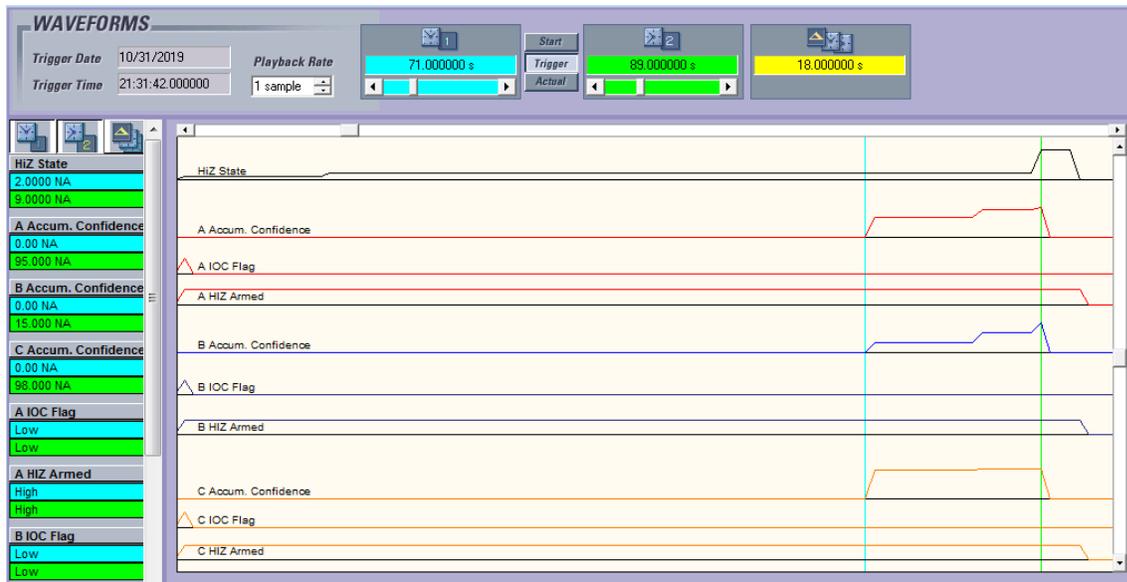
Figure 6. Hi-Z oscillography captured from F60 showing the arming and operation of DNC.

From the sequence of events log shown in Figure 5, it is evident that at time 22:31:43.794345, a 3-phase IOC event occurred, which armed the DNC logic in all the phases. It can be seen from the Figure 6 that for 70 seconds after IOC event, Hi-Z algorithm did not detect any signature of Hi-Z fault. Thereafter, Hi-Z element started detecting the signature of Hi-Z fault and built-up enough confidence within next 18 seconds window to declare a DNC in phase C. PEPCO service crew inspected the line and did not find any downed conductor and the case was initially classified as False Downed Conductor Event.

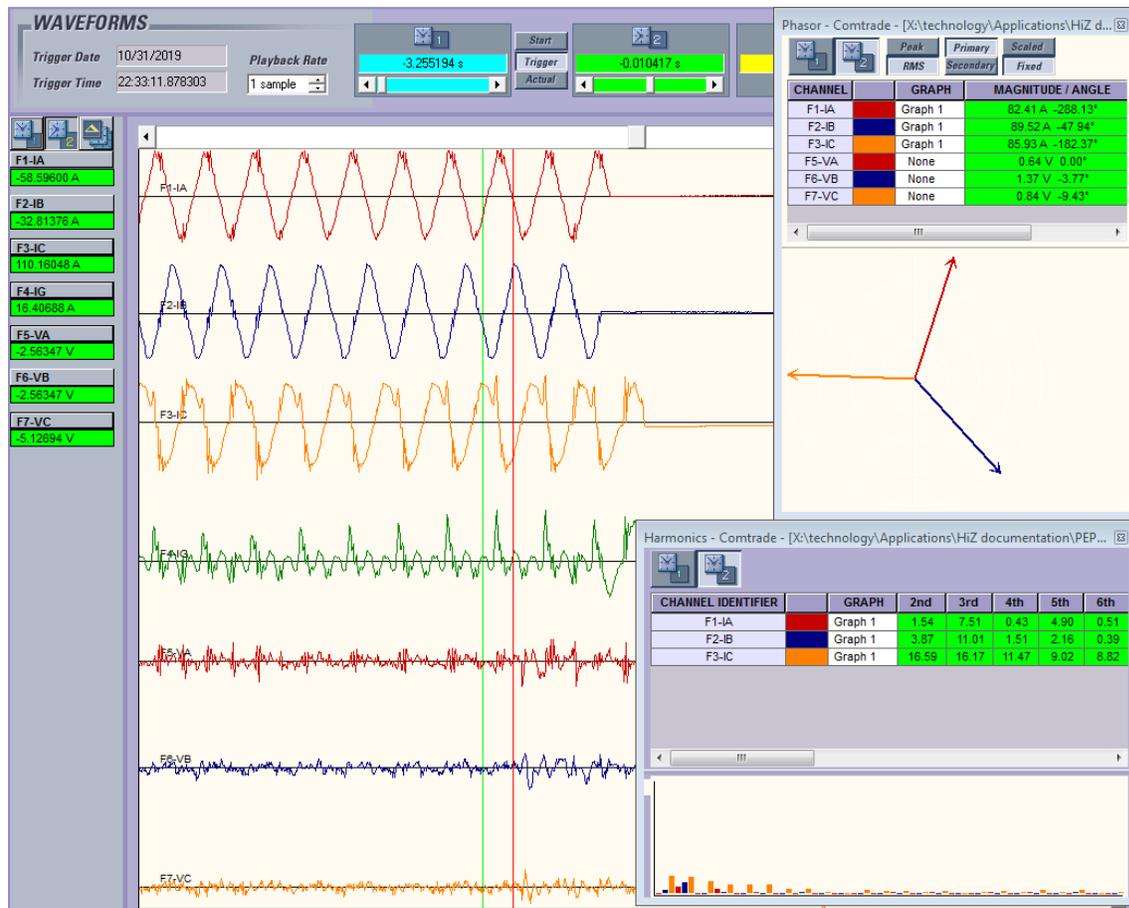
Figure 7. Current and voltage waveforms with estimated phasors and harmonics

When the waveforms captured during this event shown in Figure 7 were analyzed, it was observed that all phases had high content of harmonics especially in phase C. Another peculiar observation was that phase C showed a repeated high amount of non-linearity in each fundamental cycle, which was propagating to other 2 phases at the same time instant. Interestingly, about half an hour after the DNC operation, it was found that a tree limb was hanging on the phase C of the tie.

Another observation that becomes significant in the light of finding is a hanging tree limb on phase C: 8 minutes prior to DNC operation of the Hi-Z element, it yielded the output of Hi-Z ARC DETECTED Phase C, 5 times within the window of approximately 3.5 minutes.

Most likely, the sequence of events that led to the DNC operation was that the tree limb hanging on phase C was creating arcing that Hi-Z element was correctly being detected as "Arc Detected in Phase C", repeatedly. Unfortunately, at time 22:31:43.794345 a 3-phase switching event happened in the system which armed the Hi-Z DNC logic. The continued arcing produced by the hanging tree limb was picked up as a signature of a downed conductor by Hi-Z DNC logic. Ideally, the output for this case should also have been "Hi-Z Arc Detected C", however, due to the system events the Hi-Z element yielded "Hi-Z Downed Conductor C", in spite of there was no physical conductor touching the ground.

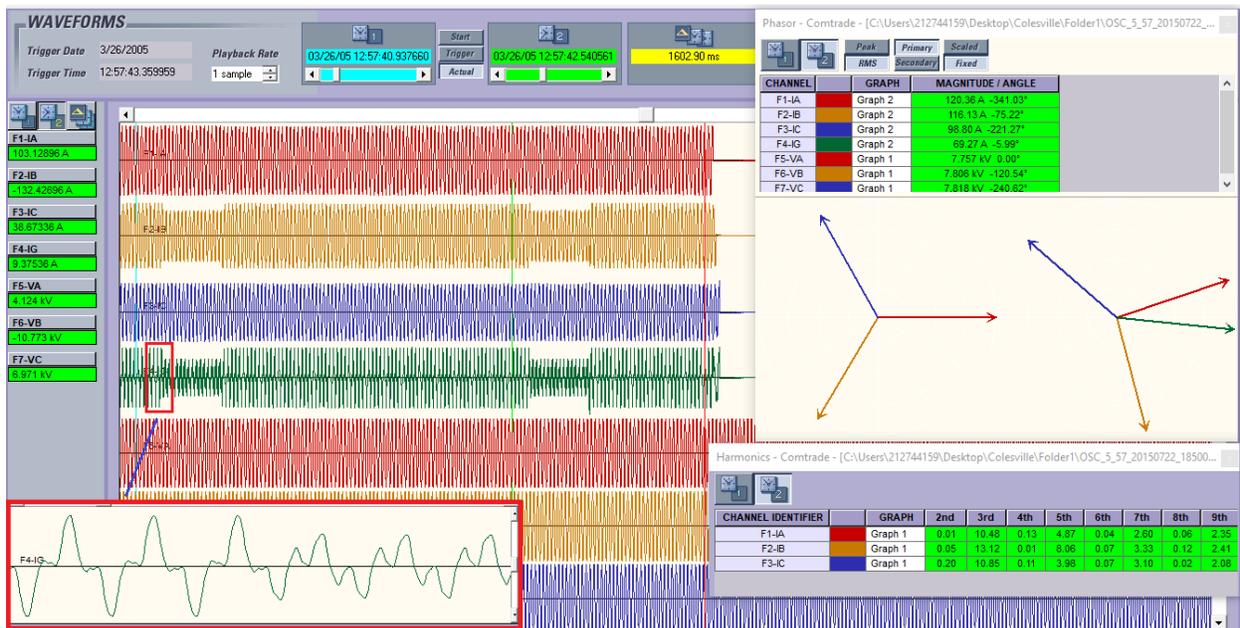
Figure 8: Current and voltage waveforms for the false downed conductor event along with estimated phasors and harmonics.

The case being reviewed is when a false Downed Conductor Event in phase-B happened due to extra-ordinary system conditions. Figure 8 shows recorded current and voltage waveforms for this case. The phase voltages were balanced, while, significant unbalance was observed in the phase currents. Also, a relatively high neutral current (~70A) was noted which is approximately 60% of the Phase B current.

It can also be seen from Figure 8, that two 'dips' occurred in phase B and neutral currents, simultaneously. Following are the interesting facts observed about the 'dips':

- Both 'dips' involved identical change in the phase B and neutral fundamental currents (approximately 30A).
- Duration of both 'dips' was identical (250ms).
- The fundamental component of the neutral current was reduced significantly during the 'dips' as seen from the magnified waveform of the neutral current around one of the current 'dips' in Figure 8 (highlighted in red)

From facts above, it is highly likely that a relatively high power electronic device (such as a VFD or an inverter) was malfunctioning in Phase B. The HiZ algorithm picked the abrupt decrease in phase B as loss of load and got armed. The event log of the relay presented in Figure 9 shows that "HiZ- Loss of Load-B" was logged multiple time before HiZ algorithm declared the "HiZ-Downed Cond-B". As a matter of fact, during a window of 53 seconds, "HiZ- Loss of Load-B" was asserted 11 times as highlighted in Figure 9. The event log further showed that (not shown in Figure) that this unusual disturbance in phase-B lasted for about 3.5 hours, before the operation of "HiZ-Downed Cond-B".

This false DNC operation occurred due to extra-ordinary system operating conditions which involved repeated occurrence of loss of load events, high harmonic content in phase and neutral currents which varied with time. Thus, satisfying loss of load criteria and the randomness, and energy algorithms of the HiZ algorithm.

- Use voltage supervision to detect voltages are normal - HiZ faults don't cause voltage dips.
- IOC or LOL events cannot arm the downed conductor detection for too long – usually when conductor is on the ground, harmonics accumulation starts happening right away. In current HiZ implementation it is arming for 120 seconds without monitoring if harmonics accumulation is happening shortly after IOC or LOL event.

- IOC or LOL in any specific phase can arm DNC in this phase only. IOC or LOL detected simultaneously in more than one phase should not arm DNC and instead should inhibit algorithm for some time.
