Voltage Potential Device Impact on Negative Sequence Directionality

Sophie Gray, P.E.
CenterPoint Energy – Houston, Texas

70th Annual Conference for Protective Relay Engineers
Texas A&M University – College Station Texas
April 3 – April 6, 2017

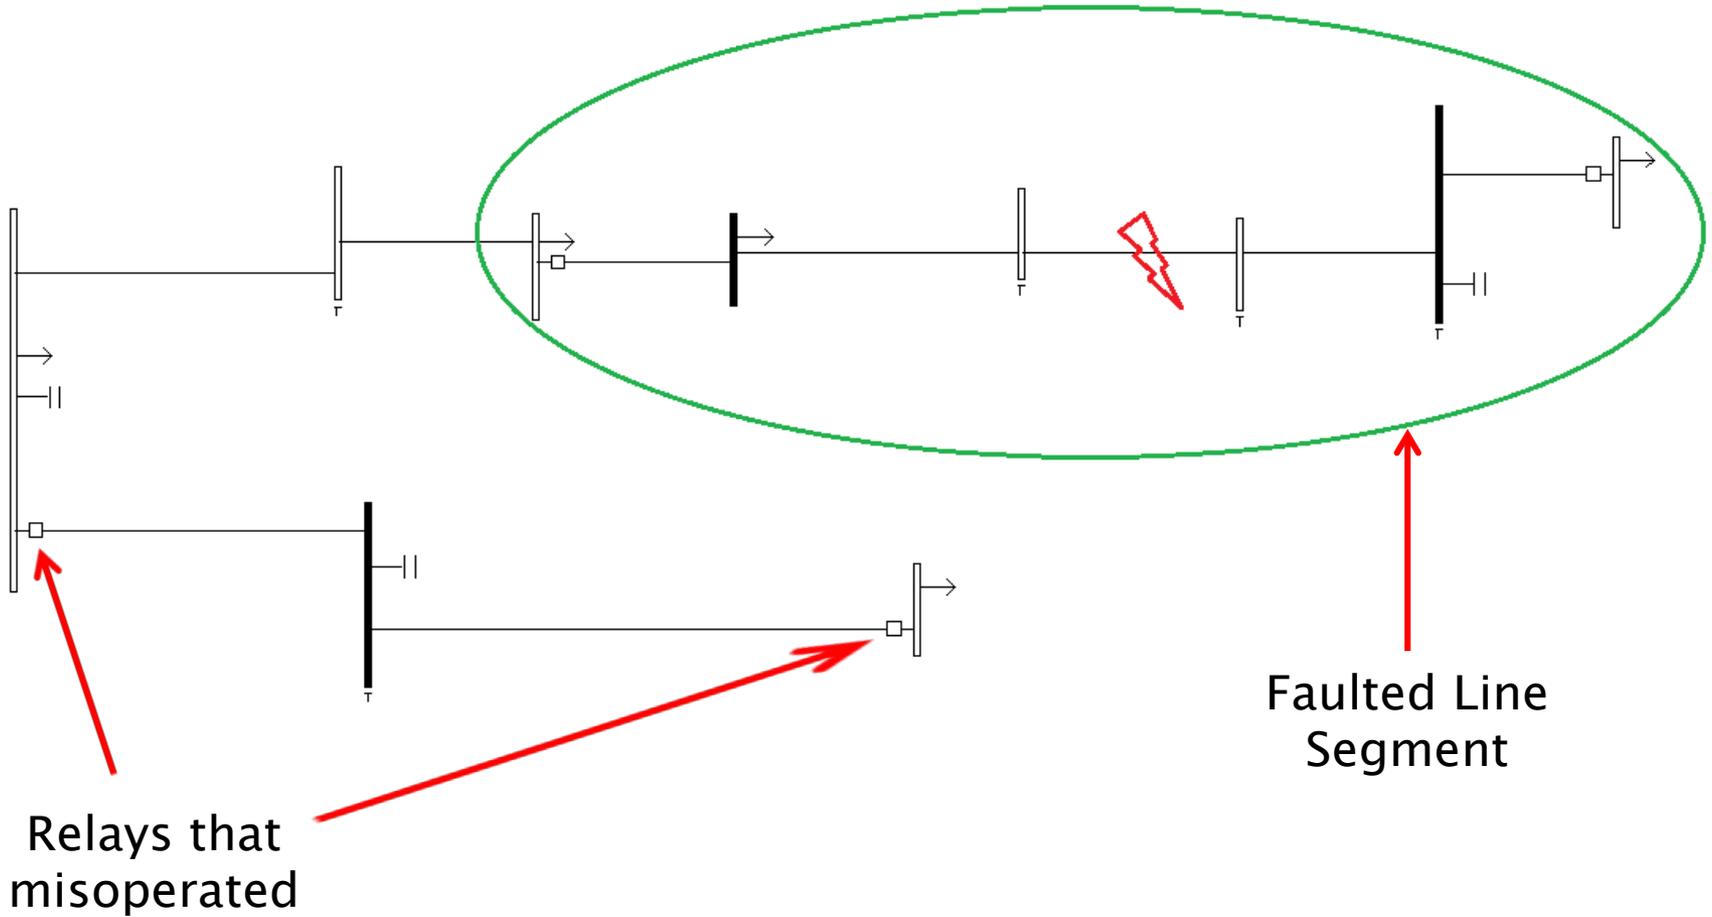
Topology of Area

- ▶ On 7/25/16, at 06:58:57.634, a utility experienced a disturbance event on a transmission line.
 - Fault type was A phase to Ground.
 - Fault location was about 3 miles from one end of a 9-mile long line.
 - Fault duration was four cycles.
- ▶ At the same time, a nearby line operated at both ends.
 - There was no fault on nearby line.
 - Fault appeared to be reverse-looking, to one of the ends that misoperated.
 - Fault appeared to be forward-looking, to the other end that misoperated.
