A Current Story – When Primary Met Secondary

Genardo Corpuz, *Lower Colorado River Authority*
Swagata Das and Ariana Hargrave, *Schweitzer Engineering Laboratories, Inc.*

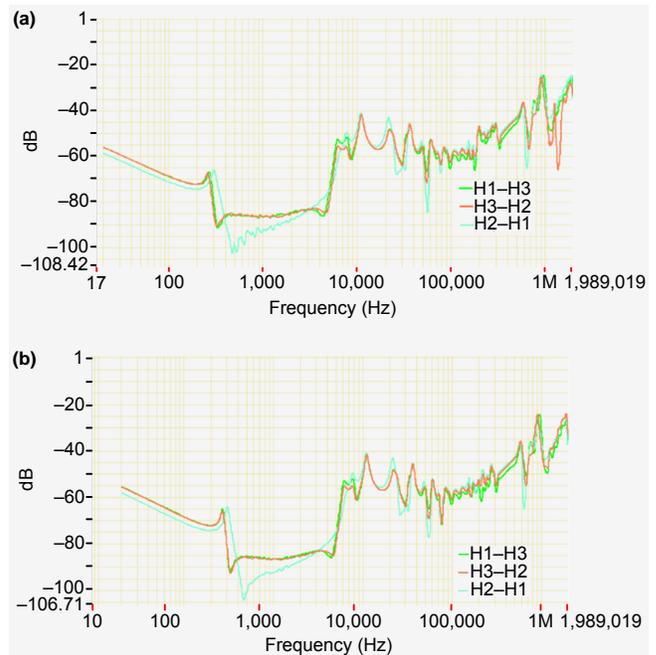
A sweep frequency test assesses the mechanical integrity of the transformer and detects core and winding problems [10]. The test is based on the premise that a transformer winding is nothing but a complex network of distributed resistance, inductance, and capacitance. The resistive-inductive-capacitive (RLC) network produces different output voltages at different frequencies that act as a unique signature. Any deviation of this signature from baseline tests conducted at the factory, during commissioning, or during a regular maintenance cycle provides a strong indication of a problem with the core or the winding. In this event, the sweep frequency test conducted by the utility in 2012 as part of its routine maintenance served as the baseline case and is shown in Fig. 10a. The sweep frequency test conducted after the transformer trip is shown in Fig. 10b. Both traces match and no problem was found.

Fig. 10. Sweep frequency test performed during a maintenance test in 2012 (a) and after the fault in 2015 (b)

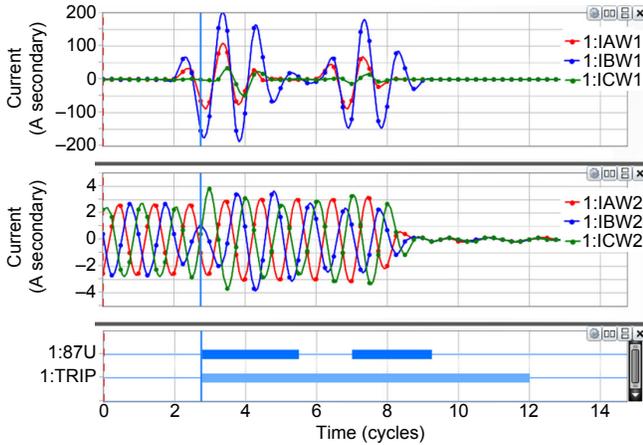
Fig. 18 shows the filtered event report from the transformer differential relay (Relay Y) protecting Transformer T1. The blue vertical line shows when the relay issued a trip on the unrestrained differential element (87U). The event shows that fault current is very high on the high side of the transformer (IAW1, IBW1, and ICW1), with not much change to the currents on the low side (IAW2, IBW2, and ICW2). Because fault current did not pass through the low-side CTs, it can be concluded that the fault was upstream of those CTs.

Fig. 18. Filtered currents on high and low side reported by transformer relay

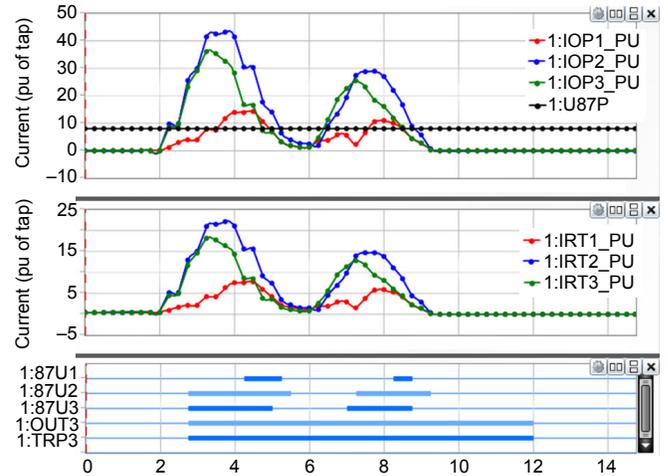
Fig. 19 shows the operate and restraint currents recorded by the transformer relay in per unit (pu) of tap. IOP1_PU and IRT1_PU correspond to the A-phase operate and restraint currents that the relay calculates after it has compensated IAW1 and IAW2 (in Fig. 18) by magnitude and phase angle, as described in Section I. Similarly, IOP2_PU and IRT2_PU correspond to the B-phase and IOP3_PU and IRT3_PU correspond to the C-phase operate and restraint currents. Note that when the fault starts to occur at Cycle 2, both the operate and restraint currents increase. The B-phase and C-phase operate currents soon become higher than the unrestrained element pickup value (U87P) of 8 pu. Unrestrained elements 87U2 and 87U3 assert, and the relay operates. The transformer relay tripped correctly for the increase in operate current that it saw from the fault.

Fig. 19. Operate and restraint quantities from the transformer relay

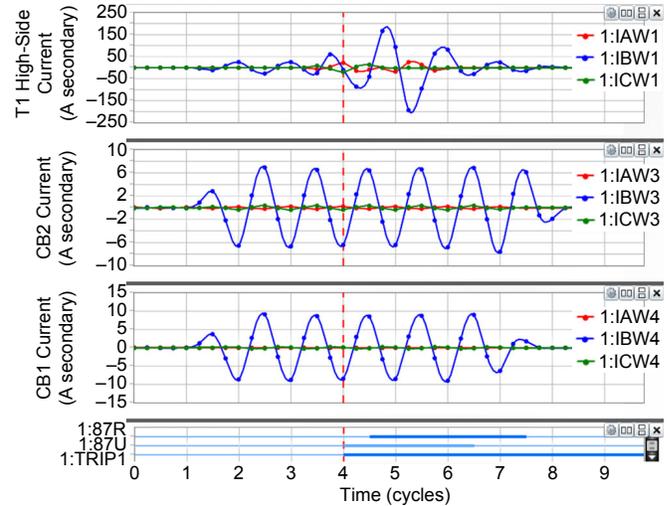
Fig. 21 shows the filtered event report from the low-impedance bus differential relay (Relay X). The dashed red vertical line shows when the relay issued a trip on the unrestrained differential element (87U). The W2 input on the bus relay (corresponding to the high side of Transformer T2) is not shown because it was not a source of fault current throughout the event.

Fault current begins to flow at Cycle 1 of the event. Between Cycle 1 and Cycle 3, B-phase fault current was seen on the W3 and W4 inputs of the relay (corresponding to the incoming transmission lines) as well as the W1 input (corresponding to the high side of Transformer T1). For a true external fault, the currents coming into the zone of protection

Fig. 21. Filtered currents reported by the bus relay

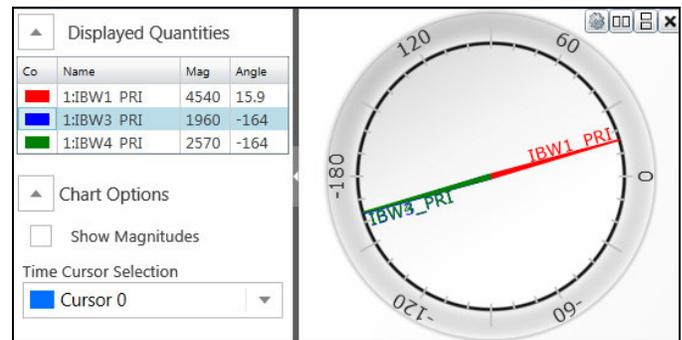
should equal the currents leaving the zone of protection. Fig. 22 shows the B-phase current phasors in primary amperes for W1, W3, and W4 at Cycle 3 of the event. The phasors show that the two incoming feeds (W3 and W4) have the same phase angle, and their sum is equal to and 180 degrees out of phase with the outgoing feed (W1). This is what is expected for an external fault.

Fig. 22. B-phase current phasors in amperes primary reported by the bus relay at Cycle 3

This part of the event can be related to what was going on physically inside of the transformer at the time. This external fault corresponds to the transformer relay CT secondary wiring making initial contact with the primary system. The bus differential relay correctly identified the fault to be outside of its zone of protection and remained secure during these first 3 cycles.

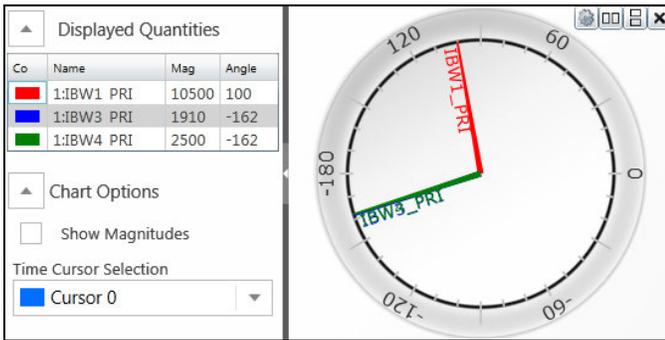
At Cycle 4, the bus relay operated on unrestrained differential. Fig. 20 shows that between Cycles 3 and 4, there is a change in B-phase current on the W1 input (corresponding to the high side of Transformer T1). Fig. 23 shows the B-phase current phasors at Cycle 4 of the event. Note that W3 and W4 still have the same magnitude and phase angle, but because the W1 input changed, their sum is no longer equal to and 180 degrees out of phase with W1. Note also the dramatic increase in W1 current. Because the system is radial, the magnitude of W1 can never be greater than the summation of the W3 and W4 currents for a fault on the system. The fact that this occurred leads us to conclude that the relay could not have been receiving reliable signals, and the CT secondary wiring of the bus relay W1 CT also became involved in the fault.

Fig. 23. B-phase current phasors in amperes primary reported by the bus relay at Cycle 4

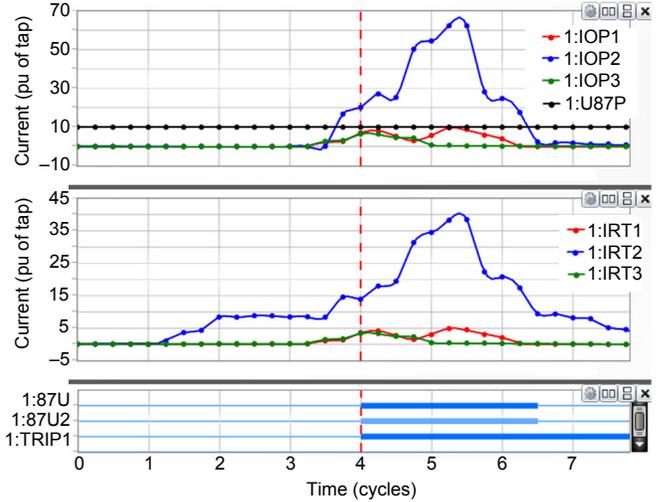
Fig. 25 shows the operate and restraint currents during the event in pu of tap. Note that when the fault starts to occur at Cycle 1, the B-phase restraint current (IRT2) increases, but there is no increase in the B-phase operate current (IOP2). This keeps the relay secure for the external fault. At Cycle 3.5, the fault starts to evolve and the operate current increases dramatically. At Cycle 4, the operate current becomes higher than the unrestrained element pickup value (U87P) of 10 pu, and the relay operates.

Fig. 25. Operate and restraint quantities from the bus relay

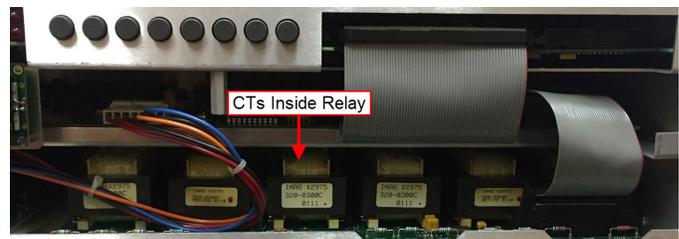
Fig. 27. CTs inside a bus differential relay

Thermal stress can manifest itself in two forms. First, the transformer windings can short together, causing the relay to measure and report an undesired current value proportional to a reduced turns ratio. Second, the leads that connect the internal CTs to the terminal block on the back of the relay can melt. A complete melting of the leads would result in the relay reading no current value on that input. It is possible to detect melted leads with a visual inspection, but knowledge about how to take the relay apart and what to look for is required. An alternative method of verifying the integrity of the internal relay CT circuitry is to perform a metering test. This test validates that the relay is metering within specifications and confirms that no significant thermal damage to the windings or leads has occurred.
