Methods and Benefits to the Application of Ultra-High-Speed Transformer Protection

Roy Moxley, Stefan Nohe, - Siemens

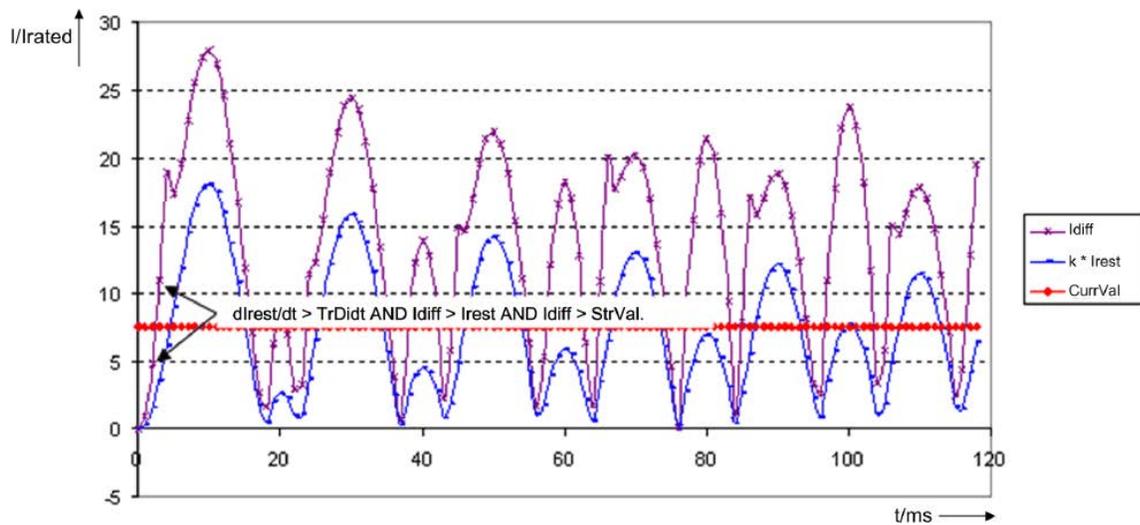
Figure 6. Internal Short Circuit with Transformer Saturation

In both the internal fault of figure 6 and the external fault of figure 7 the differential current goes above the restraint current in the case of a saturated CT. Note however in the case of the internal fault (figure 6.) the differential current is above the restraint current starting at time zero, or practically measured when the current goes above a setting threshold. With a high sampling rate, it is possible to have several samples measured before CT saturation can cause an apparent differential current to go above the restraint.
