# Transmission Interconnection: Lessons learned from a recent event at an acquired Generating Plant.

Michael Jensen and Lokoko Kitenza  
Electric Transmission System Protection  
Pacific Gas and Electric Co. (PG&E)

Previously presented at WPRC, Spokane in Washington in 2016

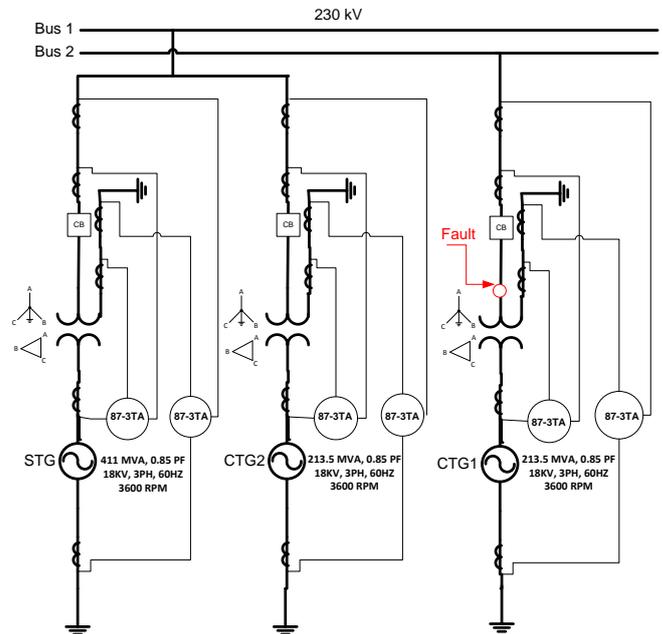
Fig.1 Generation Station Configuration

The CTG1’s Generator transformer’s sustained a C phase bushing flash over. As a consequence, the Generation Station 230/18kV CTG1 Generator Step Up’s (GSU) 230kV breaker correctly tripped on transformer differential operation, and the 230/18kV STG GSU’s 230kV breaker incorrectly tripped on Restricted Earth Fault (REF), also known as the ground differential, causing the loss of one of the CTGs and the Steam generator.

The transformer differential event was a legitimate operation caused by the bank high side single phase bushing flashover. The failed bushing was in the transformer differential protection zone. However, the STG2’s REF element operation was a misoperation. The sensitive ground element operation was not expected given that the fault was out of section for STG2’s sensitive ground relay. The ground differential scheme is not a standard protection for transformer protection at PG&E and it is one of the elements that are not required by NERC PRC-001 for third party interconnection projects. Since the REF operation was a misoperation in this case, we had to investigate further to determine why it operated incorrectly.

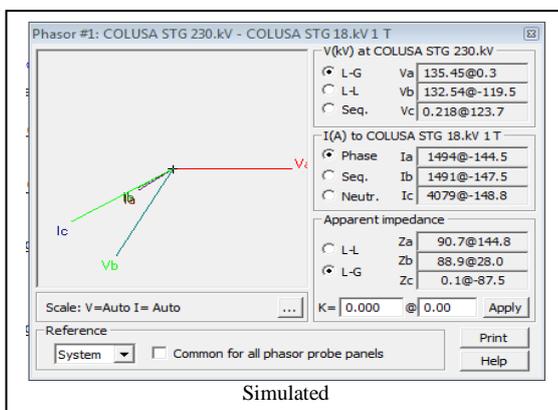
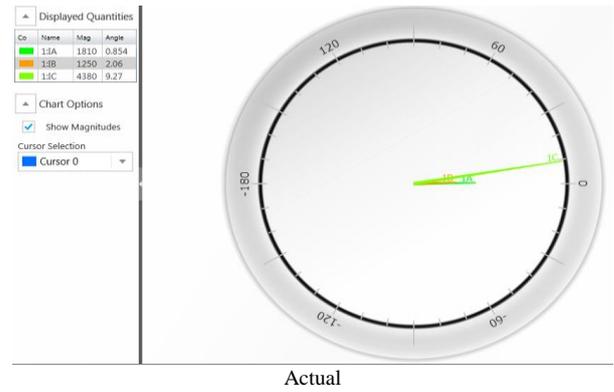
For this event, the operation was incorrect for the STG GSU because:

1. The neutral CT was wired with two separate grounds (one inadvertently left at the outdoor CT cabinet and the other at the relay cabinet in the control building)
2. The phase CT star points were ungrounded for each relay winding contribution

The observation above led the protection Engineers to recommend checking all GSU's differential wiring for both the CTG1 and STG, verify all differential protection settings, and do load and directional checks before the plant goes back online after repairs.
