Case Studies in Analyzing Transformer Installation Faults – Part 1

By Sudipta Maiti, Superintending Engineer (Electrical),

Central Relay and Instrument Testing Laboratory, Damodar Valley Corporation, India.

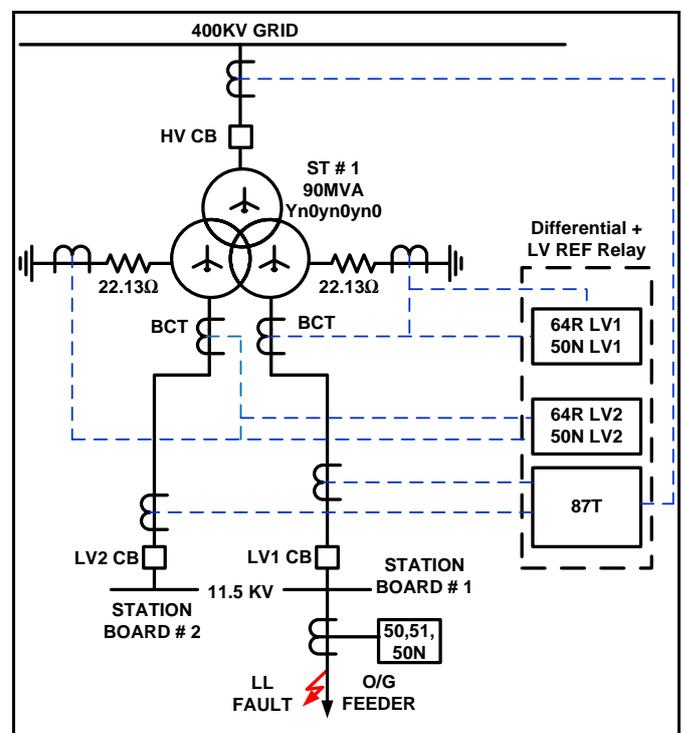
Fig 1.1: Protection One Line Diagram of ST LV REF Protection

It so happened that during a fault in downstream LV board (shown in Fig. 1.1) ST tripped through LV REF protection along with tripping of feeder relay by Hi Set Stage of O/C Protection. **The investigation point was why had LV REF operated and overtripped the ST when the fault was correctly segregated by downstream instantaneous O/C Prot.**

As it was clear that REF relay had performed correctly (tripping instantaneously with the available current), investigation was concentrated on value of Stabilizing Resistance (Rs) value calculation. It was found that the implemented Rs value was only 50Ω.

On enquiring the setting calculation basis sent by the OEM, it was found that the maximum fault current considered for REF Rs calculation was only 300A which was the maximum ground current in the 11KV system as it was grounded with 22.13Ω resistance.

On searching for the reason as to why a PS class had saturated during this fault it was found that the defined Knee Point Voltage [V_k or KPV] for this CT was only 100Volts which was too low. The minimum V_k of CT core to be used in this application should have been twice the maximum voltage developed across the stabilizing resistance in case of full saturation of one phase CT during a 3LG fault = 2*146.21V = 292.42V ≈ 300V. **It was clear that this was a design problem and the OEM designers had later acknowledged that the CT KPV calculations had been based on maximum theoretical 1LG fault current of 300A.**

Any High Impedance REF stabilizing resistance calculation should take into consideration CT saturation during the severest fault conditions i.e. maximum phase fault current among 3LG, 2LG, 1LG and LL faults. Generally Phase Current for 3LG fault or Neutral Current for 1LG faults are the 2 severest currents. So we must take the maximum of the two.

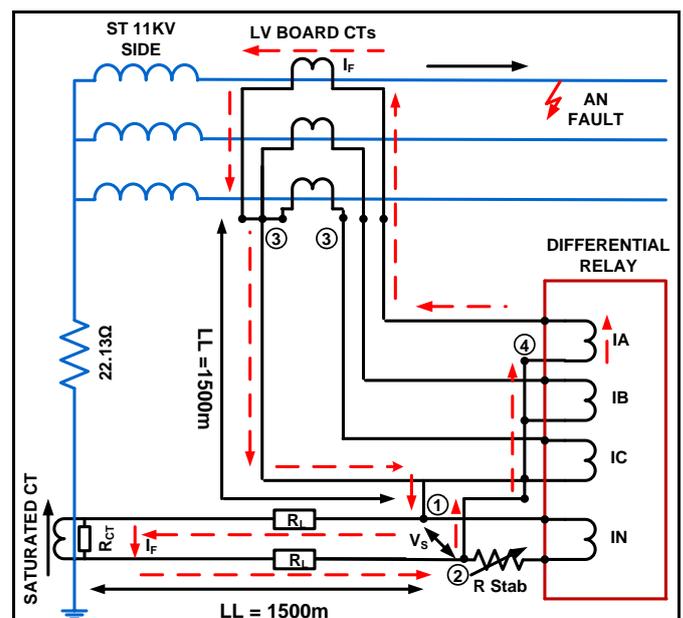
Fig 2.3: Fault Current path in LG fault with NCT saturated.

normally. The fault current path during NCT saturation is depicted in Fig No. 2.3.

If the Phase CT saturates instead of the NCT, the V_s derivation remains the same only the fault current path reverses. Thus Fig. 2.3 is applicable for this scenario too, only with reversed currents and the R_{CT} to be included shall be that of the Phase CT.

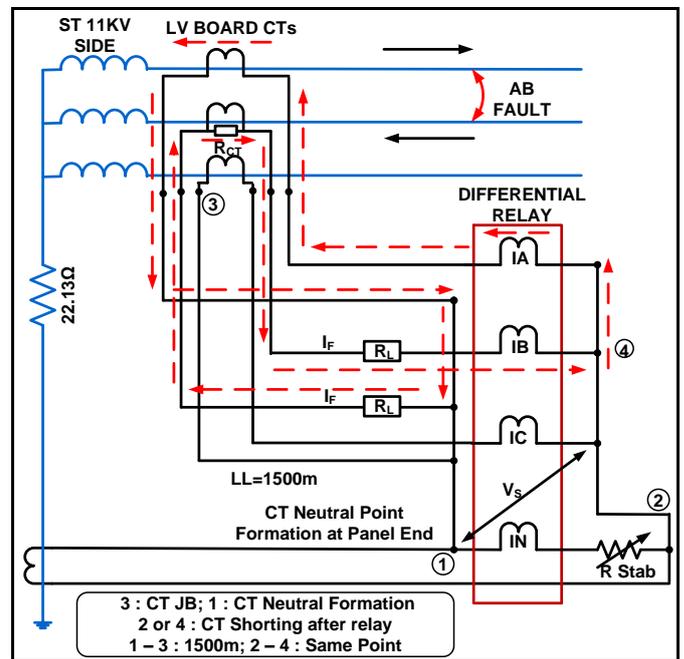
Fig 2.5: Fault Current Path during CT saturation during LL fault if CT Neutral formation is done at Panel End

Had the CT neutral point formation taken place at the panel end instead of at CT JB i.e. 6 wires instead of 4 would have come to the panel end (as shown in Fig 2.5) then the fault current had to traverse twice the lead resistance and V_s calculation would be the conventional $V_s = I_f \cdot (R_{CT} + 2 \cdot R_L)$ during LL or 3LG faults. But creating CT neutral at relay panel end is generally never a practice and in almost all designs the CT neutral is formed at CT JB or transformer marshalling kiosk. Thus such designs have not been considered further.

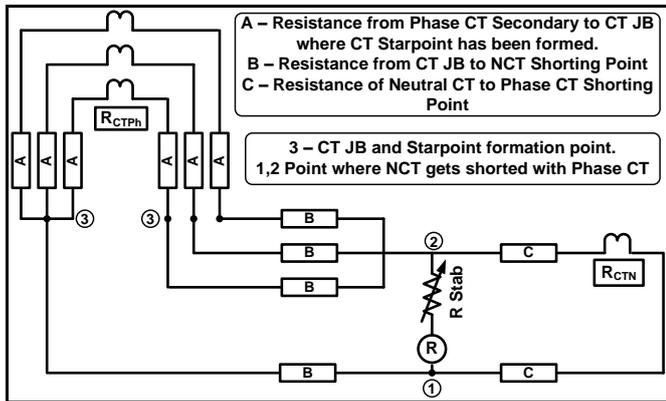
Fig 2.6: Generalized V_s calculation

$V_s = I_f \cdot (R_{CTPh} + 2 \cdot A + B)$ [$I_f = 3LG / LL$ current]

The maximum value of V_s among these 3 scenarios should be taken for Stabilizing Resistance calculations. This generalized derivation should suffice for all varying field scenarios with varying R_{CT} and varying lead lengths. If the R_{CT} across phases is also varying take the maximum R_{CT} for calculations.

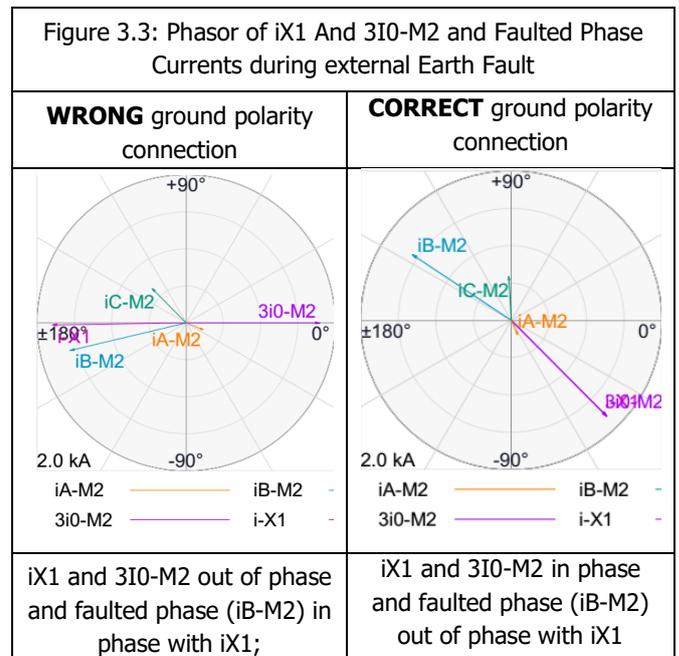
reversing the Ground CT polarity in software was checked and it was found that no reversal has been done in software. On physical inspecting and tracing the ground side and transformer side neutral CT secondary wire it was found to be reversed.

It is known that in all Siemens 7UT Siprotec relays the software calculated zero sequence current ($3I0$) is always shown opposite to actual the vector addition of the three phase currents at that location. **So the thumb rule to understand correct polarity of ground CT during zero sequence stability tests is that $3I0-M2$ (here M2 is Star HV Side) should be cophasal with $iX1$ (Ground Current – HV Side).**

The phasor relationship of $iX1$, $3I0-M2$ and faulted phase current as seen by Siemens 7UT Differential relay during external fault with wrong neutral CT connection vis. a vis. the correct one have been shown in Fig 3.3. This DR reconfirmed the fact that the root cause analysis of the event was correct.

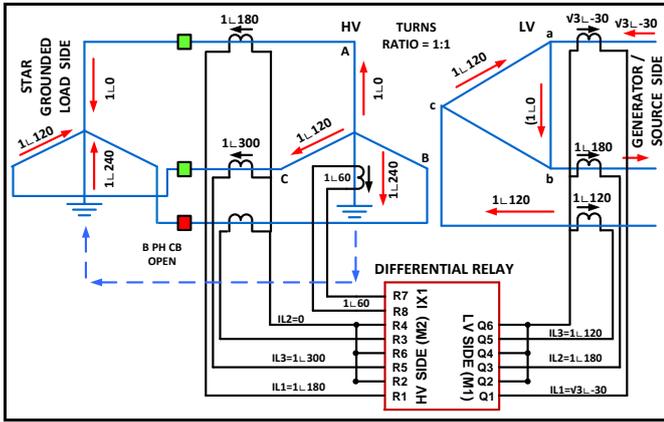
Fig. No. 4.2: Theoretical Current Phase Angle during Y Pole OPEN conditions in GT HV Side.

- Currents at relay terminals: $IL1_{HV}=1L180^\circ$; $IL2_{HV}=0$; $IL3_{HV}=1L300^\circ$ and $iX1=1L60^\circ$. Thus $3I_0-M2 = \sqrt{3}L300^\circ$ ($\sqrt{3}L60^\circ$ i.e co-phasal with $iX1$ for Siemens 7UT). Taking $IL1_{HV}$ as reference the currents are re-written as $IL1_{HV}=1L0^\circ$; $IL3_{HV}=1L120^\circ$ and $iX1=1L240^\circ$.
- CONCLUSION: The ground current during one pole open conditions is of opposite polarity in the relay to that of pre-fault current of the opened pole.**

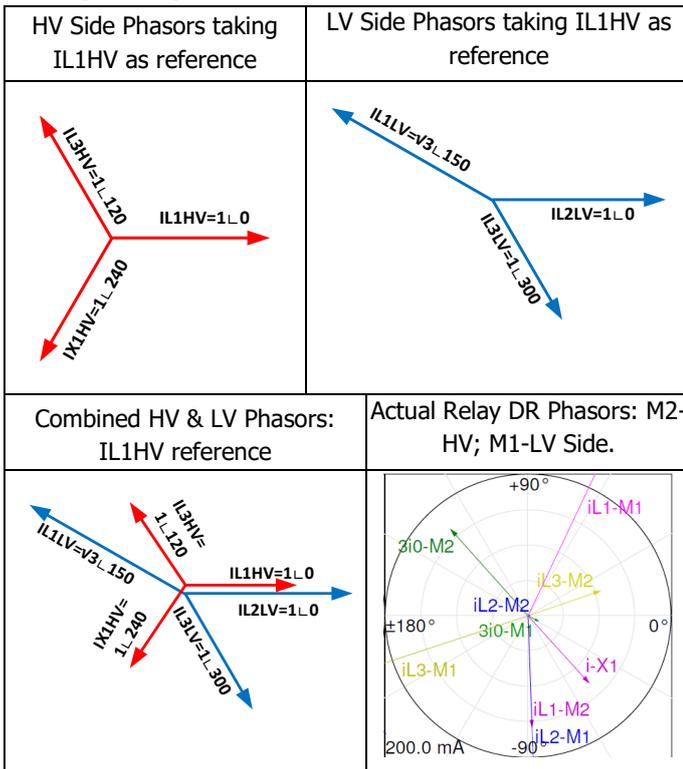
- Note that $IL3_{HV}$ and $IL3_{LV}$ are 180° apart and $IL1_{LV}$ leads $IL1_{HV}$ by 150° in the theoretical phasor. The actual DR phasor also confirms all these derivations.
- We see in the DR that $iX1$ as measured by relay is opposite to the pre fault B pole current thus proving that the ground CT polarity has been reversed. On tracing the wires the predicted mistake was proved.

The ground CT wires were reversed and the Generator was put into service.

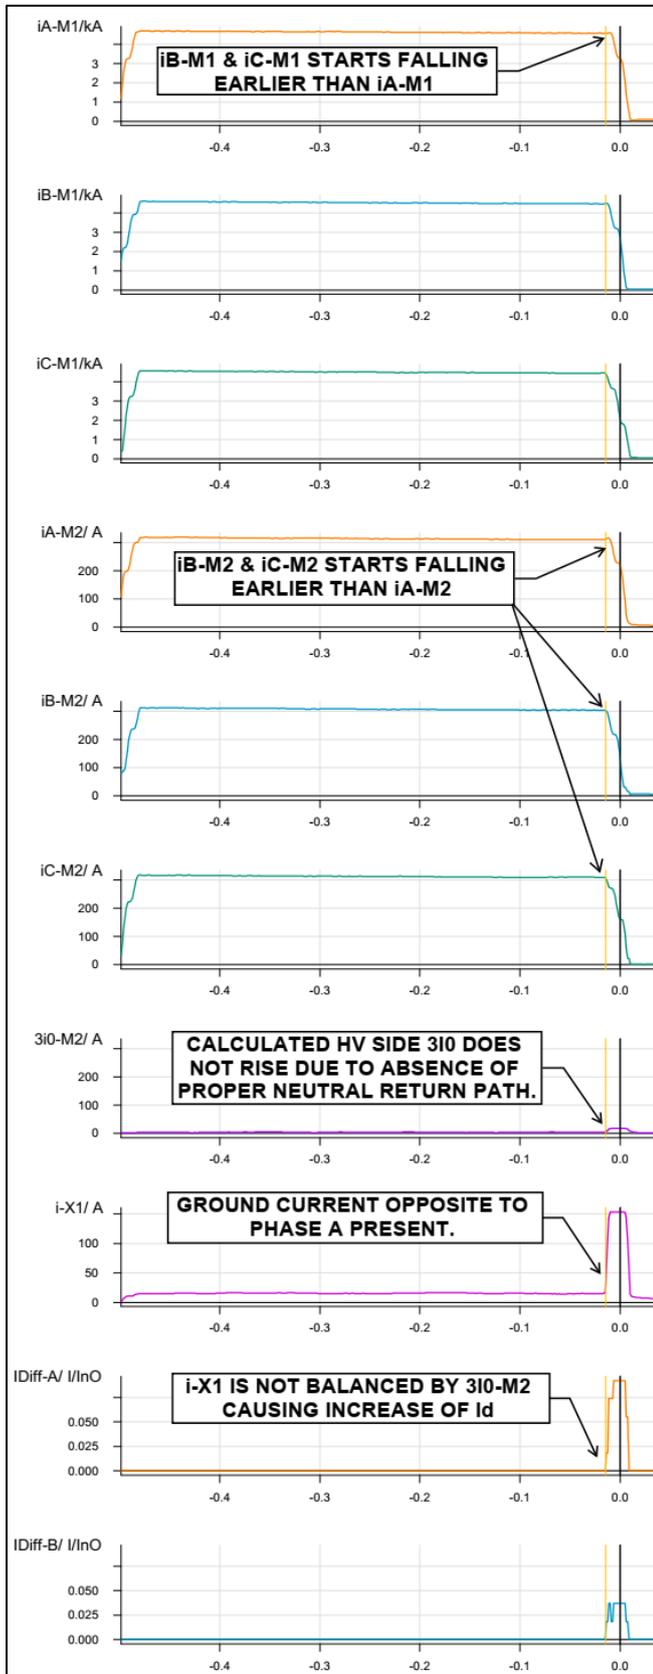
Figure No. 5.4 DR waveforms of fourth tripping.

But in DR we see no rise in 3I0-M2. **It appears that as the zero sequence current is quite small in this case the driving voltage from CT is not high enough to drive the CT secondary current through the loosely connected neutral return.** We observe the difference of this case with that of Case Study # 4. There in a similar situation we had relay calculated 3I0-M2 exactly matching the ground current iX1.

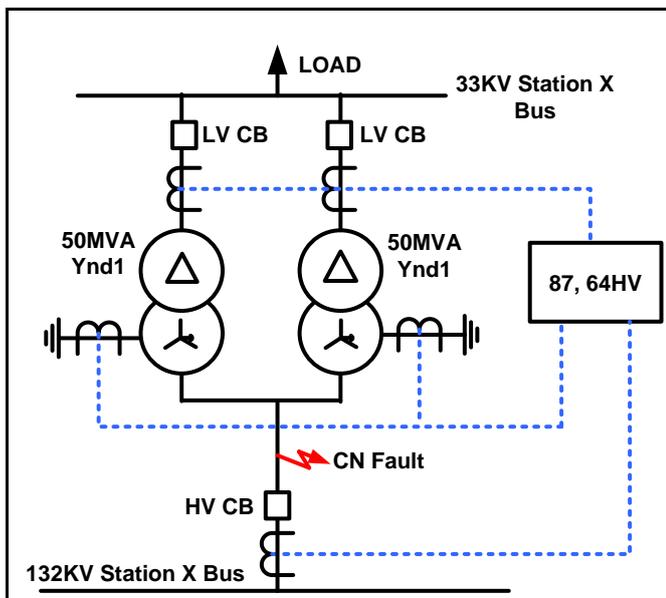
Fig 7.1: Protection Single Line Diagram

BRIEF HISTORY: It was reported that at Substation 'X' power transformer 2 & 3 had tripped through Differential protection. Here the Low Impedance REF of HV side [64R] & Differential Protection [87] was given from the same CT core. As the fault was found to be on HV side within the REF zone and 87 protection had detected the fault correctly and with the REF protection processing the same currents it would be expected that REF should have operated. The unanswered question thus was why was REF protection unresponsive to this fault?

The peculiarity of this installation was that there were two transformers with only one Differential & REF relay the reason being only one bay was available on the HV side. Basically instead of augmenting one 50MVA transformer by a 100MVA one, two 50MVA transformers with similar percentage impedances had been connected in parallel to cater additional load. On LV side there were two bays having two separate sets of CT and breakers but on HV side the paralleling was done by jumpering at primary level and there was only one CT available. The LV Phase CT and HV neutral CT wiring had been paralleled before entering the 87/64HV relay as two separate sets were available.
