Finding Common Ground: A Case Study of Phantom Currents and Ground Loops

Matthew Boecker and Genardo Corpuz, *Lower Colorado River Authority*
 Jared Candelaria and Ariana Hargrave, *Schweitzer Engineering Laboratories, Inc.*

Abstract—In February of 2018, a current differential relay protecting a 138 kV/69 kV autotransformer tripped for an out-of-zone ground fault. System conditions were such that the low side of the autotransformer was open, but the relay event reports showed fault currents present on the low side. Initial investigation hinted at a current transformer (CT) secondary circuit problem (the CT, cable wiring, or relay input), and three more faults that occurred the following week helped narrow it down. This paper describes the investigation into these faults, how root cause was found, and how ground potential rise can cause phantom currents to flow in relay CT circuits.

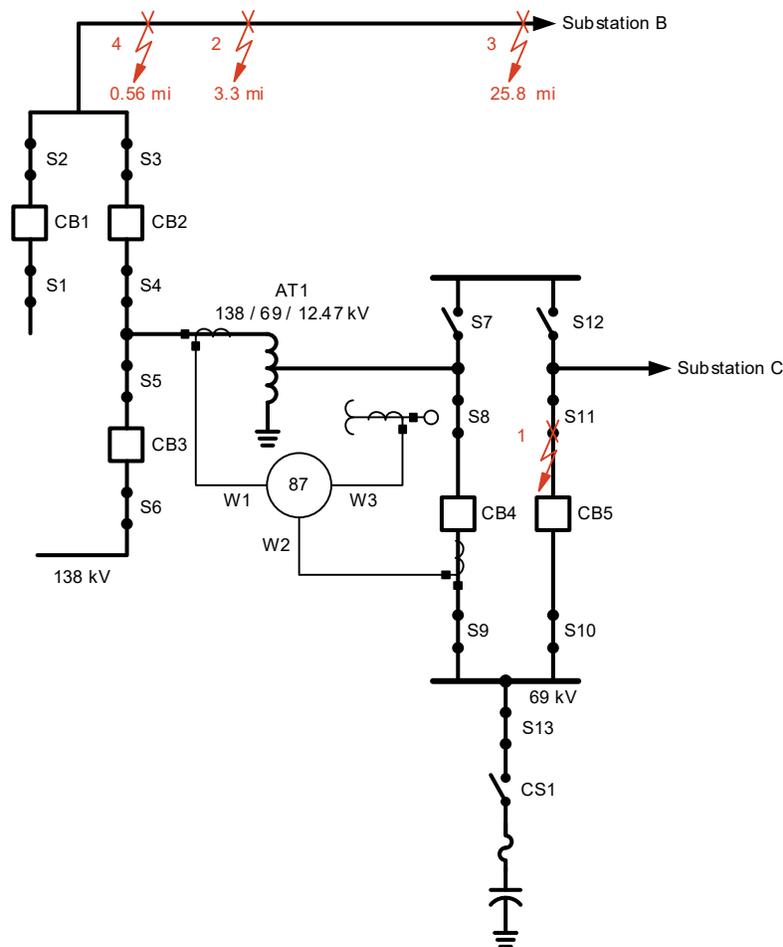
Fig. 4. One-line diagram of Substation A.

The one-line diagram of Substation A and the system configuration at the time of the event are shown in Fig. 4. The transformer shown is a 138 kV/69 kV/12.47 kV wye-wye-delta (YYD) grounded autotransformer, with the delta tertiary used for station service. Circuit Breaker CB5, Circuit Switcher CS1, and Switches S7 and S12 were all open, effectively open-circuiting the load side of the transformer. A microprocessor-based current differential relay was protecting the transformer.

The first fault occurred on February 14 at 3:34 a.m. It was an AG fault on Switch S11 on the line side of the open circuit breaker, CB5. Fig. 5 shows the switch, where a flashover to the structure caused the switch to break away from the insulator. The location on the system is shown as Fault Location 1 in Fig. 4. Even though this fault was clearly not in the transformer relay's zone of protection, the relay tripped on the C-phase percentage-restrained differential element. The 138 kV circuit breakers (CB2 and CB3) and the 69 kV circuit breaker (CB4) opened in response.

One week later, on February 20 at 11:55 p.m., a BG fault occurred on the 138 kV transmission line going to Substation B, 3.3 miles from Substation A. Operations noted that the probable cause of the event was the presence of lightning storms in the area. Crews inspected the line and found no evidence of a fault. The system configuration at this time was the same as it had been when the first fault occurred, as shown in Fig. 4. The second fault was located at Fault Location 2. The transformer relay again tripped on the C-phase percentage-restrained differential element.

Before any testing could be performed, the power system delivered another surprise. The next day, on February 21 at 9:56 a.m., a CG fault occurred on the 138 kV transmission line going to Substation B, 25.8 miles from Substation A. This is shown as Fault Location 3 in Fig. 4. This time, the transformer was completely isolated from the system with Breakers CB2, CB3, CB4, and CB5 all open. Operations again attributed the fault to lightning in the area, since no physical evidence of a fault was found. Although the line relay operated for this fault, the transformer relay did not trip.

Later that same day, at 12:58 p.m., a CAG fault occurred on the 138 kV transmission line going to Substation B, 0.56 miles from Substation A. This fault was also attributed to lightning in the area and is shown as Fault Location 4 in Fig. 4. The A-, B-, and C-phase differential elements all asserted and caused the transformer relay to trip.

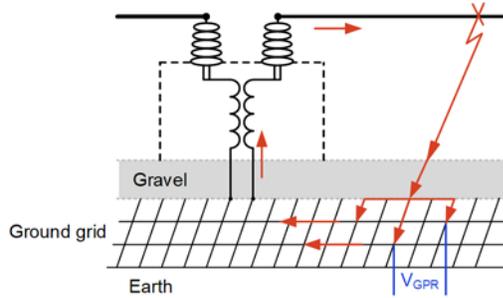
Fig. 9. Ground current flow during a ground fault causes GPR at a substation.

When ground faults occur, the zero-sequence current returns to the source through the earth, as well as through other paths such as neutral conductors, overhead ground wires, and cable shields. The total zero-sequence current splits between the earth and these alternate paths [3] [4]. When a fault occurs near a substation, a large amount of current flows through the station ground grid. Because the ground grid has some impedance, the zero-sequence current flowing through it causes a voltage to develop across the grid. This is known as ground potential rise (GPR) and is illustrated in Fig. 9. IEEE 80 defines GPR as:

The GPR voltage only defines the maximum voltage possible. The voltage will drop across the substation ground grid, resulting in a gradient of different voltages at different points on the grid, as illustrated in Fig. 9.

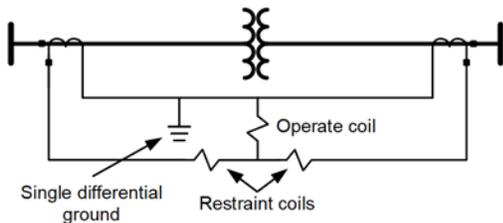
Fig. 15. Electromechanical differential relay connection diagram.

In electromechanical differential relays, all CTs associated with the differential relay had to share a single ground. The reason for this was due to the electromechanical relay sharing operate and restraint coils between all the connected CTs on a single phase. This caused the CTs to be electrically connected inside the relay, as shown in Fig. 15. Grounding each CT individually would cause multiple grounds in the differential circuit, which, as we have seen, can cause undesired current to flow through the relay and result in misoperations.

In modern microprocessor-based differential relays, each set of CT inputs is isolated from one another. Because they are no longer electrically connected, each CT circuit can be grounded individually. Individual grounding of CT circuits is preferred for multiple reasons. First, the insulation integrity test described in Section VIII yields more accurate results when measuring a single circuit versus multiple circuits in parallel. Second, with each CT circuit grounded individually, the possibility of having a design error with a ground at each location where a CT cable lands on a panel is minimized.
