# A Troubleshooting Methodology for Issues Discovered During End-to-End Testing

Jose R. Garza

*Transmission Field Services – P&C Tech Support Engineering*  
*American Electric Power*  
Corpus Christi, TX  
jrgarza3@aep.com

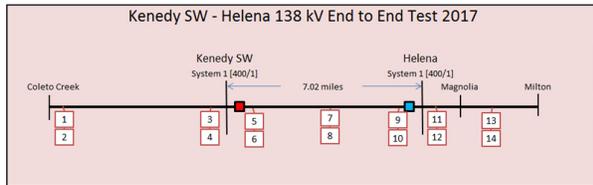
Fig. 8. Kenedy SW – Helena online and simulated fault locations

Field personnel at each end performed no-comm testing on System 1 and found no errors. Comm testing was then performed and identified issues at the Kenedy SW end. The

POTT scheme at Kenedy SW was overreaching for phase faults, and not operating at all for ground faults.

The issue of the POTT failure on ground faults pointed to an issue with the TRCOMM logic equation @Kenedy. The equation was set for the Zone 2 ground distance element.

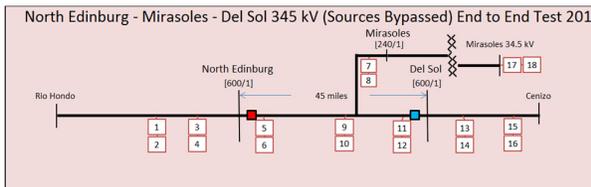
Fig. 20. North Edinburg – Mirasoles – Del Sol online and simulated fault locations

Testing began on the System 1 fiber current differential relaying. Field personnel elected to run communications testing before no-comm testing, and chose to start with faults behind each terminal. During testing, all three terminals tripped on differential for faults at locations 3, 14, 17.

Due to the relay records arriving at different times, each record was compared to the test plan applied currents as they were received. Comparing analog values confirmed that there were no rolled leads or improperly applied analogs at any of the three stations.

At this point, the test plan was confirmed not to have any errors, the settings were found to be correct, and relay records confirmed no errors in application by field personnel. Tests 3, 14, and 17 were run again to verify improper operation, and again tripped on differential. Since the test plan and settings were correct, efforts were focused on a yet un-explained cause in the field. With events from all three stations available, they were time-synced and examined for any irregularities.
