# American Electric Power's Experience with Protection System Misoperations and Improvements

75<sup>th</sup> Annual Conference for Protective Relay Engineers

## AEP Misop Event of 1/26/2022

# AEP Fifth Avenue Mobile Misop

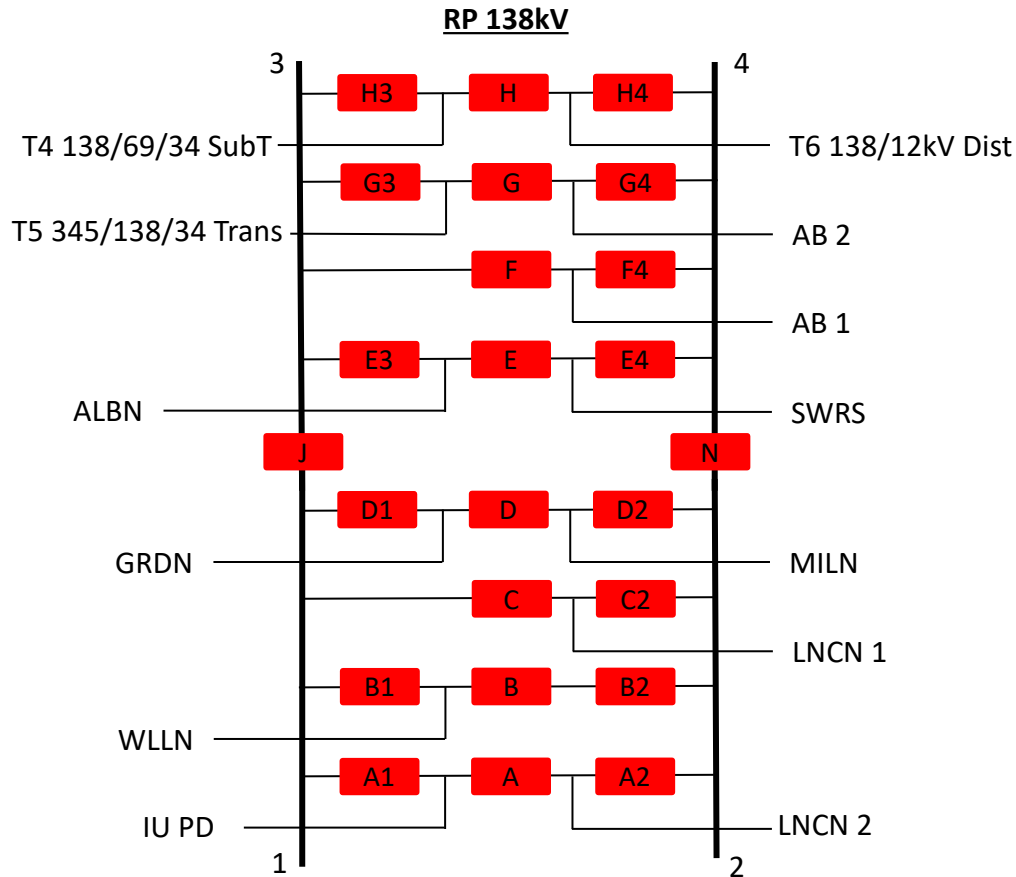
# Pre-fault Configuration

- 138kV RP Station
- System Normal
- CB-E3 is the fault location
- 5 – 345kV circuits on highside of T5
- 10 – 138kV circuits
- 4 – 138kV Bus zones
- Transformers
  - Trans = Transmission Auto
  - Dist = Distribution 2-Winding
  - SubT = Sub-Transmission Auto

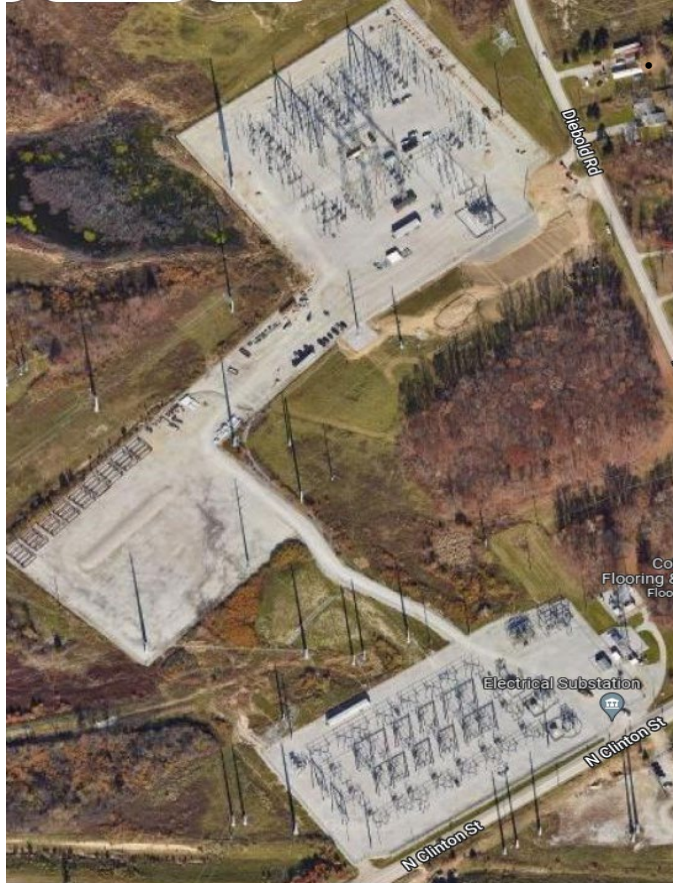
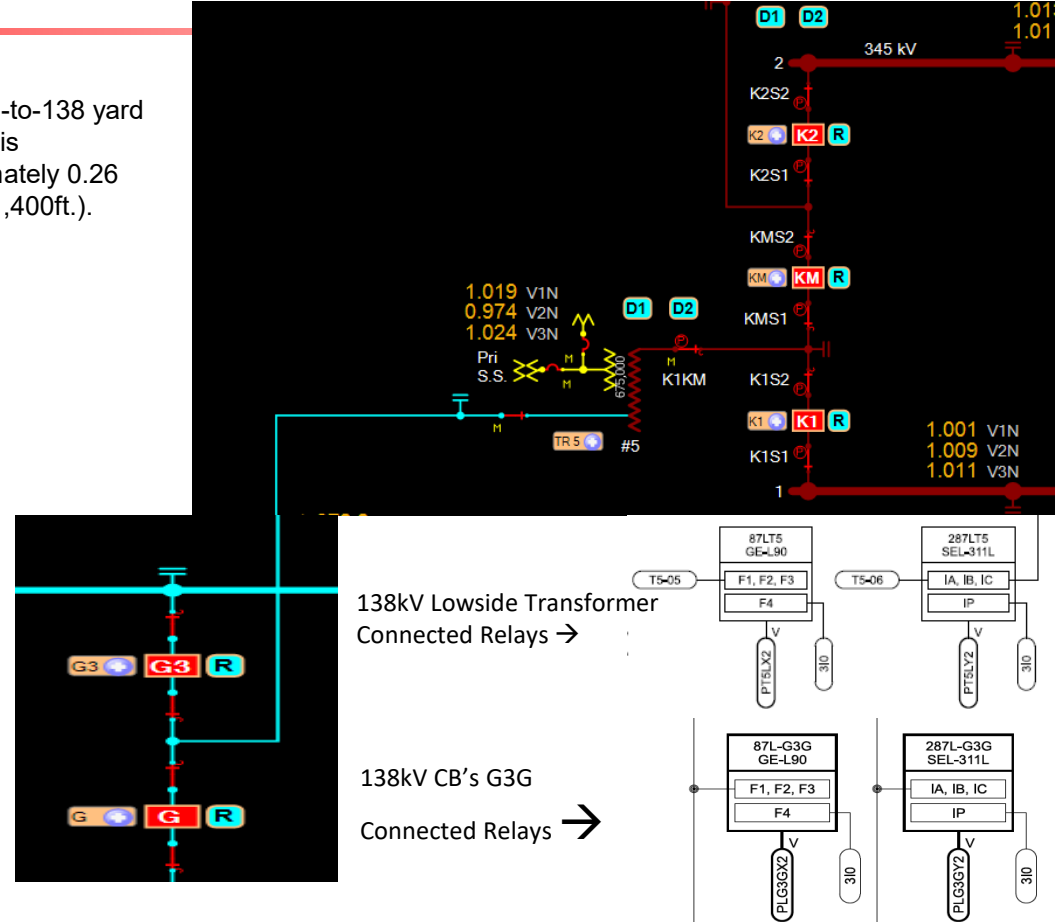
# RP T5 Layout

345 Yard-to-138 yard distance is approximately 0.26 miles (~1,400ft.).

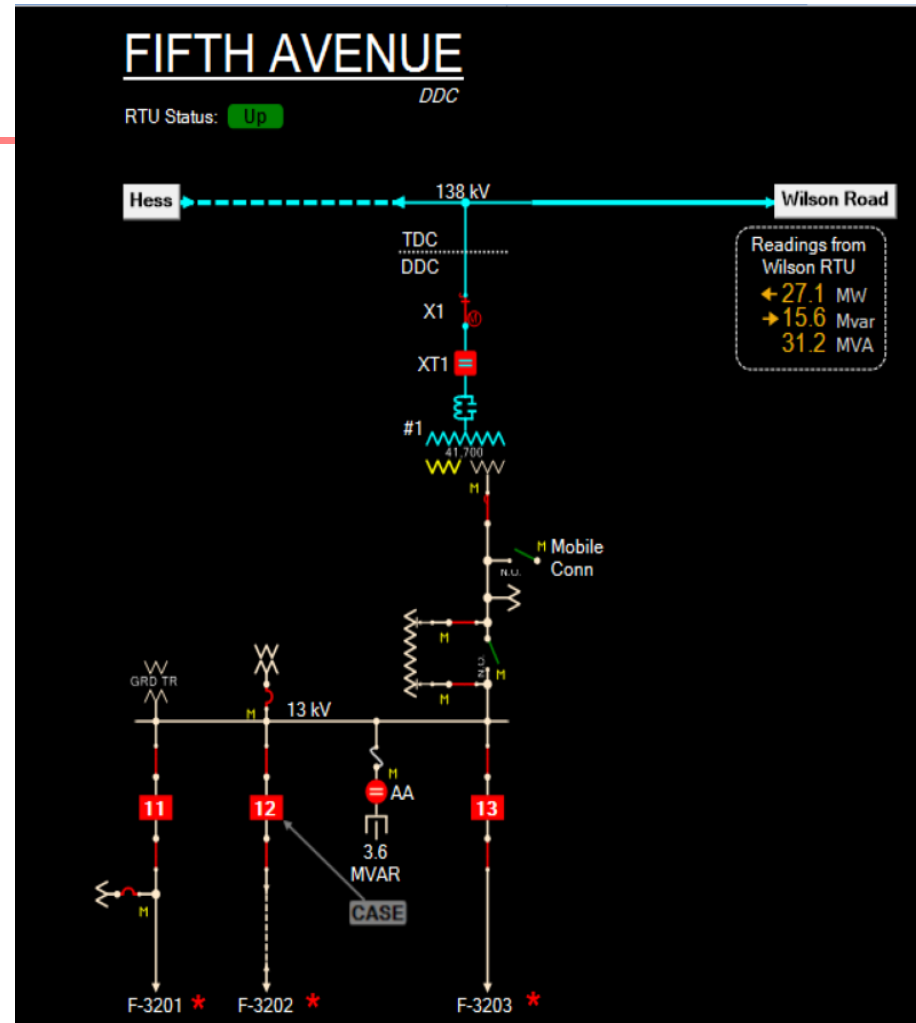
- TFS needed to do XF maintenance, so a mobile unit was required
- Not your typical distribution XF (it is a wye-grounded high side / delta low side)
- Since delta low side, a grounding XF is required
- To keep things in phase with the existing XF, mobile CSP-9 was selected since it is an auto XF with the same vectors
- Mobile CSP-9 is very modern and is outfitted with all new IED relays

- Mobile had been commissioned and was in service for a few days, but then tripped out via its SEL-787 XF diff for a 1LG feeder fault (out of zone fault)
- During commissioning, no differential current was present on the SEL-787 while doing final load checks

- The two non-faulted feeder circuits were tripped and locked out along with the feeder that actually had the fault on it
- Since mobile CSP-9 didn't include a high side interrupting device (only ground switch/MOAB) the remote 138kV terminals were also tripped

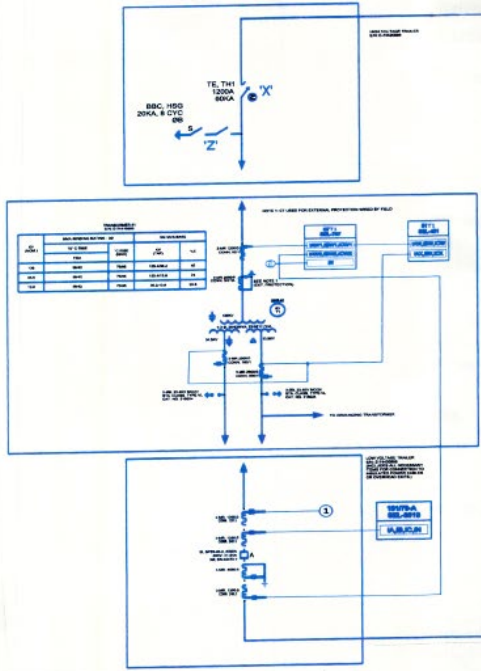
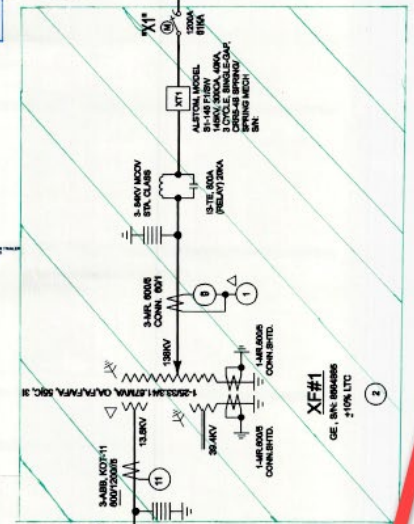
# CSP-9

Plan was to re-use the existing GND XF
