A Tale of Two Out-of-Phase Synchronizing Events at BC Hydro

Mukesh Nagpal and Lesley Gu, *BC Hydro*
 Ralph Barone, *Barone Technical Consulting Services Ltd*
 Ritwik Chowdhury and Michael Thompson, *Schweitzer Engineering Laboratories, Inc.*

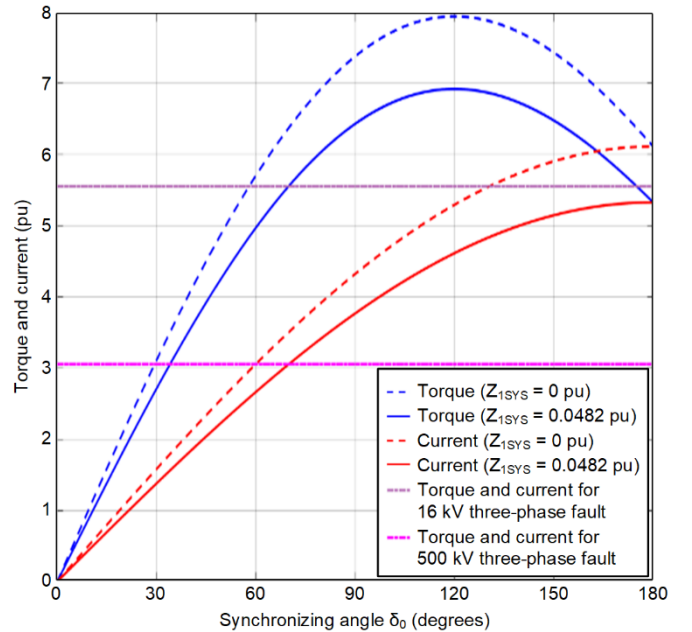
Fig. 6. Torque and current for a three-phase fault at generator terminals and for OOPS events versus synchronizing angle.

The torque and currents for the different synchronizing angles for this system and for an infinitely strong system are shown in Fig. 6. As in the system featured in this paper, power systems are usually much stronger than the impedances presented by the generator and the GSU. This makes it so that in most installations, the torque and currents for an OOPS event are primarily limited by the generator and GSU impedances. The torques and currents in Fig. 6 do not consider the unit's saliency. However, the difference is not significant enough—less than 5 percent torque difference and about 10 percent current difference for our application—to justify the added complexity that would be associated with a revision of these equations. It can also be observed from (1) and (2) and Fig. 6 that the anticipated maximum electromagnetic torque and current are experienced when the synchronizing angles are 120 degrees and 180 degrees, respectively.

A current of 1 pu in Fig. 6 corresponds to 19 kA at the LV (16 kV) level (see Table I) or 593 A at the HV (512.5 kV) level. For comparison, a three-phase fault on the 500 kV bus results in both a torque and current of 3.06 pu. In this system, an OOPS with a δ_0 of about 34 degrees and an OOPS with a δ_0 of about 70 degrees result in similar torque and current levels as a three-phase fault on the 500 kV bus, respectively.

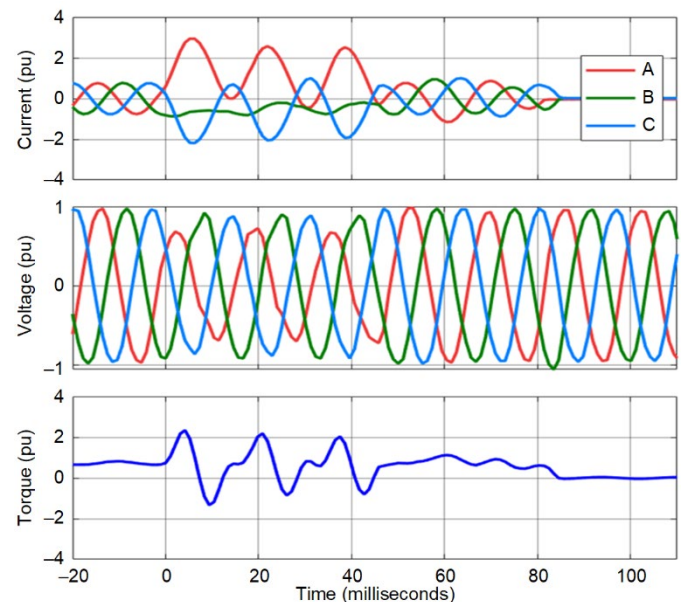
Fig. 10. External CAG fault that occurred 91 kilometers (56.5 miles) from the generating plant.

The event report and the calculated torque in per-unit quantities for the CAG fault are shown in Fig. 10.

An important and relevant characteristic of the fault shown in Fig. 10 is that, unlike most faults (which occur near a voltage peak), this fault occurred near a zero-crossing of the fault loop voltage, V_{CA} . Because of the point-on-wave of fault inception, the faulted phase currents had a very high dc offset. This high dc can contribute to delayed zero-crossings and is a much more important consideration for OOPS events. This is discussed further in Section IV.

The near loss of zero-crossings on the faulted phases and the actual loss of zero-crossings on the unfaulted phase was also evident from the field event of the external CAG fault (Fig. 10) that had significant dc offset in the currents. The point-on-wave of fault inception made it so that the dc offset of the A-phase fault current had the same polarity as the load. That fault was 91 kilometers (56.5 miles) away, which reduced the X/R ratio and the dc time constant of the fault current. If the fault were closer, it is possible that the current could have had delayed zero-crossings.

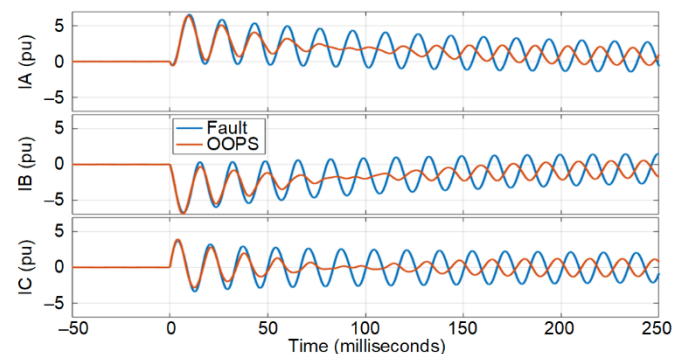
Fig. 17. Behavior of zero-crossings during three-phase fault and 60-degree OOPS simulation.

The delayed zero-crossings phenomenon for OOPS events has been discussed in previous literature [3] [4] and is much more severe than it is for external faults. This is illustrated in Fig. 17, which shows a comparison of a simulated three-phase fault at the GSU HV terminals and an equivalent 60-degree OOPS simulated event that has a similar current envelope (because they have the same voltage difference). For the three-phase fault, the ac current magnitude reduces during the event. This is because of the gradual transition from subtransient to transient reactance, which makes it nearly lose zero-crossings.

For an OOPS event like the one shown in Fig. 17, the decaying ac component associated with the transition from subtransient to transient reactance, as for an external fault, still exists. Additionally, as the rotor pulls in with the system, the voltage difference between the generator and the system decreases relatively quickly. This reduced voltage difference lowers the ac component of the fault current further, increasing the likelihood of delayed zero-crossings [4].

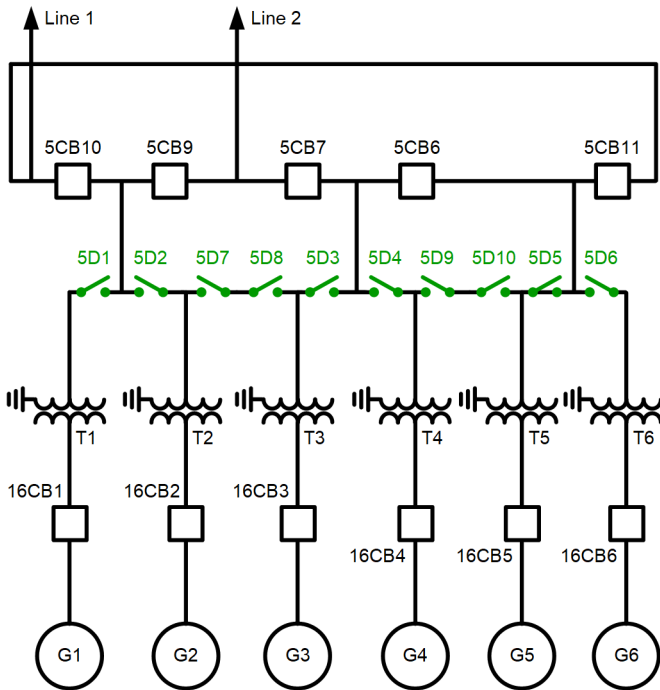
Fig. 20. One-line diagram showing switches that add plant operational flexibility.

The one-line diagram in Fig. 1 is simplified and does not show the many disconnect switches that add operational flexibility at this plant. These switches are shown in green in Fig. 20. For instance, depending on the position of the switches, 5CB6 and 5CB7 might no longer synchronize G3 and G4, but could synchronize any other generator. The presence of these switches can add significant scheme complexity, because their status requires consideration before the appropriate unit generator breaker is tripped. Furthermore, the generators might have different parameters that could impact the 50H pickup setting. For a plant with such operational flexibility, the scheme of Fig. 19 would require some additional complexity, as described in the next paragraph. However, this scheme can be an excellent choice for plants with no unit generator breaker and a dual-breaker bus configuration.

A solution for the application shown in Fig. 20 should not rely on problem-prone topology tracking of the configuration switches. One proposed solution is for the 500 kV breaker OOPS relays to send the trip to each generator relay. The generator relay would then only pass on the trip to its breaker if the generator were energized and carrying no real or reactive load before the event. This would indicate that the generator is

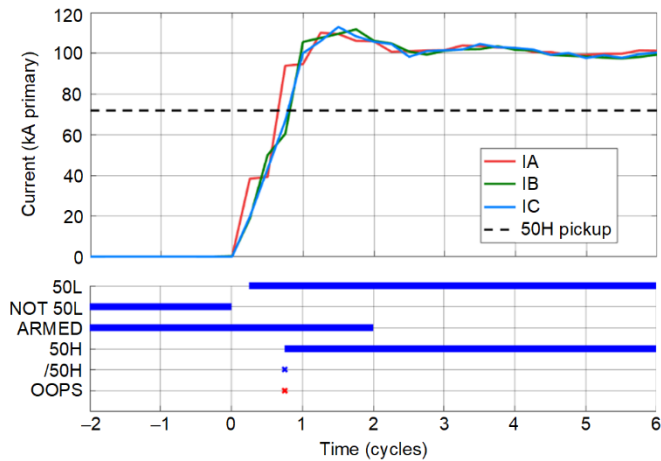
Fig. 22. Dependability of OOPS scheme for 180-degree OOPS event.

The dependability of the scheme of Fig. 21 for the second OOPS event is shown in Fig. 22. The 50L pickup is set to 2 percent of the generator rated current, the 50L arming timer dropout is selected as 2 cycles, and the 50H pickup is set to 120 percent of the generator contribution to a three-phase fault on the high-side of the GSU, which is 70 kA (equal to $1.2 \cdot 3.06 \cdot 19$ kA). It is clear that the element is dependable for the 180-degree OOPS event and, based on the analysis from Section III.A, it would remain dependable for events with a synchronizing angle greater than 80 degrees.

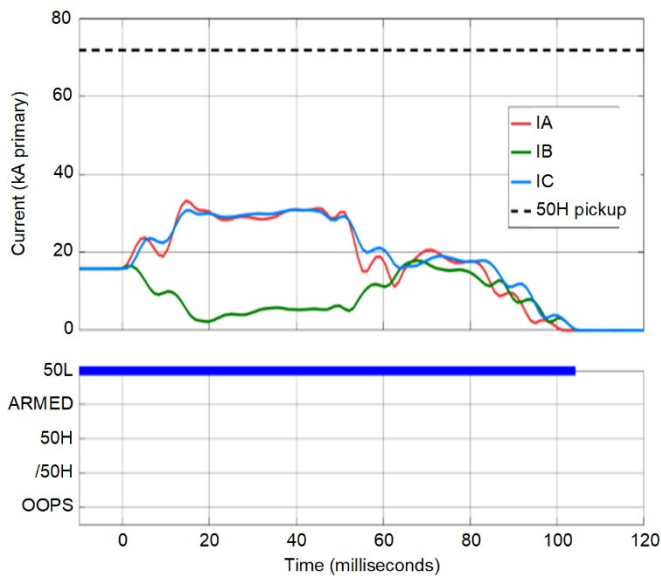
Fig. 23. Security of OOPS scheme for external multiphase fault.

The security of the scheme for the external multiphase fault of Fig. 10 is shown in Fig. 23. The element does not remain armed because of the load current asserting 50L. Even if the element were armed, the fault current is not high enough to assert 50H, which is set to remain secure for a bolted three-phase fault at the GSU 500 kV terminals. Infeed and fault resistance further reduce the fault current so that the element is at no risk of a misoperation.
