Electromechanical Differential Relays Misoperation and Investigation. Part 2.

Alex Rangel, *Saber Power Services*

Abstract— In January 2022, an industrial site had a partial blackout due to an improper operation of one of its main electromechanical differential relays. The system was being upgraded and reconfigured, and a mistake was introduced during the demolition process. This paper describes the investigation into the nuisance trip and how careful demolition could have prevented this issue.

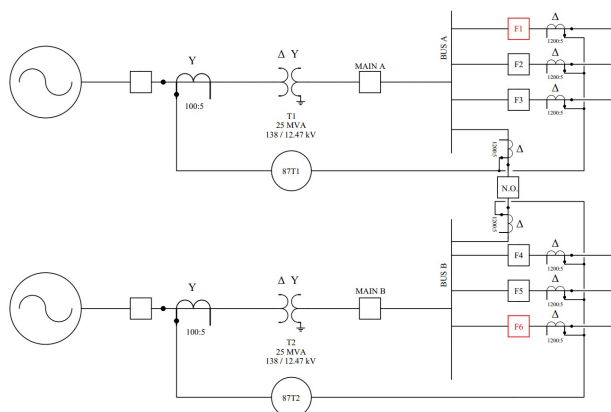
Fig. 1a. One line diagram, existing system (simplified)

This industrial site feeds several large loads. However, the load of interest in this paper is a large motor fed mainly by feeder F1, which can be alternatively fed by feeder F6. Figures 1a and 1b show the one-line diagram of the electrical system feeding the industrial site, as well as the configuration of feeders F1 and F6 feeding the motor of interest.

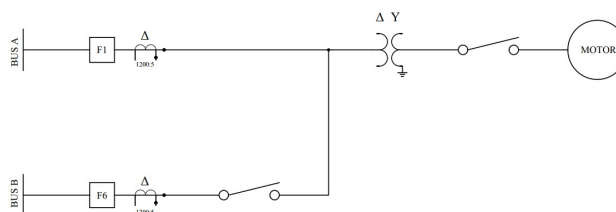
Fig. 1b. One line diagram, large motor fed through breakers F1 or F6 (simplified)

On January 13, 2022, the industrial site experienced a nuisance trip while performing startup of the motor shown in Figure 1b. The sequence of events is the following:

- The motor was running and it was stopped as part of the site's procedures
- Field personnel attempted a motor start through feeder F1. Relay 87T1 operated, taking Bus A out of service.

- Field personnel performed switching to the B-side (feeder F6). They attempted a motor start through feeder F6 and the motor started and remained in service.

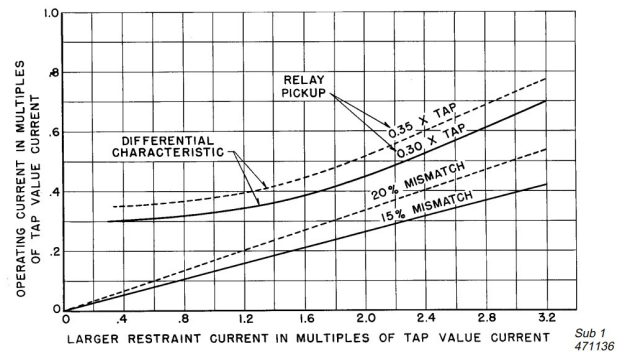
Fig. 5. Differential characteristic per the manufacturer's instruction manual [1]

The differential characteristic curve mentioned above is shown in Figure 5. The restraint current is plotted in the x-axis, while the operate current is plotted in the y-axis. If the resulting plot is below the curve, the relay will restrain, and if the plot is above the curve, the relay will trip. This curve will be used in the scenarios in the next section.

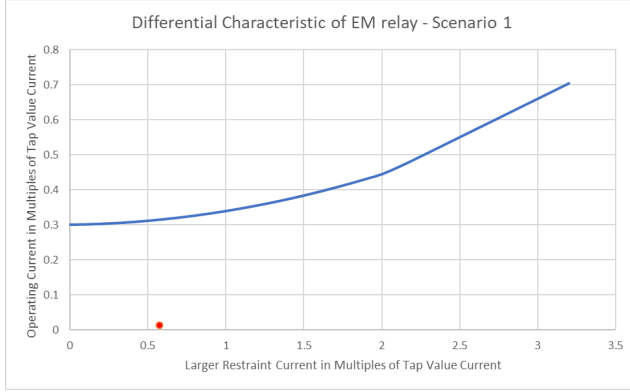
Fig. 6. Differential characteristic for scenario 1

Scenario 1. According to field personnel, the motor produces approximately 400 A of inrush current on the 12.47 kV side, which is 36.1 A on the 138 kV side. Assuming that no other load is energized on Bus A, the restraint current is ~0.5 pu on each side of the transformer, while the operate current is very close the 0.

Note: Because the CTs on the secondary side are delta-connected, it is necessary to introduce a multiple of $\sqrt{3}$ on restraint current #2. Figure 6 shows the largest restraint and operate current plotted on the differential characteristic used by the 87T1 relay in scenario 1.

$$I_{RT_1(pu)} = \frac{I_{138kV}}{CT_{W1} * TAP_1} = \frac{36.1}{20 * 3.2} = 0.564 pu \quad (1.1)$$

$$I_{RT_2(pu)} = \frac{I_{12.47kV} * \sqrt{3}}{CT_{W2} * TAP_2} = \frac{400 * 1.732}{240 * 5} = 0.577 pu \quad (1.2)$$

$$I_{OP(pu)} = |I_{RT_1(pu)} - I_{RT_2(pu)}| = |0.564 - 0.577| = 0.013 pu \quad (1.3)$$

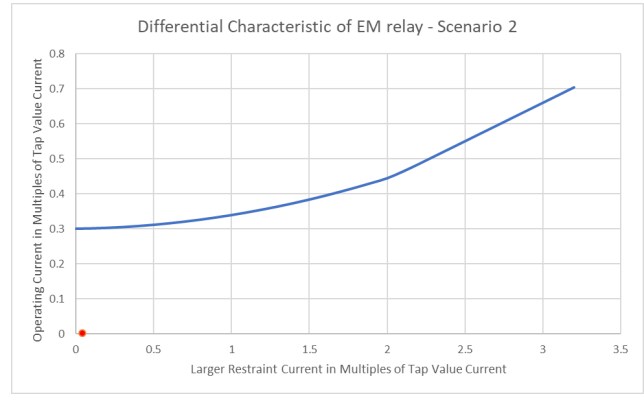
Fig. 7. Differential characteristic for scenario 2

Scenario 2. According to field personnel, the motor has an FLA value of approximately 30 A at the 12.47 kV level, which is 2.7 A on the 138 kV side. Assuming that no other load is energized on Bus A, the restraint current is ~ 0.04 pu on each side of the transformer, while the operate current is very close the 0. Figure 7 shows the differential characteristic for scenario 2.

$$I_{RT_1(pu)} = \frac{I_{138kV}}{CT_{W1} * TAP_1} = \frac{2.71}{20 * 3.2} = 0.042 pu \quad (2.1)$$

$$I_{RT_2(pu)} = \frac{I_{12.47kV} * \sqrt{3}}{CT_{W2} * TAP_2} = \frac{30 * 1.732}{240 * 5} = 0.043 pu \quad (2.2)$$

$$I_{OP(pu)} = |I_{RT_1(pu)} - I_{RT_2(pu)}| = |0.042 - 0.043| = 0.001 pu \quad (2.3)$$
