**ELECTROMECHANICAL DIFFERENTIAL RELAYS
MISOPERATION AND INVESTIGATION
PART 2**

**BY: ALEX RANGEL, P.E.
SABER POWER SERVICES**

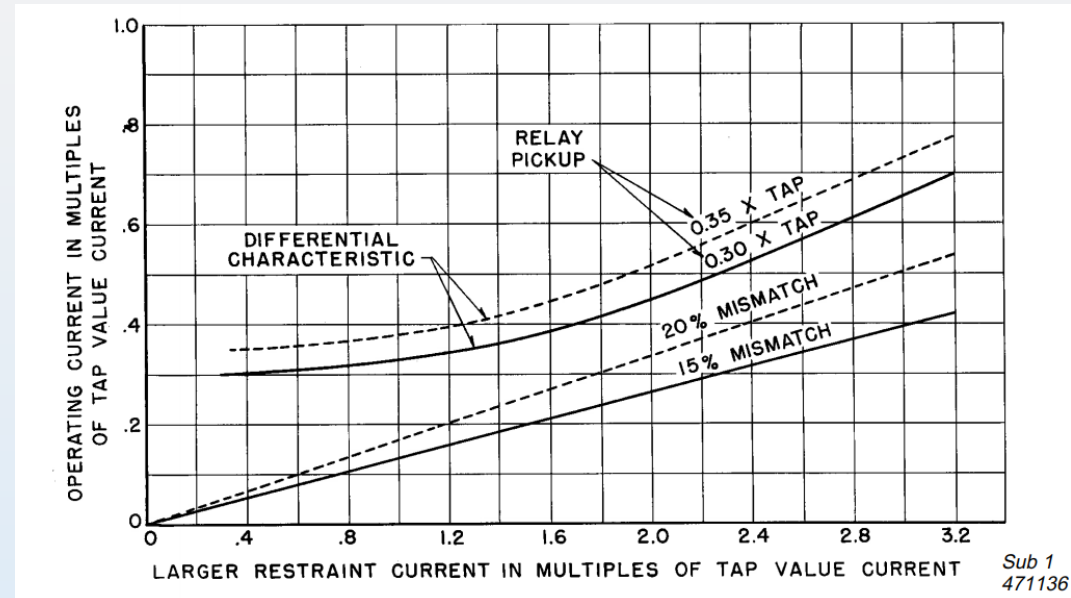
- Per the instruction manual:
 - “The operating current required to close the contact of the differential unit expressed in percent of restraint current varies with the magnitude of the larger restraint current. To use these curves, divide each restraint current by the appropriate tap and enter the horizontal axis using the larger or largest restraint multiple. Then enter the vertical axis, using the difference of the restraint multiples.”
